# Aquatic Facility Audit

AQ1-0224-DR1, Revision A

## Cleveland Aquatic Centre

**REDLAND CITY COUNCIL**

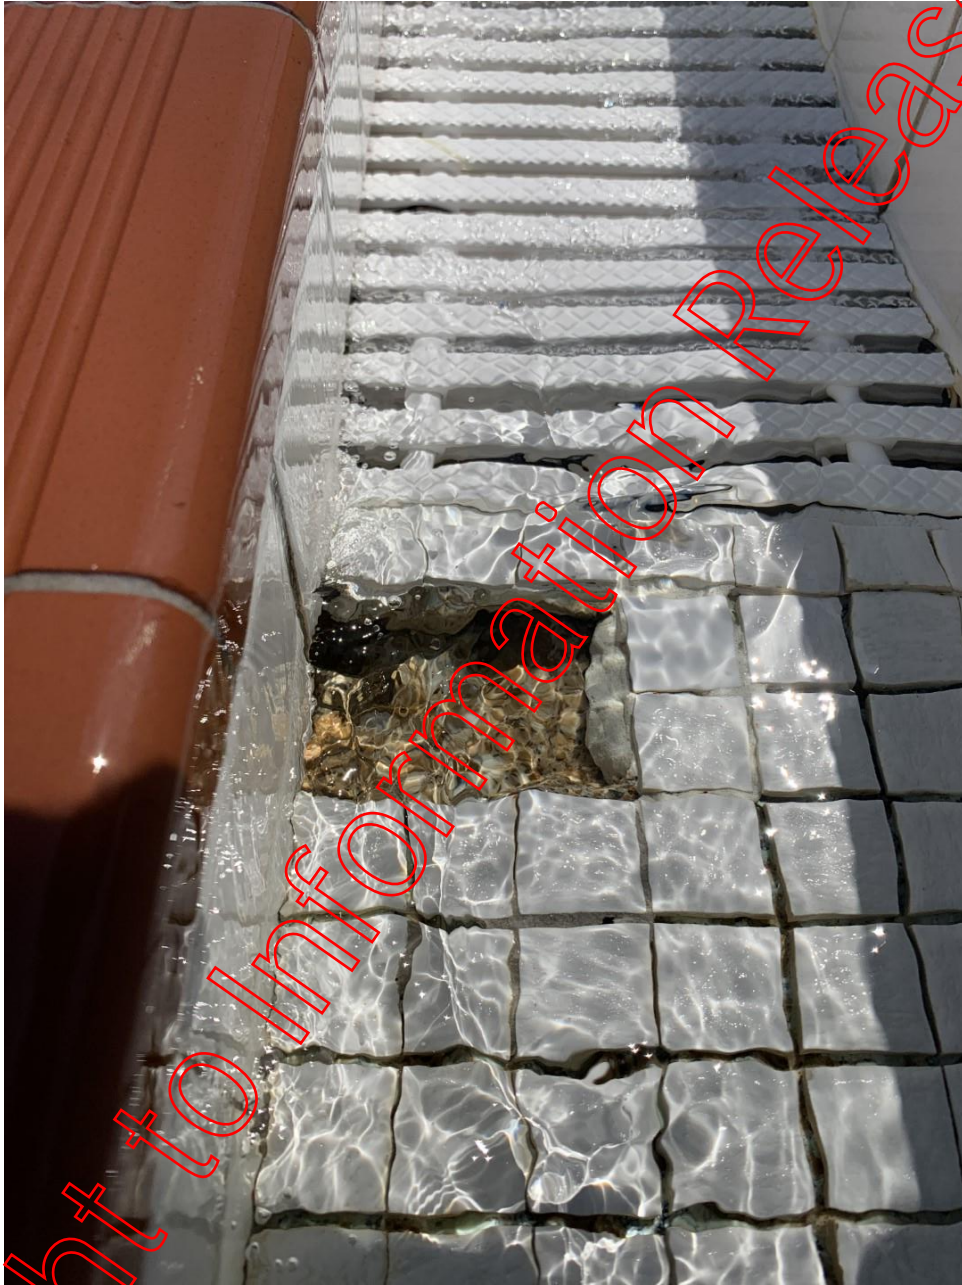
- Tiling in the wet deck gutters is failing in places.
- The tiling in the floor of the pool is not slip-resistant. Activities in the pool that require friction to the floor (such as aqua-aerobics, LTS and the like) have an increased risk of injury if slip resistant finishes are not utilized.

Figure 4: Failed tiling in gutter floor

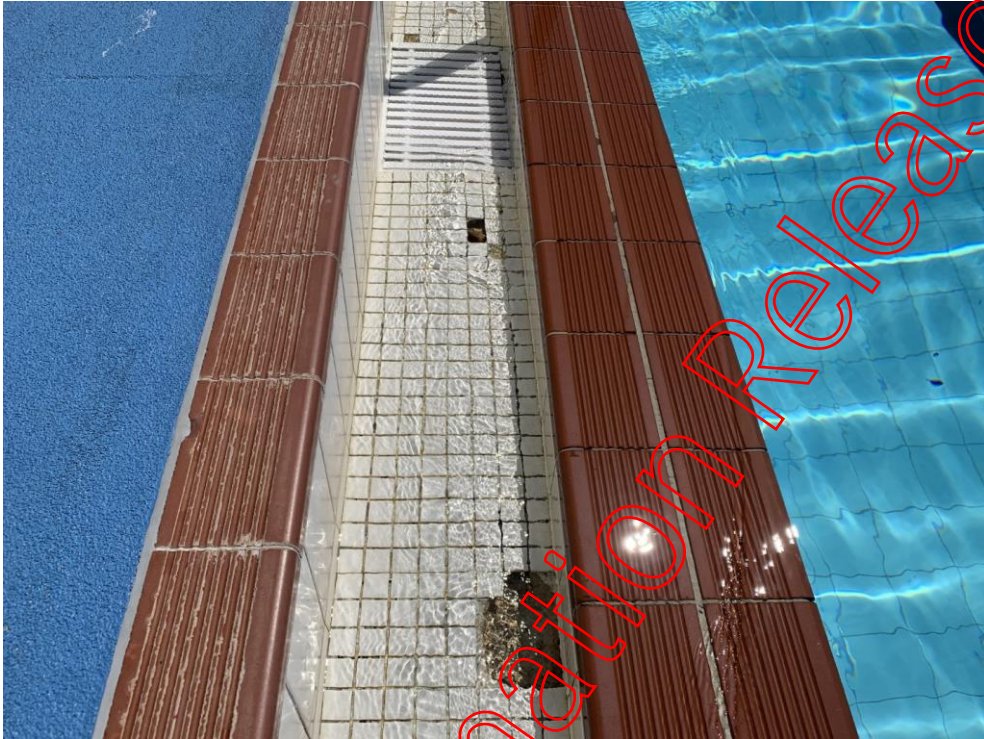
Figure 5: Damaged tiling in open gutter

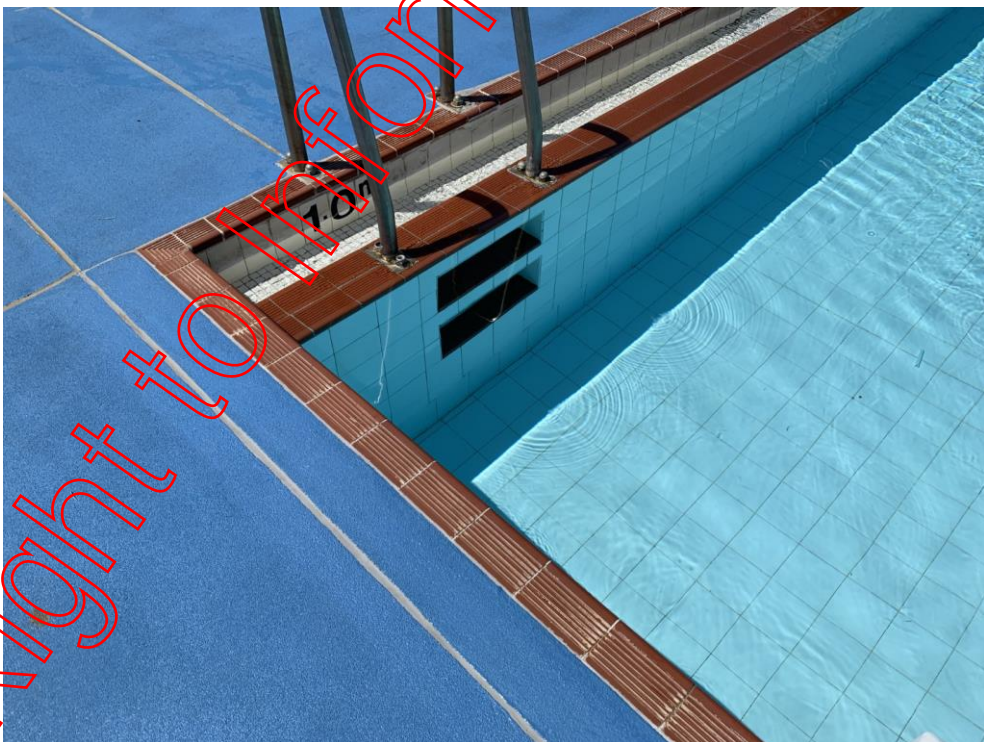
Figure 6: Steps into pool over gutter presenting injury risk

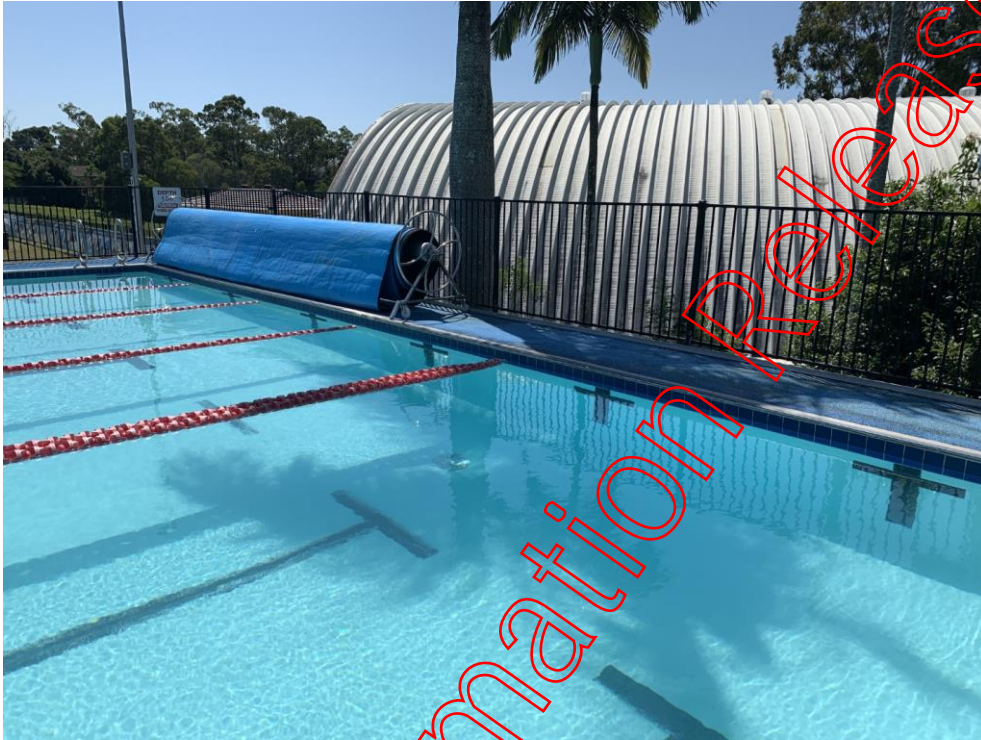
- At the time of the inspection, the pool was very cloudy. This is a reported problem by the operators, with indications that the painted internal finish is failing. This paint failure is observed in particular areas of the pool, where the finish has severely degraded and the underlying structure is visible, indicating poor installation techniques in these areas.
- Flow through the pool appears to be very low. Water ebbs into the skimmers whereas it would usually have a visible flow.
- None of the skimmers are fitted with strainer baskets, which can result in pipework blockages.
- None of the filtered water returns to the pool have a fitting such as an eyeball present. Instead, open pipes are present in the pool which could become a hand entrapment.

- Access around the pool does not comply with Royal Lifesaving Guidelines for Safe Pool Operation (min 1000mm for low traffic areas, min 3000mm for high traffic areas).
- A crack was observed in the pool wall at the upper level. This crack appears minor, however the fiberglass liner makes observation of other structural issues difficult.

*Figure 11: Cloudy water, poor access across end of pool*

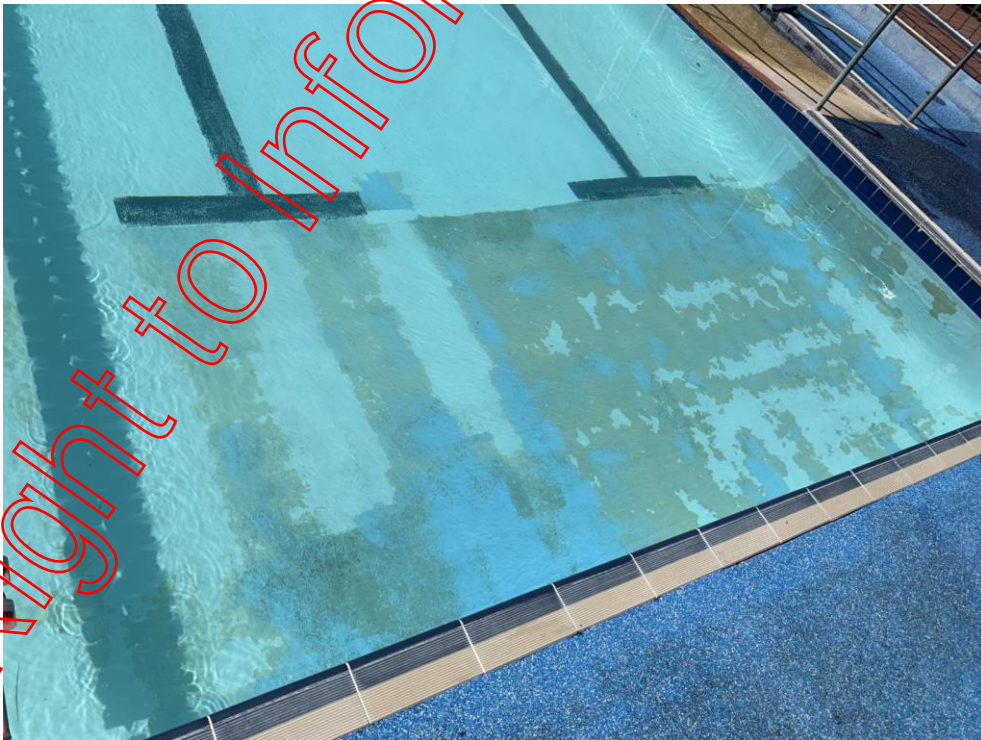
*Figure 12: Region of failed finish in pool*

- The painted finish in the pool is at the end of life and requires replacement, noting that also the fiberglass liner below the pool may be problematic due to its age. A higher-level approach towards the pool finish is required as discussed in the *Conclusions* section.
- The low flow through the filtration system is impacted by several factors, including the pipework, plant and pool fittings. This is discussed further in the *25m Filtration Plant* section.
- Provide strainer baskets to the skimmers.
- Provide eyeball fittings to the outlets.
- Review access in and around the pool and apply a risk assessment to mitigate movement and access risks.
- If the liner is to be removed, undertake a detailed structural assessment of the underlying structure.

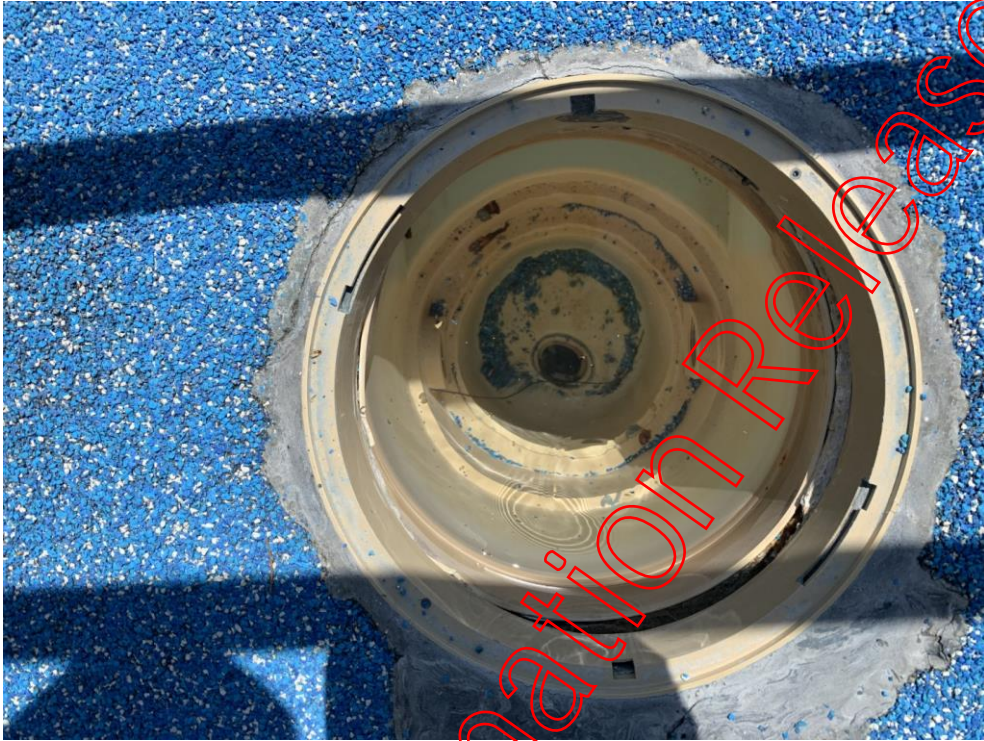
Figure 13: Skimmer without basket

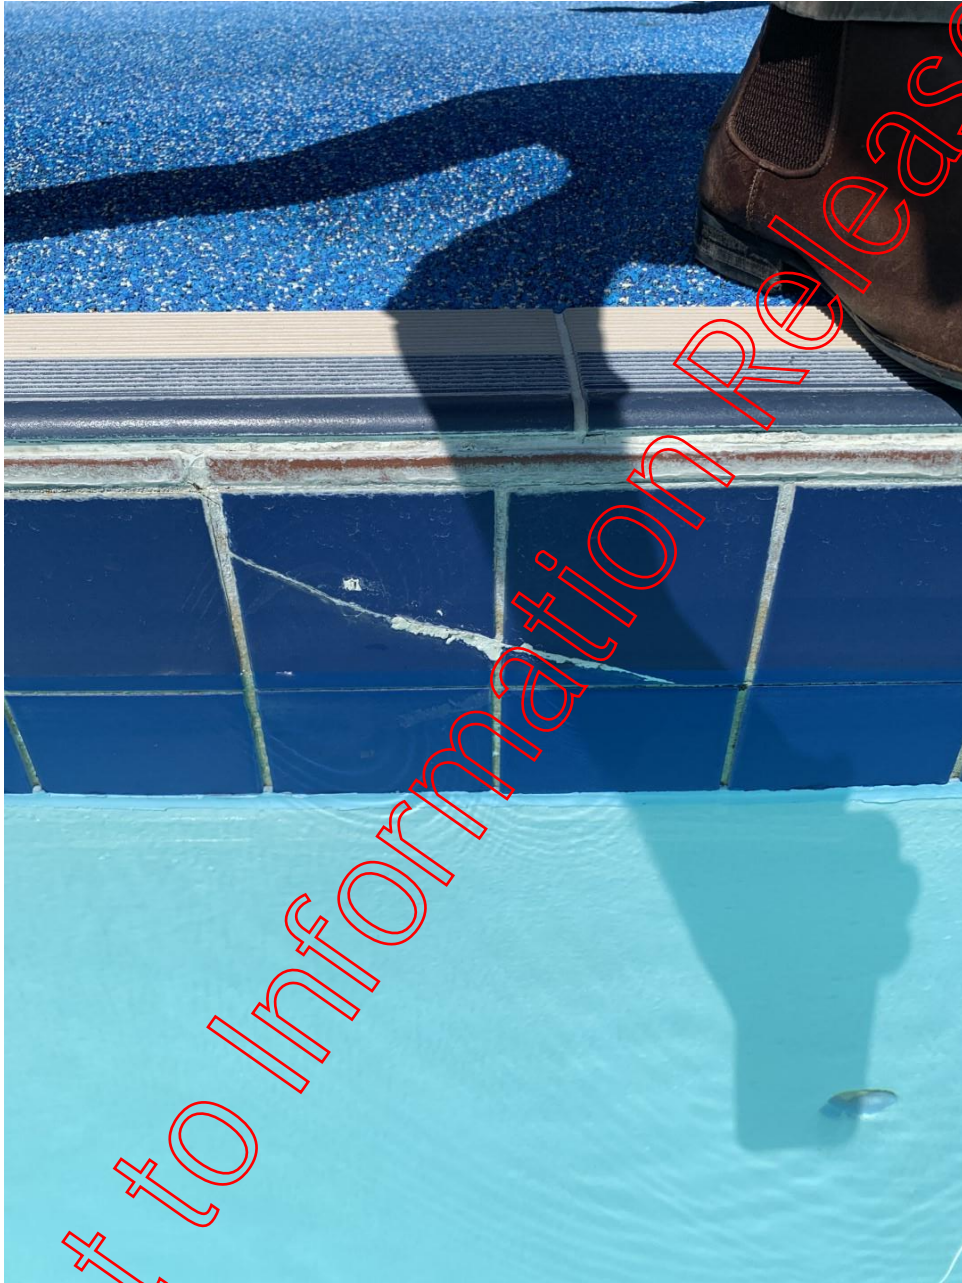
*Figure 15: Crack in structure*

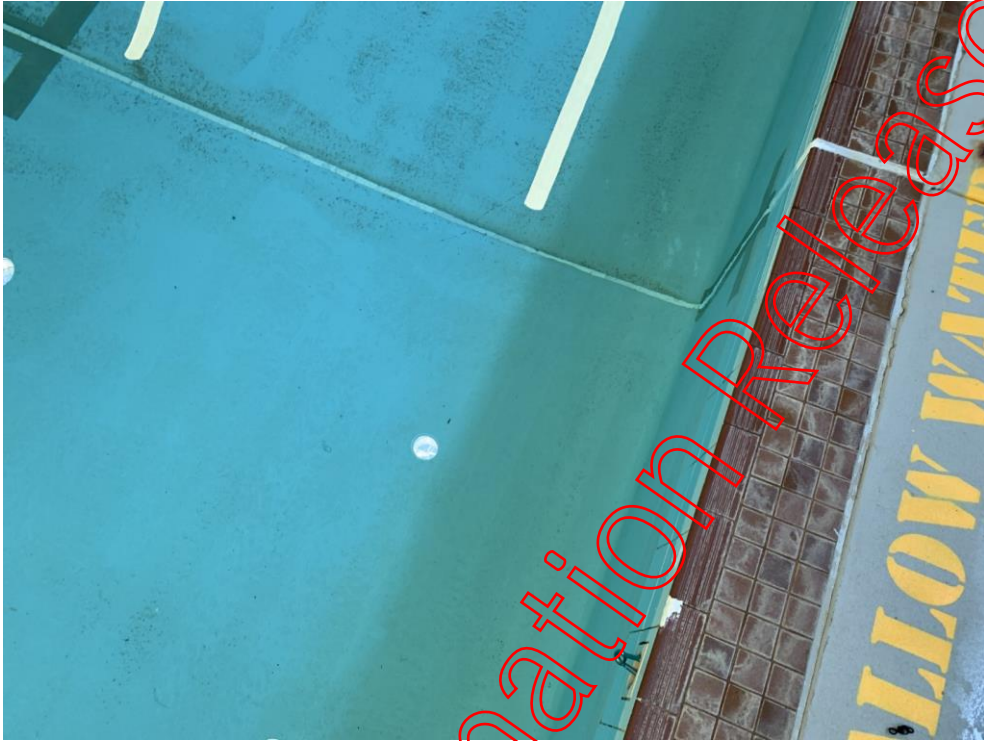
Figure 22: Failing finish on floor of pool

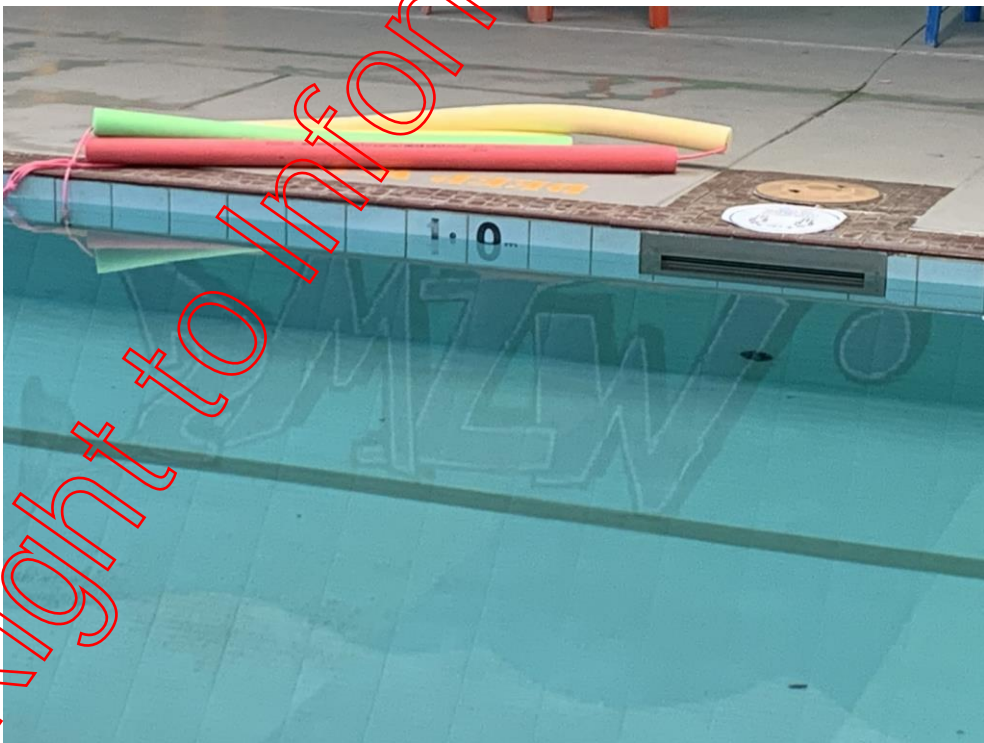
Figure 23: Submerged depth marker

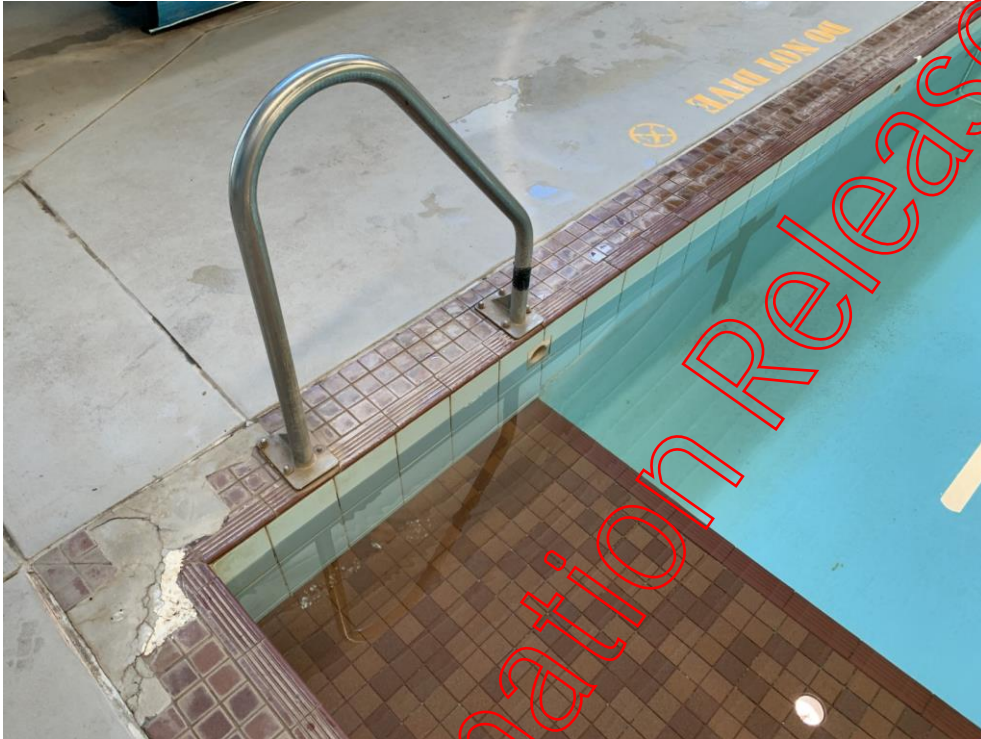
Figure 24: Damaged tiling, non-compliant access

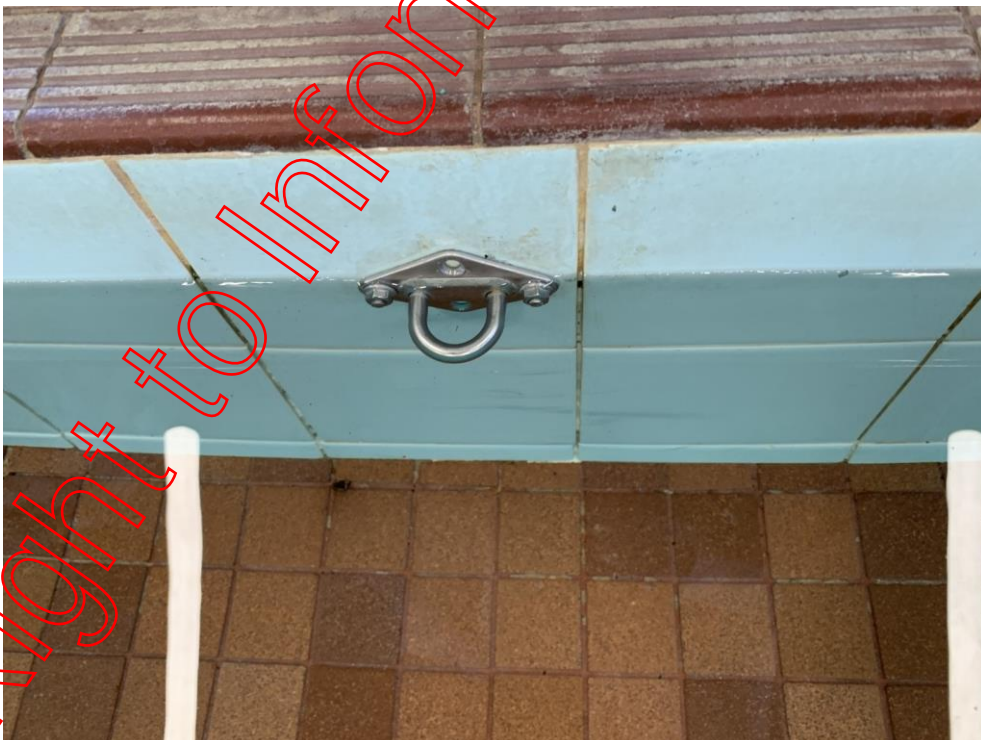
Figure 25: Prominent anchor point

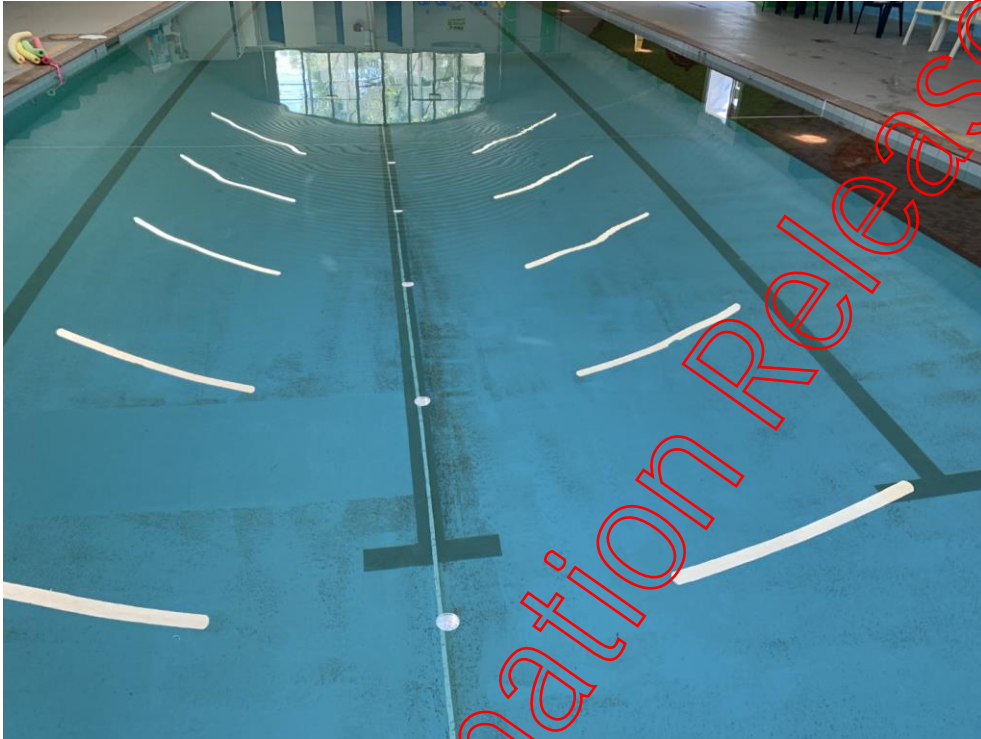
Figure 26: Wearing floor finishes

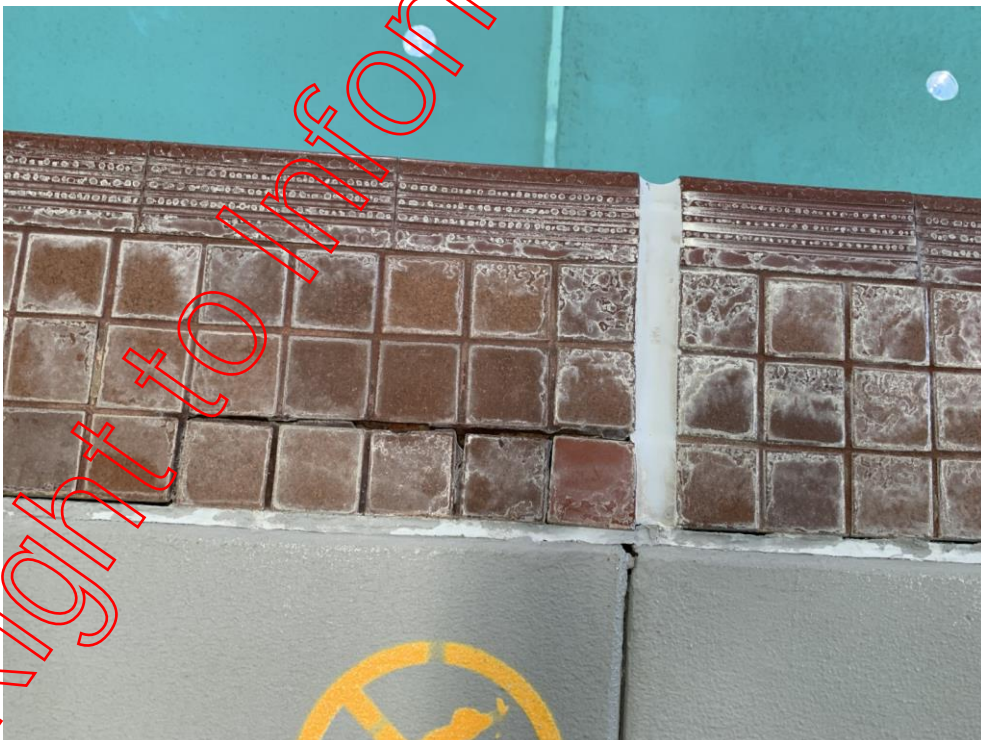
Figure 27: Degraded / damaged finishes

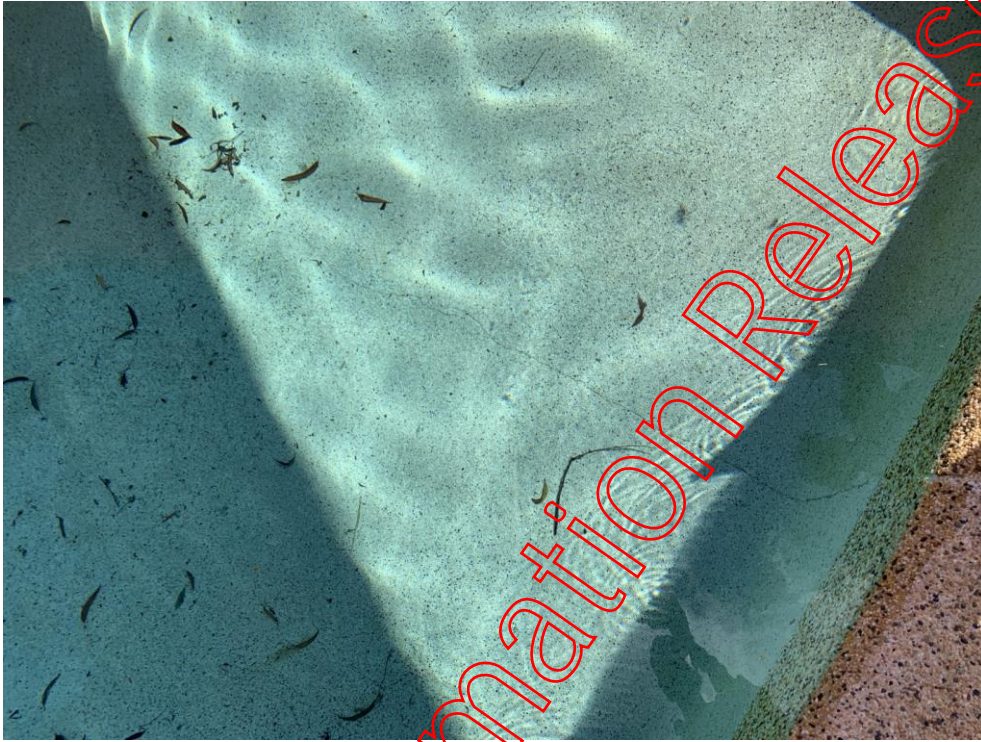
- Cracks are observed in the pool structure. The majority of the cracks appear to be relatively minor cracks at the tops of the walls likely a result of under-reinforcement in the coping, however one larger crack appears to continue across the entire pool at the waterslide landing zone region.

Figure 29: Crack across pool floor on eastern side

- Undertake dye testing on the pool cracks to determine if there's leaks. Inspect the cracks closely during the dye testing to measure the width and attempt to determine if the cracking continues through the substructure or is primarily in the finishes level. Obtain specific direction following these works.

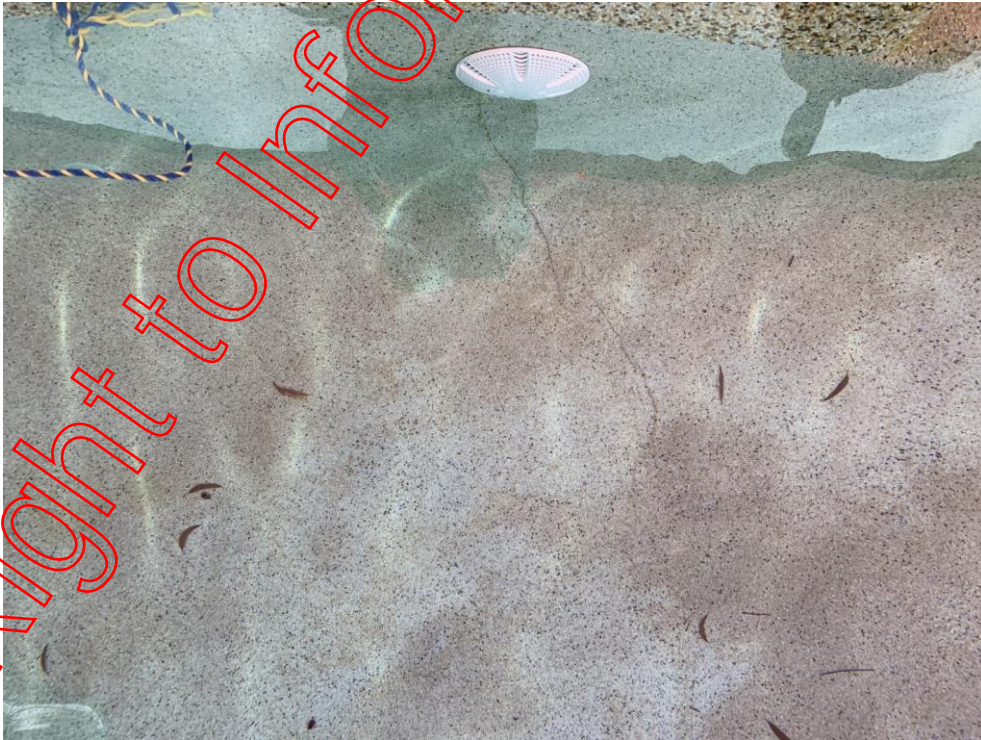
Figure 30: Crack across pool floor on western side

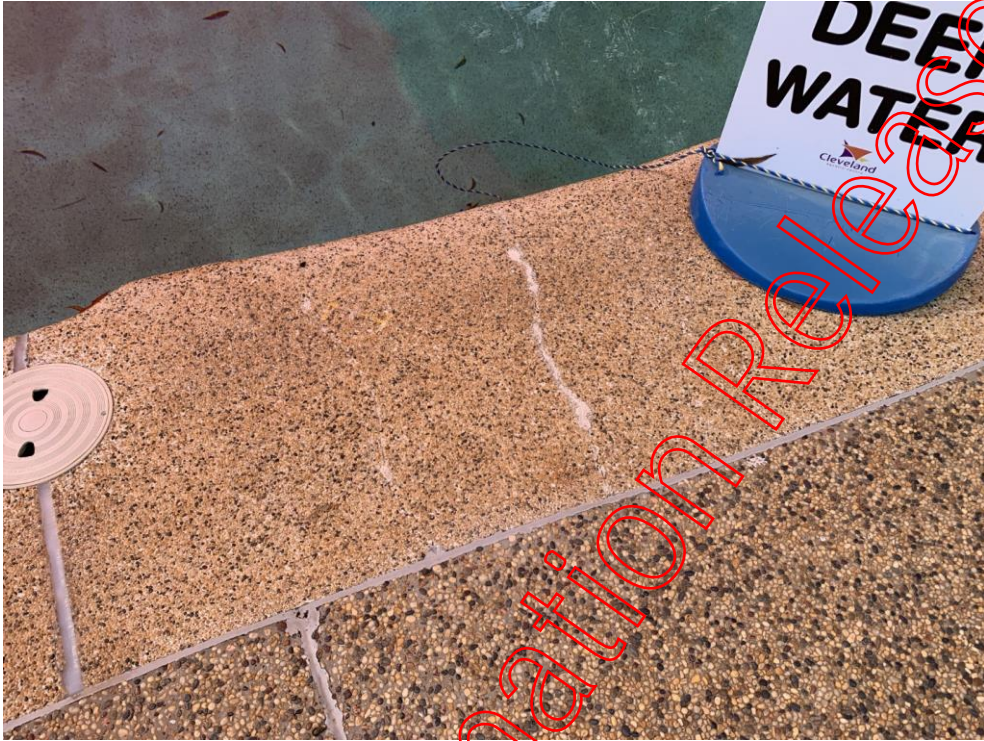
Figure 31: Cracks in coping

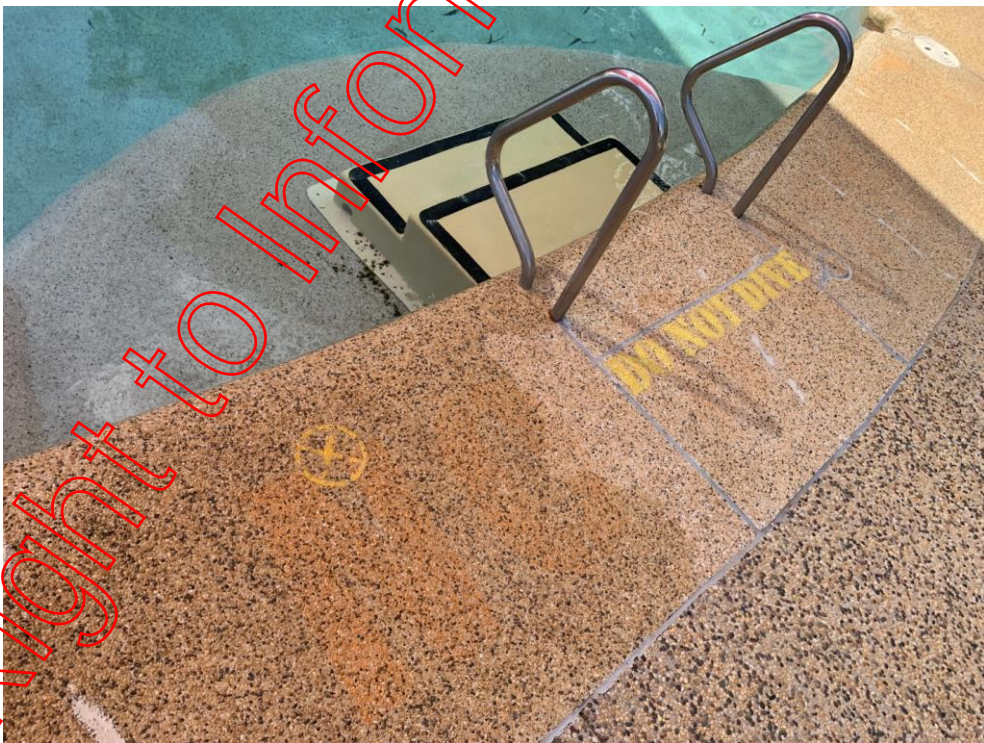
- A set of fiberglass stairs have been added to the waterslide splash down area above a bench. These only reach the bench.
- Signage around the pool is generally lacking or incorrect. For example, a warning sign adjacent the waterslide landing area notes 'deep water' however the pool is only 900mm deep here. This may cause confusion.

Figure 32: Cracks in coping, fibreglass stairs

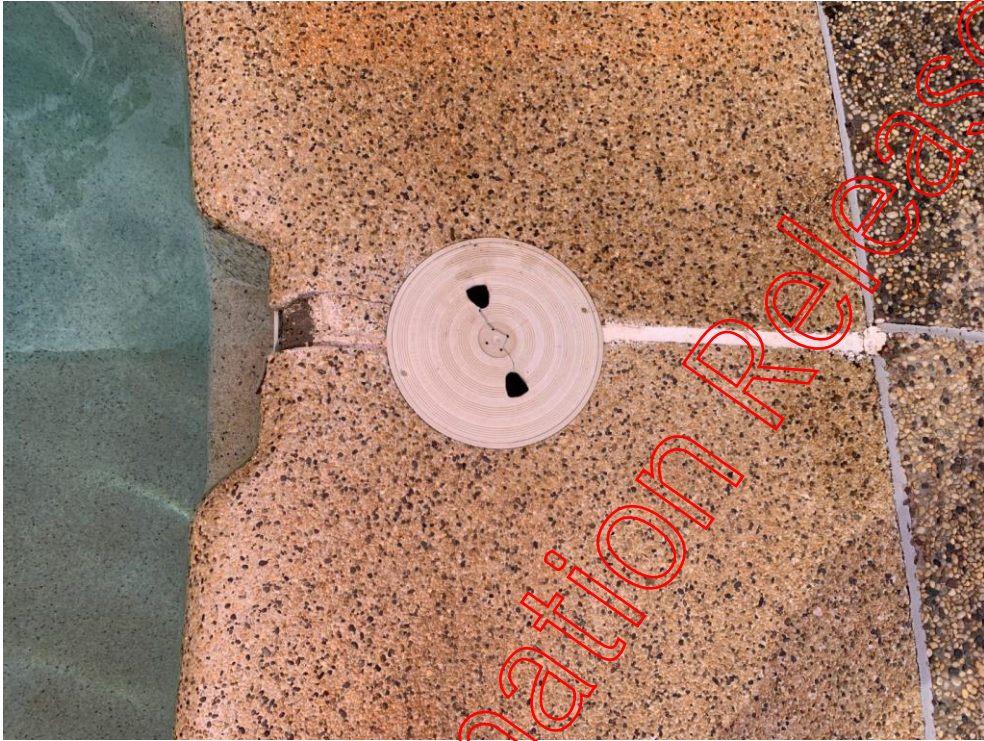
- Skimmer lids are not secure and some are cracked.
- The pool contains a mixture of old pebblecrete and new pebblecrete. The newer pebblecrete appears to be degrading, with the cement layer appearing to have been subjected to chemical attack.
- Safety suctions are provided adjacent each skimmer, assumed to be relief lines. The covers appear to be older covers and not compliant with current standards.
- The connection of the wall suctions shown in the pool and the feature system could not be confirmed. It's not sure if the system is installed in compliance with AS1926.3 *Suction Entrapment*.

Figure 33: Broken skimmer lid

- Service the water toys.
- Replace all skimmer lids with secure fitting items.
- Confirm consistent water quality is being maintained in the pool, including having the pool in a slightly scale-forming state. Undertake a detailed assessment of pool finishes for condition.

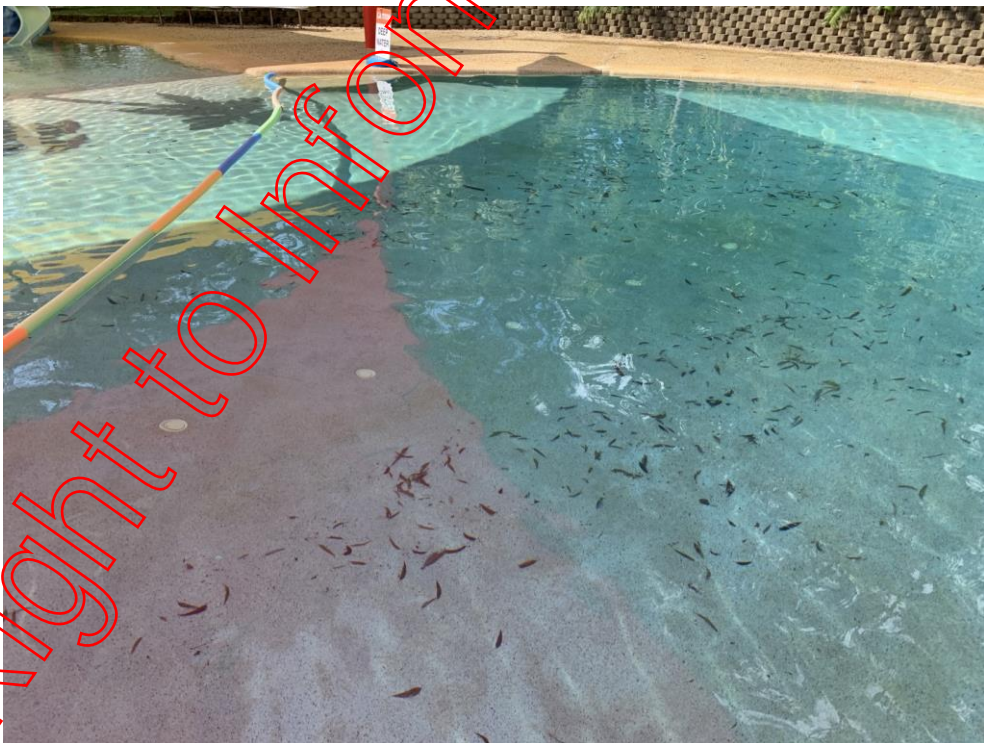
- Circulation through the pool appears low in areas. A large amount of leaf material was observed in the pool and in the shallow region some of these leaves sat on the filtered water returns without moving.

Figure 34: Leaves in deep region blown away from returns

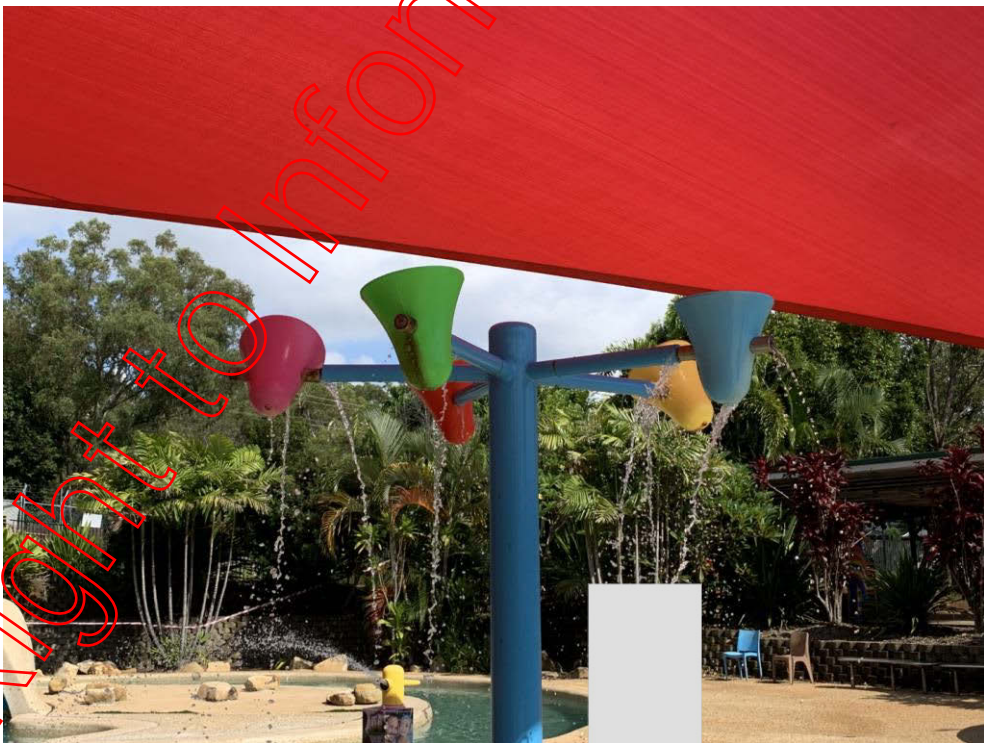
- Water toys need servicing. Several blocked nozzles were observed.

Figure 38: Jammed bucket

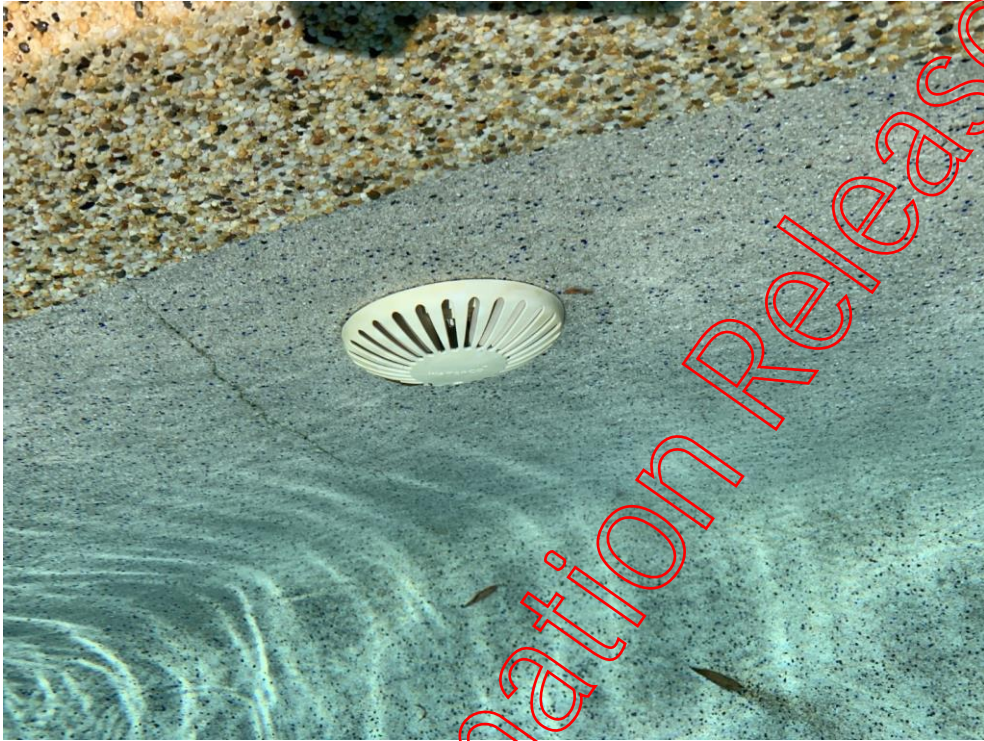
Figure 39: Older safety suction, crack in wall

- Replace all non-compliant safety suction fittings with AS1926.3 compliant covers.
- Review as-constructed documentation if located and undertake circulation and flow testing on all pool suction lines (primarily for features and skimmer balance pipes) to confirm the direct suction systems are in compliance with AS1926.3. Undertake appropriate rectifications where not.

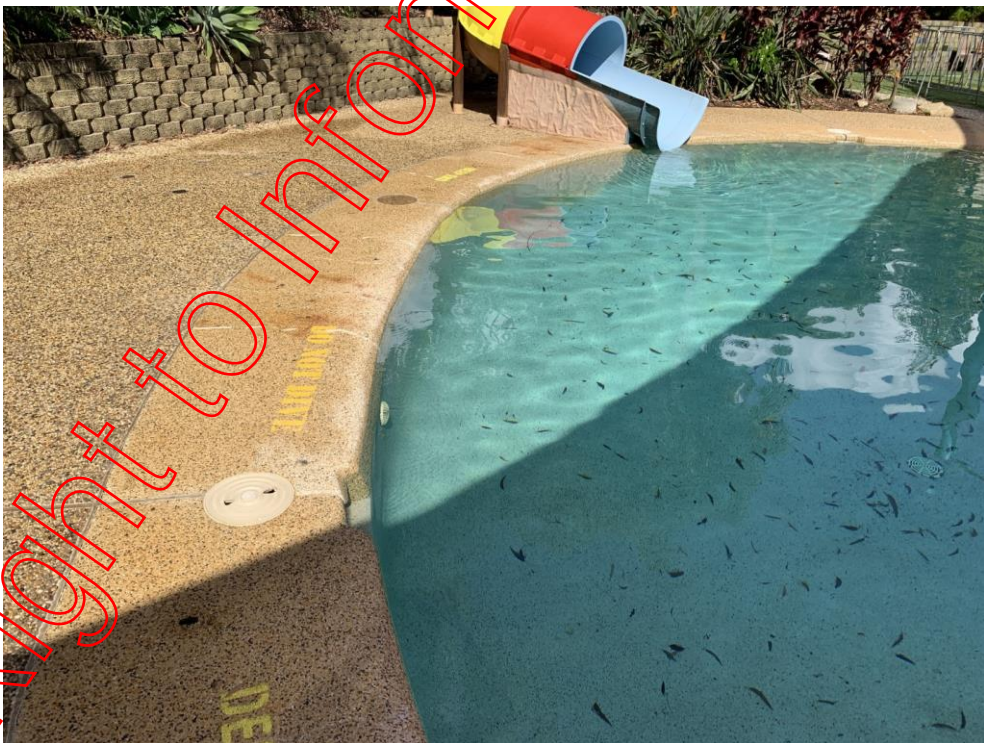
Figure 40: Cracks in coping

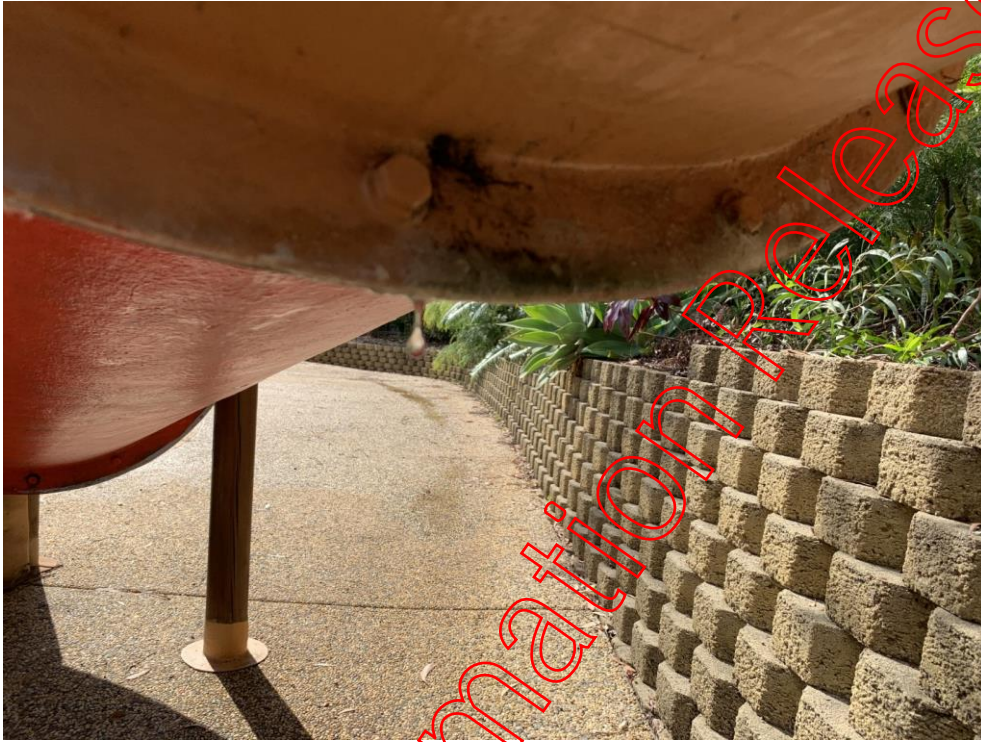
- The waterslide is leaking at several of the joints.
- The access structure to the waterslide is notably rusted.
- The waterslide obstructs access around the end of the pool. People are likely to duck under the slide to get around the end of the pool, which could result in a head strike.
- The astroturf area in front of the slide access way is lumpy and a trip hazard.

Figure 42: Leaks from slide flume

- As a minimum, refurbish the slide and access way and undertake regular inspections of the timber support posts for rot and degradation. For long term planning, consider whether the slide is fit for purpose and the risks are considered appropriate.

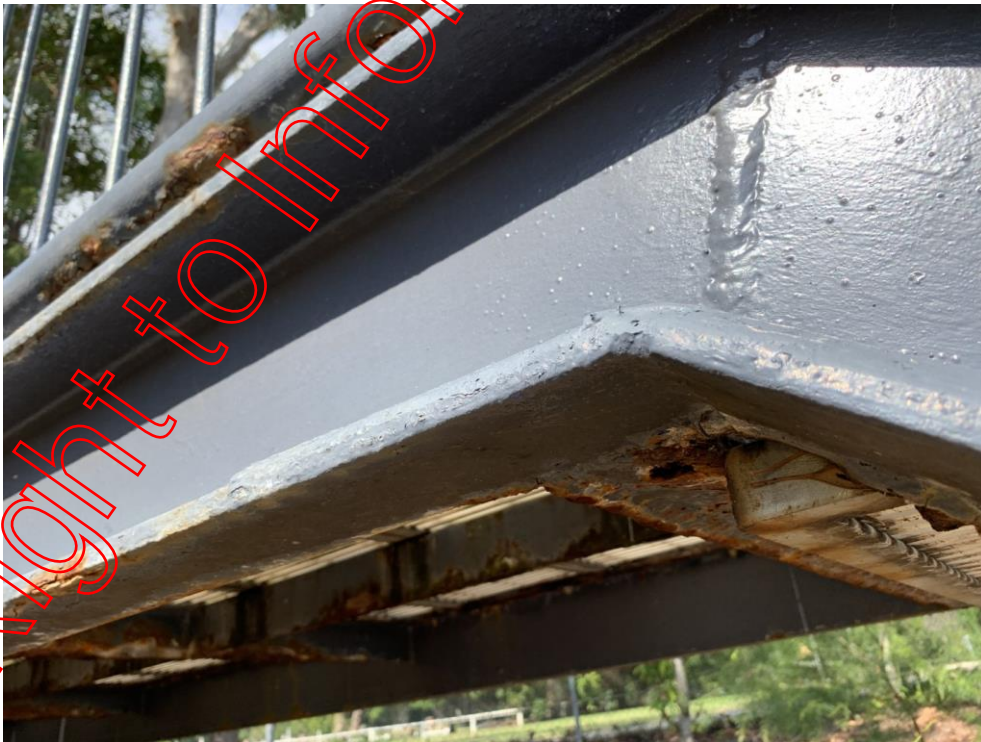
Figure 43: Rust under slide access way

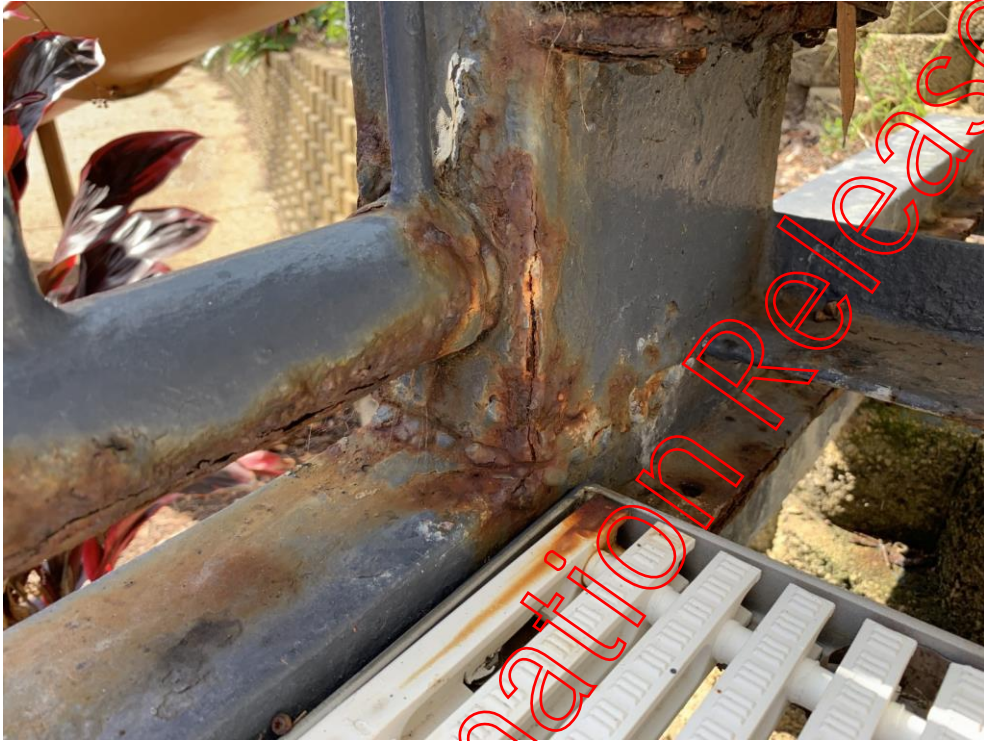
Figure 44: Rust in slide access way

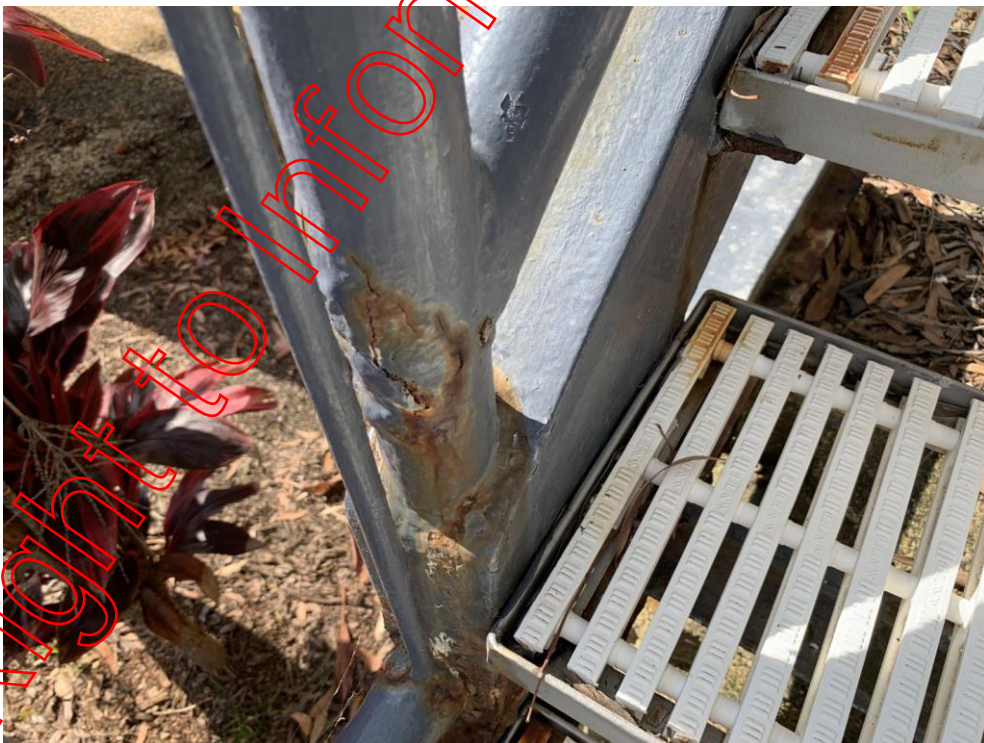
Figure 45: Rust in slide access way

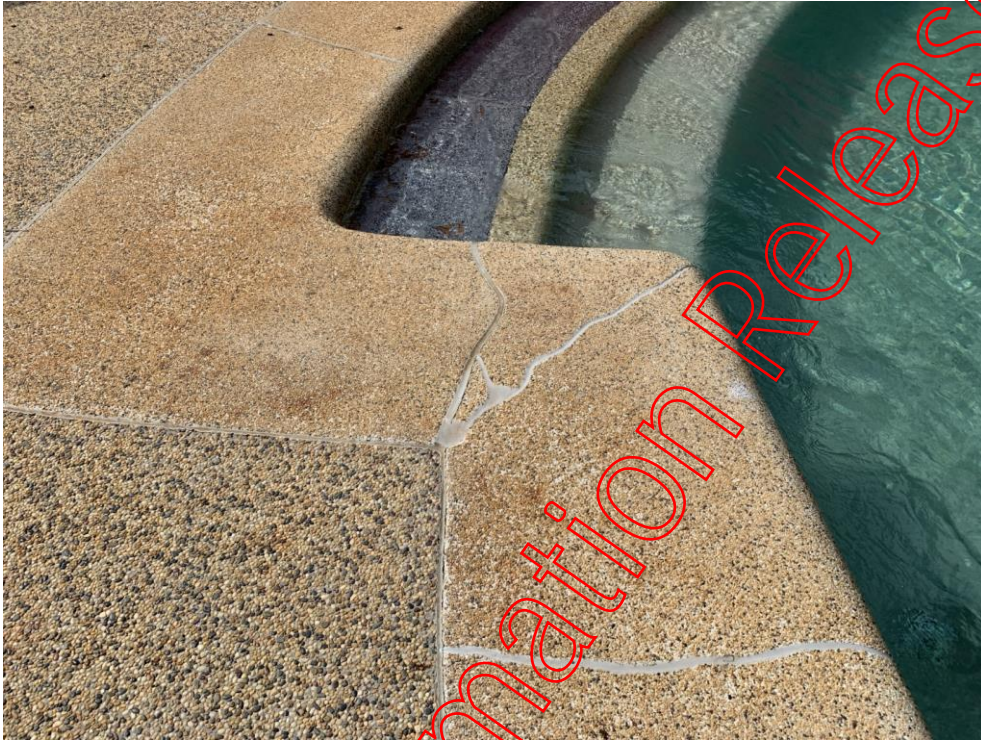
- A significant number of cracks are observed in the pool structure. The coping of the pool is regularly cracked with hairline cracks that appear to be relatively minor and likely a result of under-reinforcement in the coping. Several larger cracks are present in the walls of the pool which are larger than hairline that raise concern regarding the structural integrity of the pool. These cracks are vertical in the wall on the island and across the coping around the outlet grate. Additionally, a mass concrete bench is present in the pool which has large cracks at one end, indicating it is unreinforced.
- Filtered water returns in the floor of the pool have no water flow. This is likely due to the change in the filtration system, where the original filtration connections have been disconnected and the filtration system run in parallel

*Figure 47: Numerous cracks in pool coping*

- Undertake dye testing on the pool cracks to determine if there's leaks. Inspect the cracks closely during the dye testing to measure the width and attempt to determine if the cracking continues through the substructure or is primarily in the finishes level. Obtain specific direction following these works.
