# Aquatic Facility Audit

AQ1-0224-DR1, Revision A

## Cleveland Aquatic Centre

**REDLAND CITY COUNCIL**

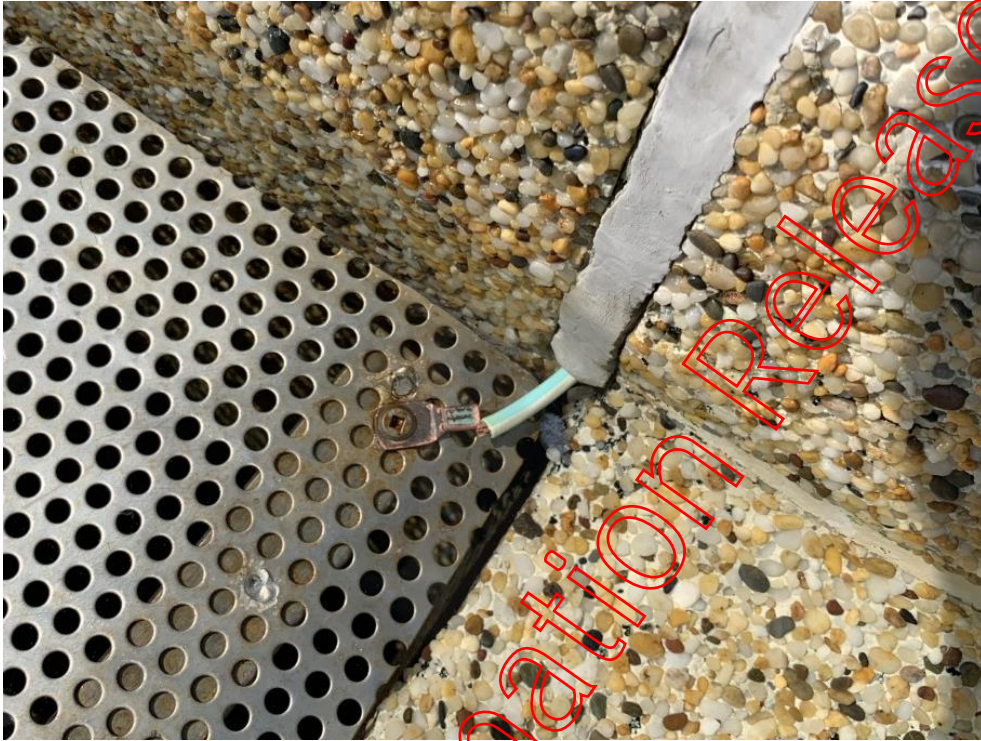
- Patches of the floor finish are missing. These are typical where the pebblecrete finish has delaminated from the base concrete structure either due to age, structural movement or incorrect installation. Whilst only a couple of areas are currently present it's possible that larger regions have delaminated but have not yet cracked away. Where sharp edges are present a cut risk remains.
- The recesses in the pool floor where the jets are located are potential trip hazards.
- Signage to the pool is poor.
- No compliant access is provided into the pool. A bench is placed in front of the overflow grate assumed to be the intended access however it's too large to comply as a set of steps and is not provided with a handrail.
- The island itself is a visual obstruction to lifeguards.
- The earthing connection to the large stainless grate is broken.

Figure 51: Broken earth connection to overflow grate

- Repair the broken earthing connection
- Provide a cover system to the floor jets

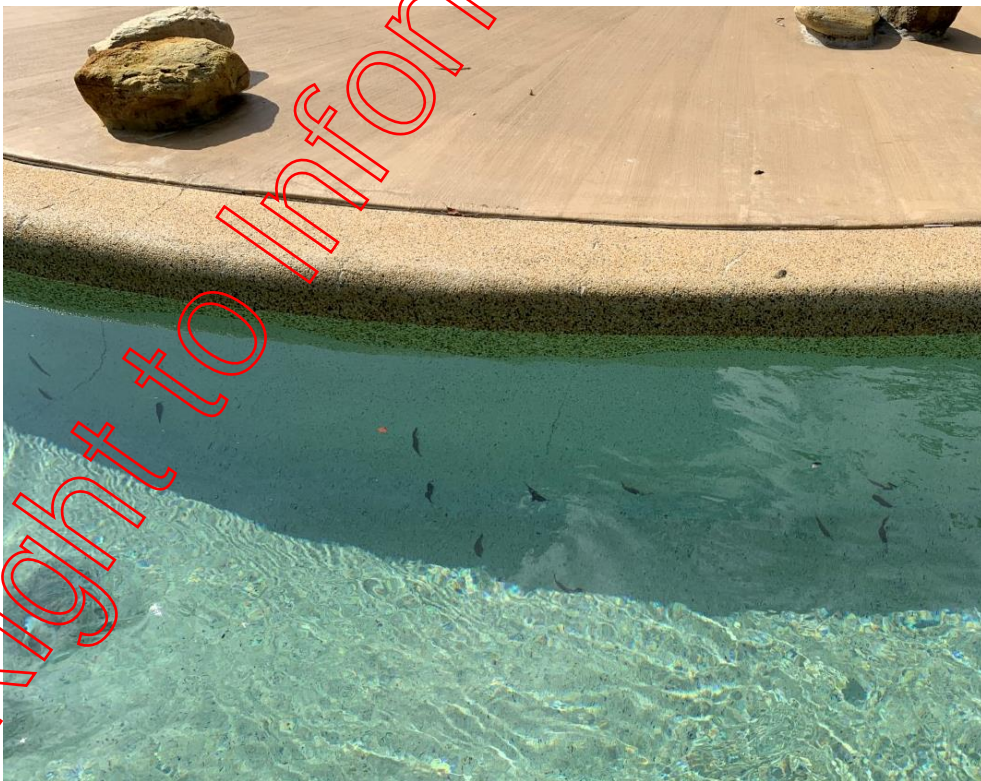
Figure 52: Cracks in pool wall

- Undertake dye testing on the pool cracks to determine if there's leaks. Inspect the cracks closely during the dye testing to measure the width and attempt to determine if the cracking continues through the substructure or is primarily in the finishes level. Obtain specific direction following these works.

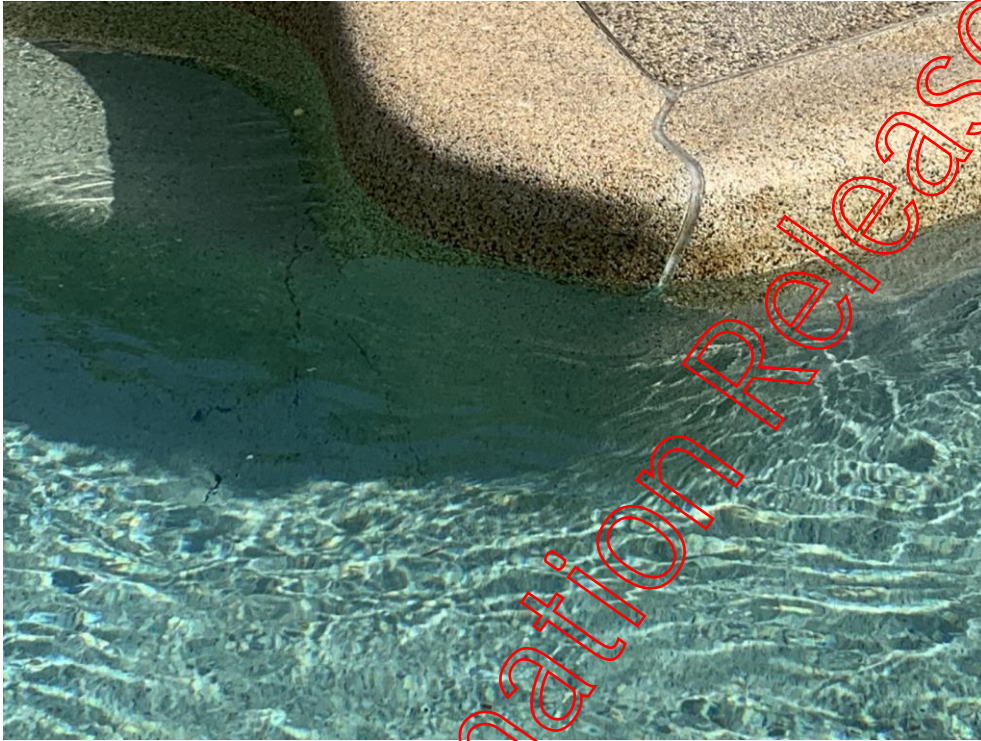
*Figure 53: Cracked bench*

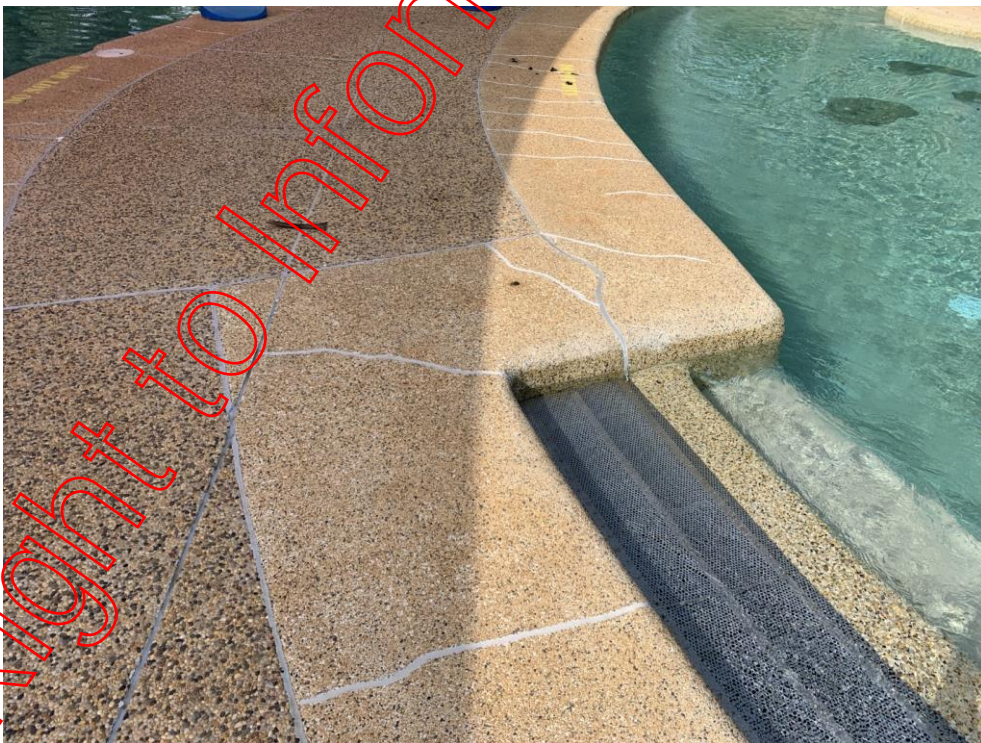
*Figure 54: Sealed cracks at overflow chamber*

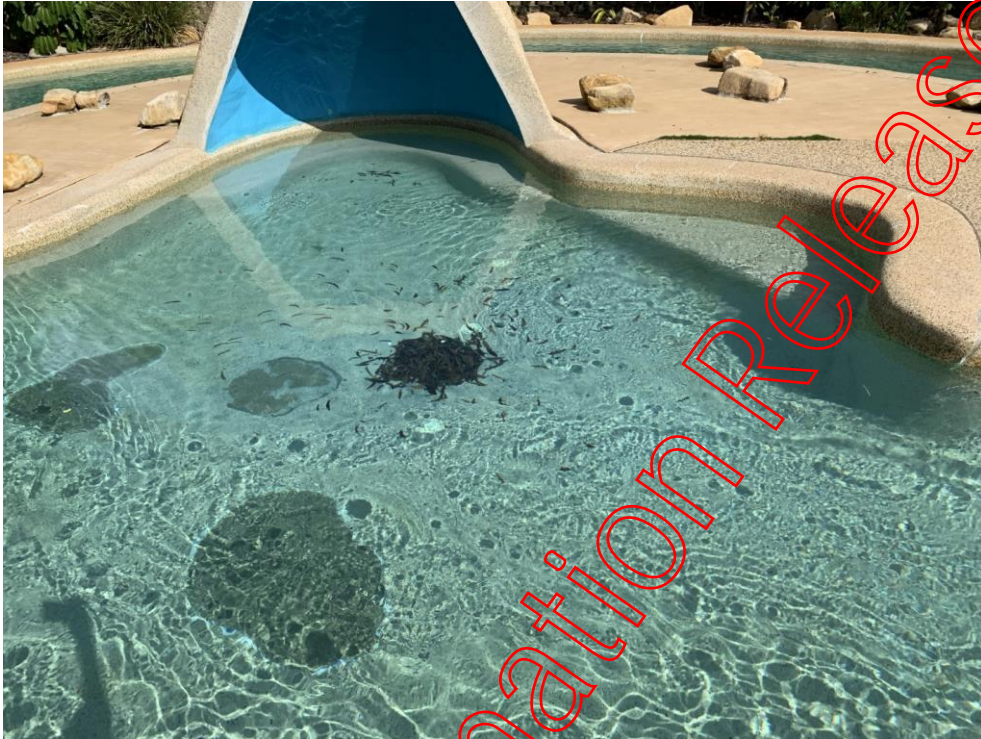
Figure 55: Missing floor finish

- Repair the failed floor finishes sections as a short-term rectification and consider full finishes replacement as a long term. For the repairs, it's recommended to drain the pool, remove any additional loose areas, make good the remaining and inspect the finishes for any other drummy sections.

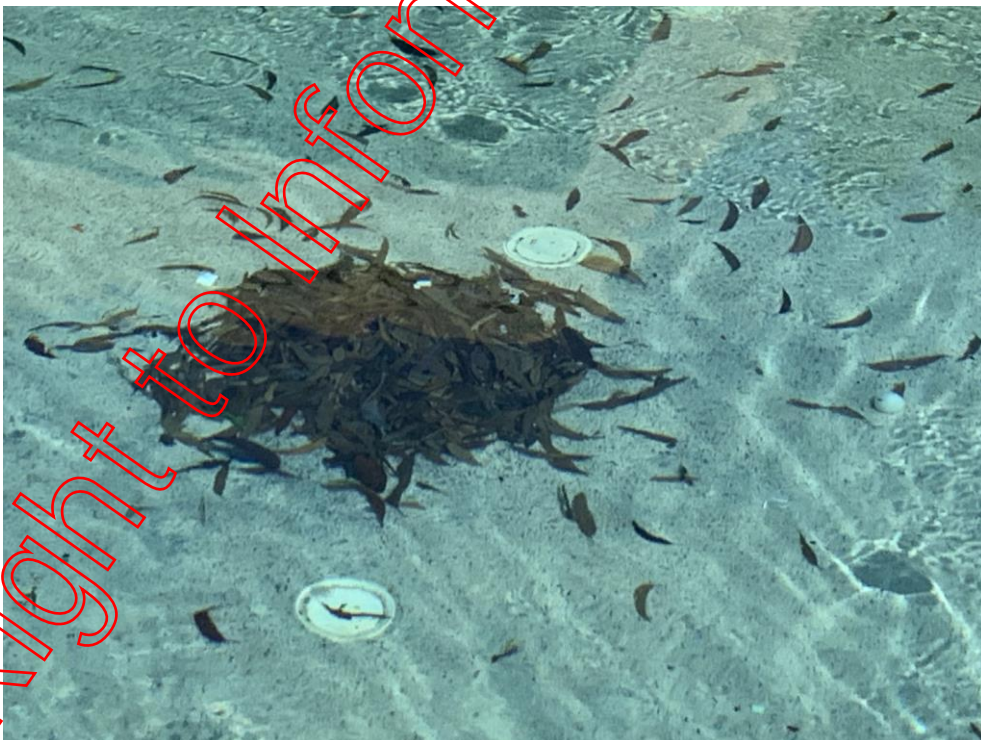
Figure 56: Debris accumulation in pool

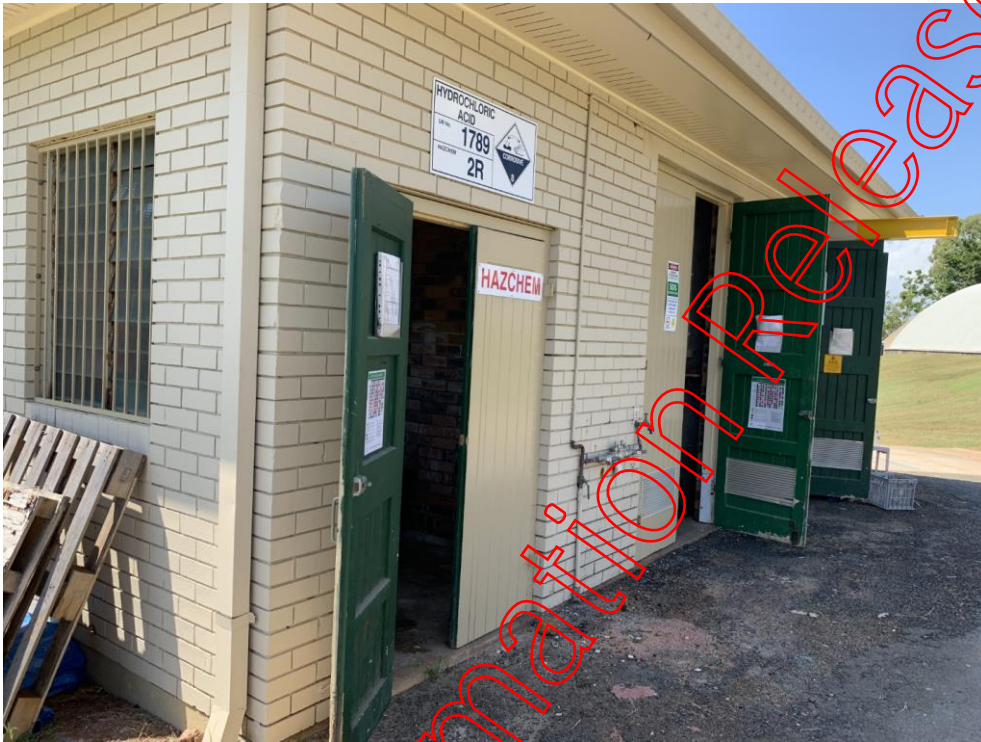
Figure 61: Chlorine unloading area

- Consider converting from bulk liquid chlorine (discussed in the *Conclusions* section) or provide a bunded truck unloading area in accordance with AS3780 *The Storage and Handling of Corrosive Substances*.
- Provide adequate signage to all chemical storage areas including the equipment room exterior and chemical dosing areas. Ensure MSDS's are located adjacent relevant chemical stores and that clear access is available to all chemics.
- Label all pipes with their flow direction and contents and label all valves clearly.
- Re-run the heater circulation pipework to be neater, correctly supported and functional.
- Engage an electrical contractor to provide a full internal condition and compliance audit on the boards and electrical installation.

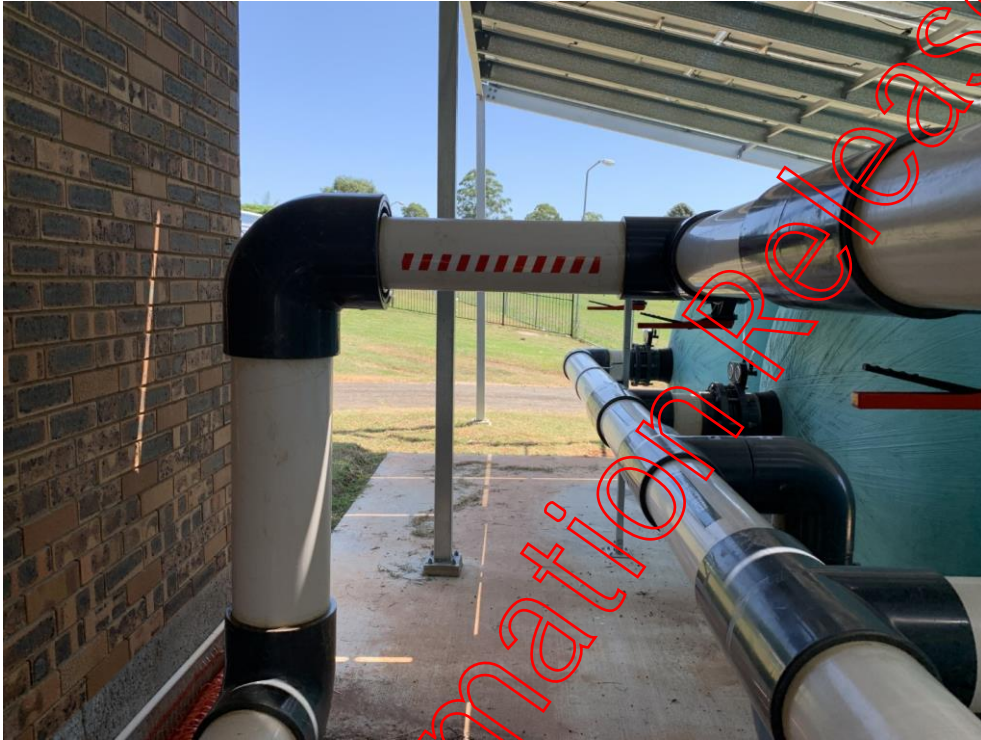
- Access through the equipment area is poor, with the filtration manifold being constructed with low level trip hazards and high-level head obstructions. These items have been marked with reflective tape however still require operators to step over them.
- The filtration manifold is poorly constructed. The system main pipework is sized as DN300 whilst the filter header manifolds are sized as DN200. The pipework drops in size to the DN200 prior to the split at the manifold, needlessly increasing the system velocity and resultant friction loss. As the system flow meter is not functional verification of the actual system flow is not possible, however assuming a nominal system flow of 85 L/s (based on a 5 hour turnover for the pool) this reduction in pipework is potentially adding an additional 1.5m of friction loss to the pool filtration system.

Figure 67: Premature step down of pipe size, head strike

- Rebuild the filtration system manifold to be correctly sized and to avoid trip and head strike issues in areas through walkways.
- Review the operational procedure for removing the hair and lint basket for cleaning and consider the addition of a lifting davit.
- Provide a new chemical controller.
- Consider replacement of the gas heating system with electric heat-pumps.
- Replace failed pressure and flow measurement equipment.
- Label chemical injectors.
- Run all chemical dosing lines in sealed conduits from dosing controllers/pumps to injection points.

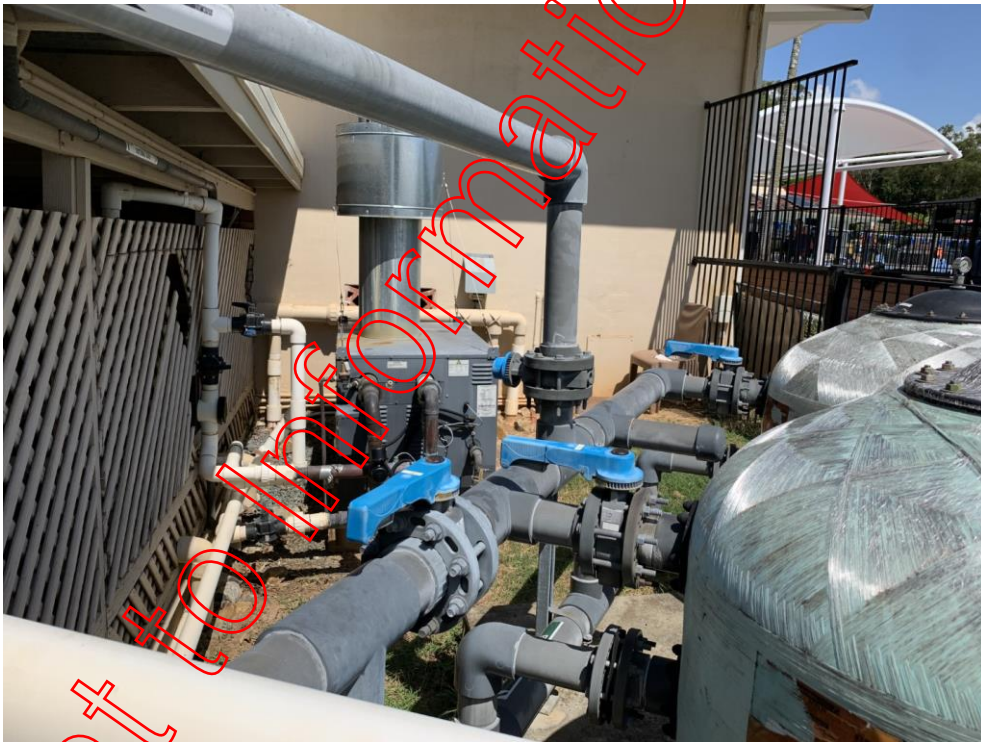
Figure 76: Poor condition external equipment, unsafe access to manifold

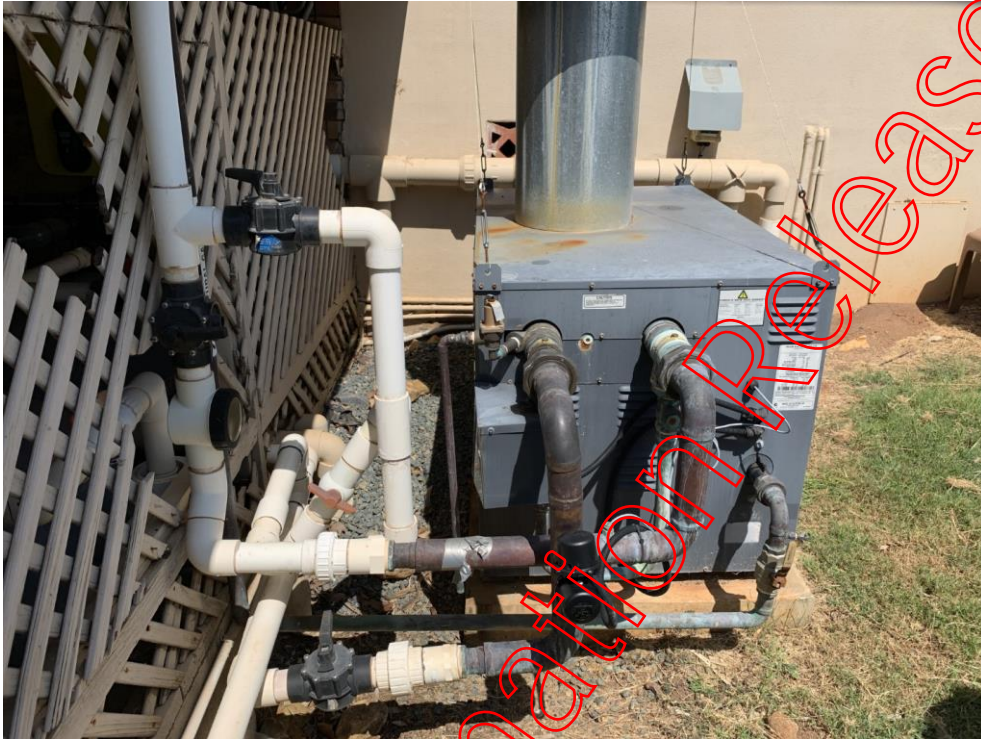
Figure 77: Poorly installed and supported pipe

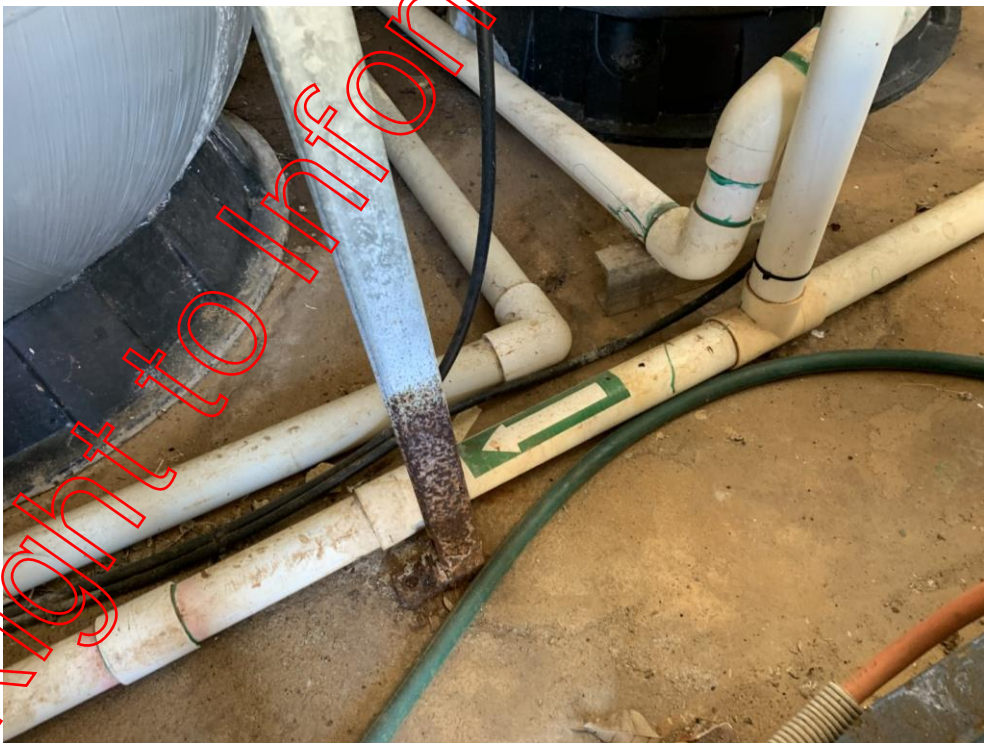
Figure 80: Rusted pipe supports, unsupported pipework

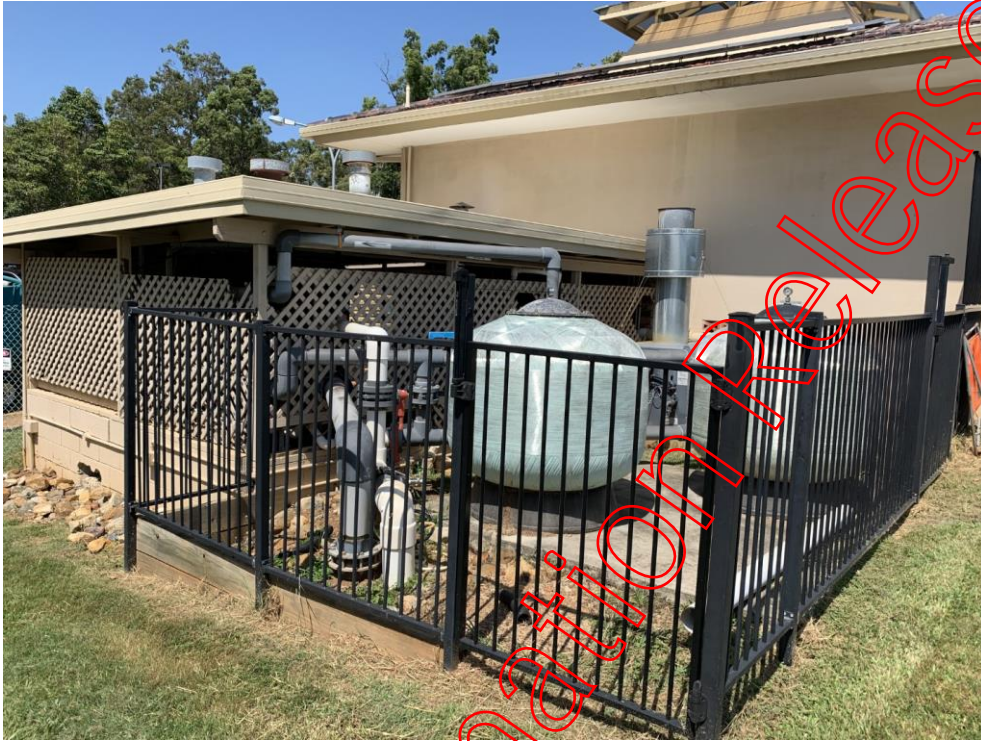
Figure 81: UV Degraded external equipment

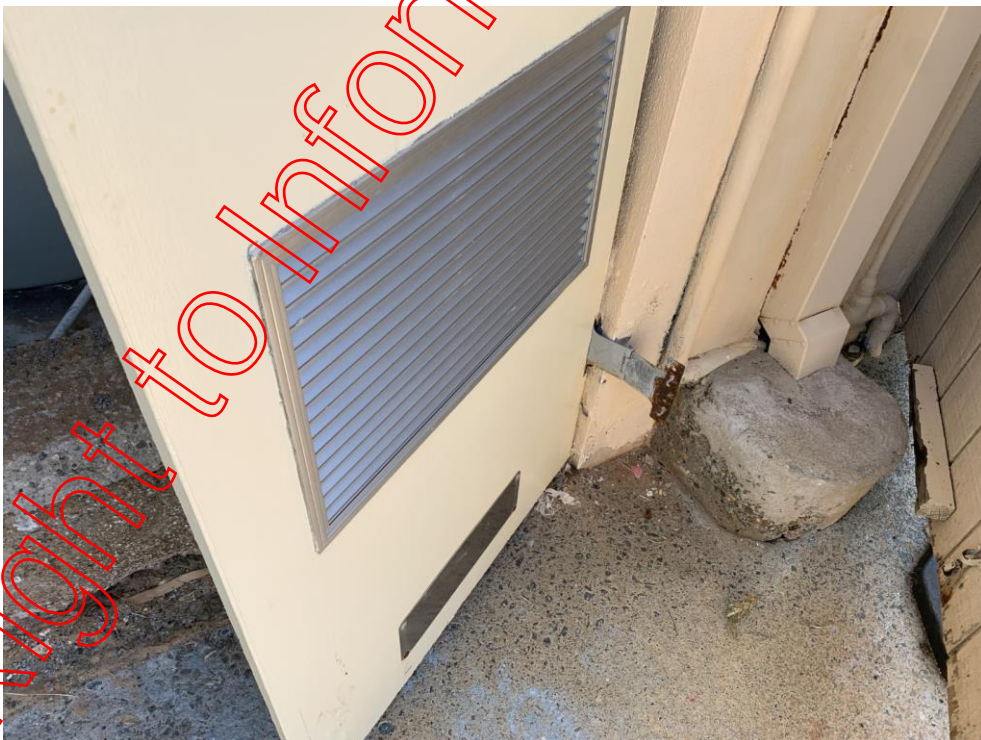
Figure 82: Failed door hinge, poor building condition

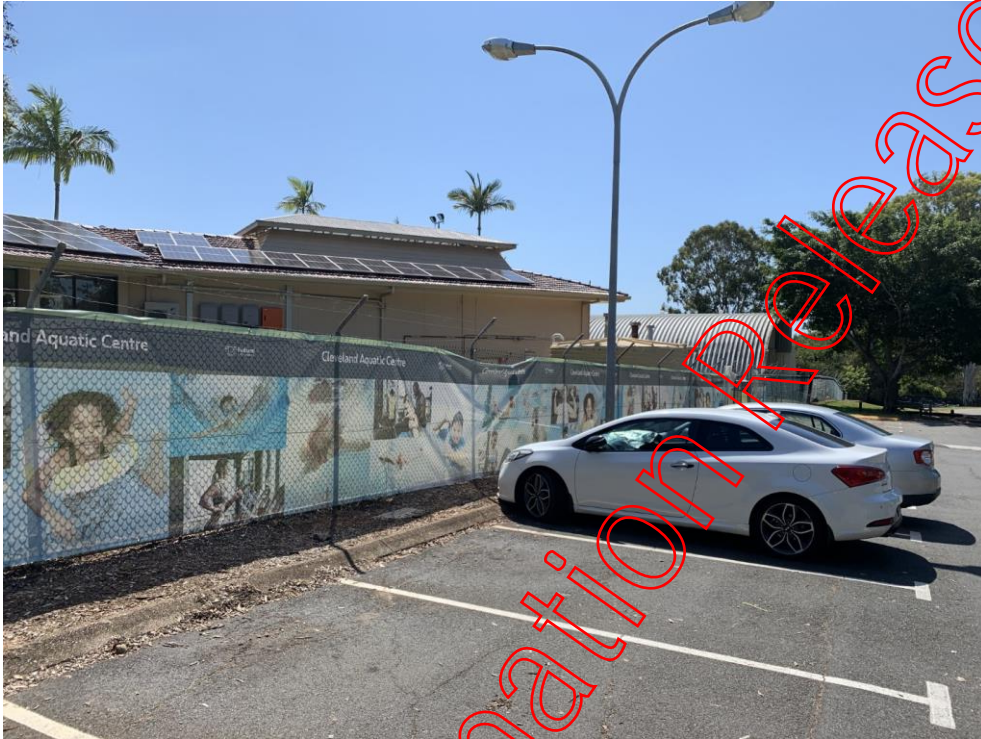
Figure 83: Public carpark where chlorine truck unloads

- Consider converting from bulk liquid chlorine (discussed in the *Conclusions* section) or provide a full refurbishment to the chlorine storage including new tank and bund as well as a bunded truck unloading area in accordance with AS3780 *The Storage and Handling of Corrosive Substances*.

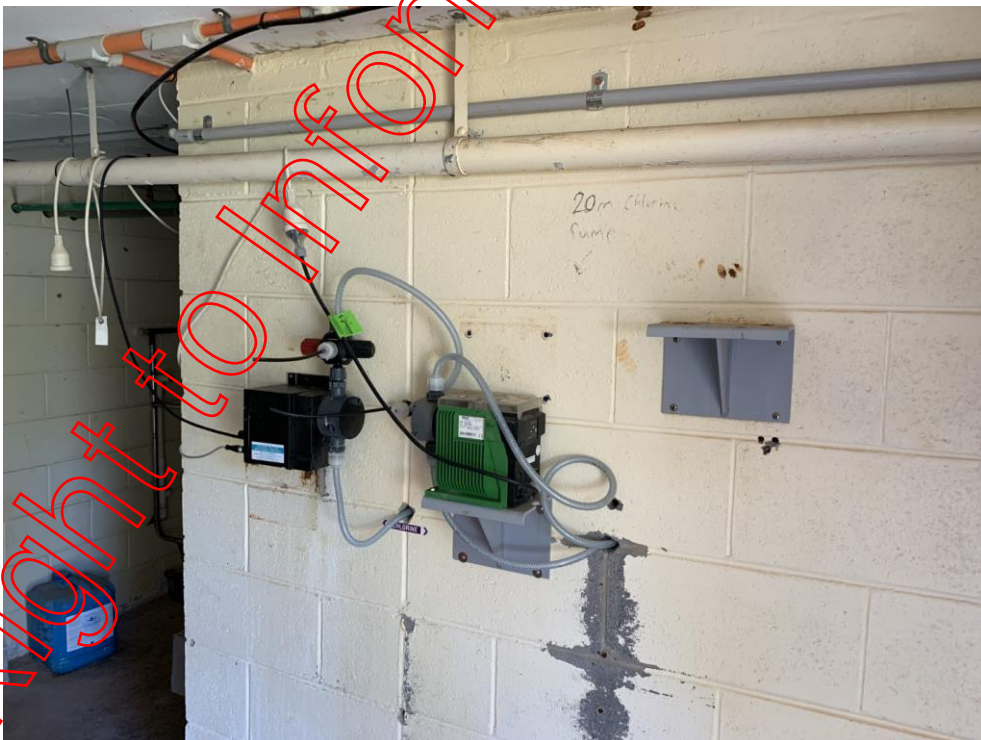
Figure 84: Unlabeled equipment in equipment room, loose extension cord

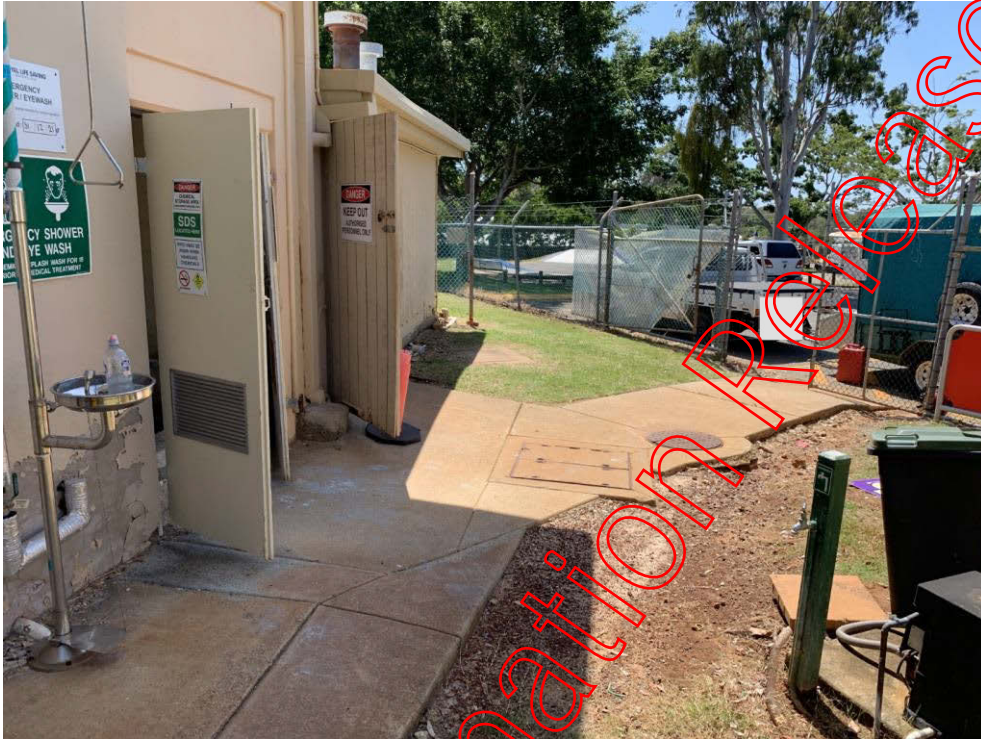
Figure 85: Unsafe working surface between plant and truck unloading area

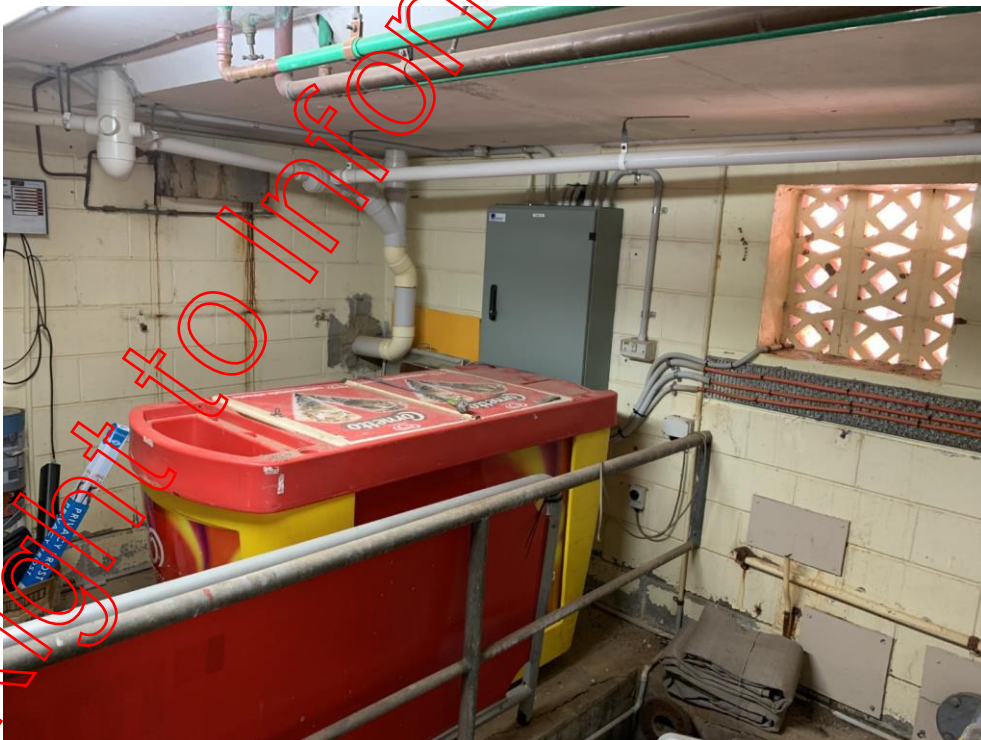
Figure 86: Obstructed main distribution board

- Label all pipes with their flow direction and contents.
- Engage an electrical contractor to provide a full internal condition and compliance audit on the boards and electrical installation.

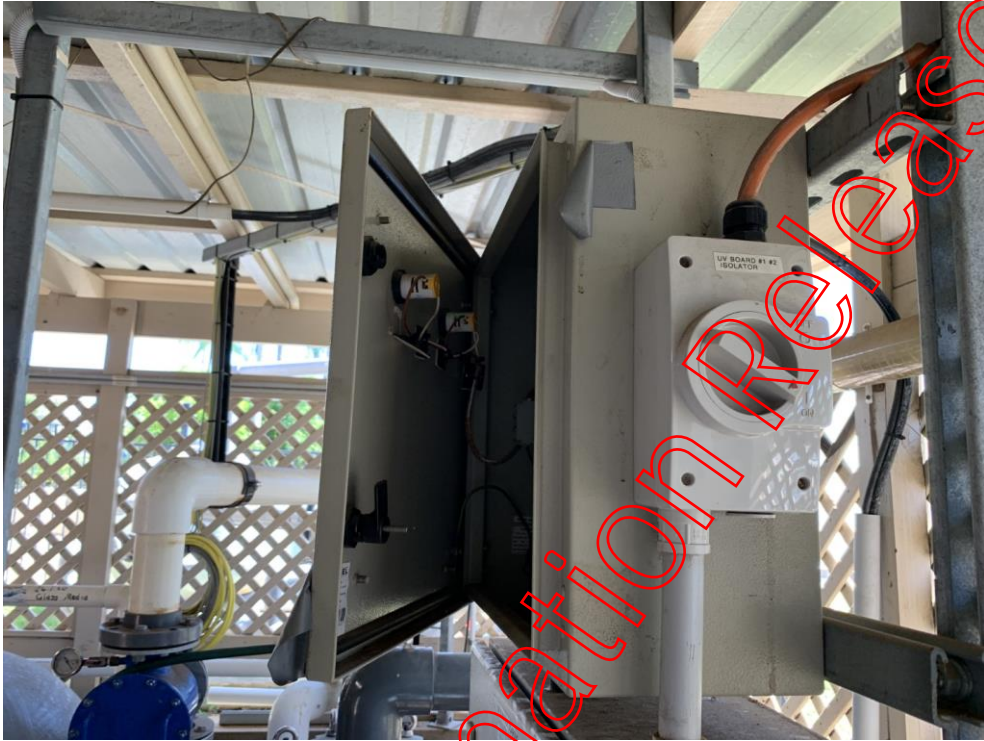
- The latch on the UV control panel in the pump area has failed with tape holding the door shut. Electrical equipment is exposed behind the door.
- The electrical installation is poor in general, with inadequate signage, disused equipment and aged components.
- The chlorine storage tank produces several compliance and condition issues:
  - No tank vent or overflow are provided as per AS3780
  - No labelling is provided on the tank as per AS3780 such as volume indicators
  - The bund is in poor condition, unlikely to be sealed in the event of a spill.
  - The fill point for the tank is poorly supported and may break during a tank fill.

Figure 87: Open UV control panel with broken latches

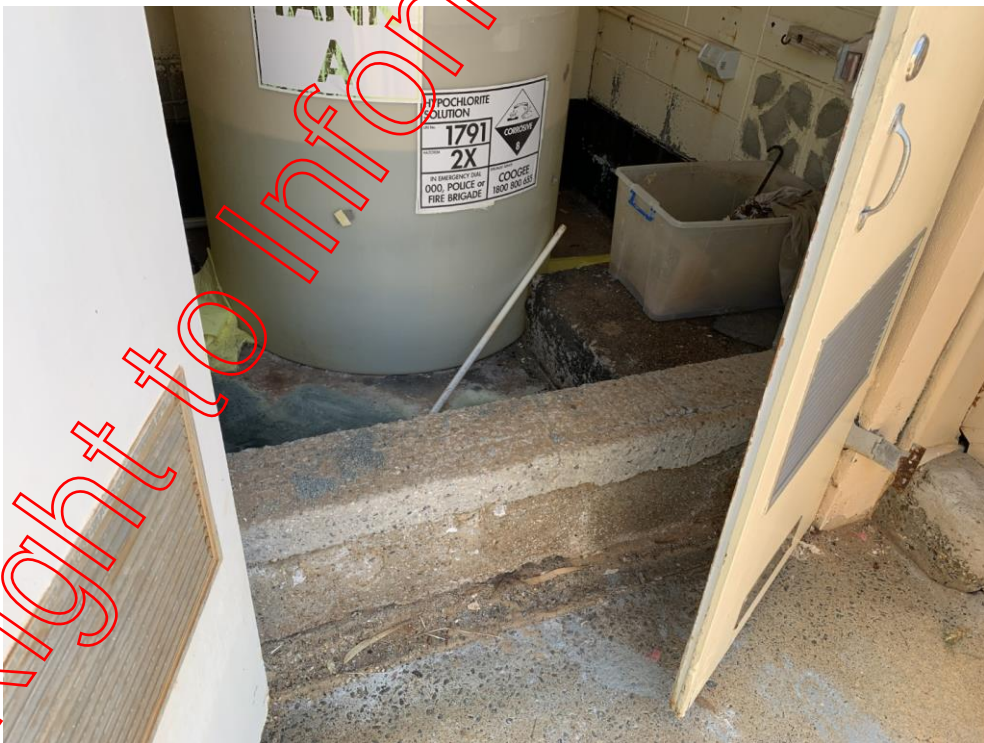
Figure 88: Poor condition bund wall

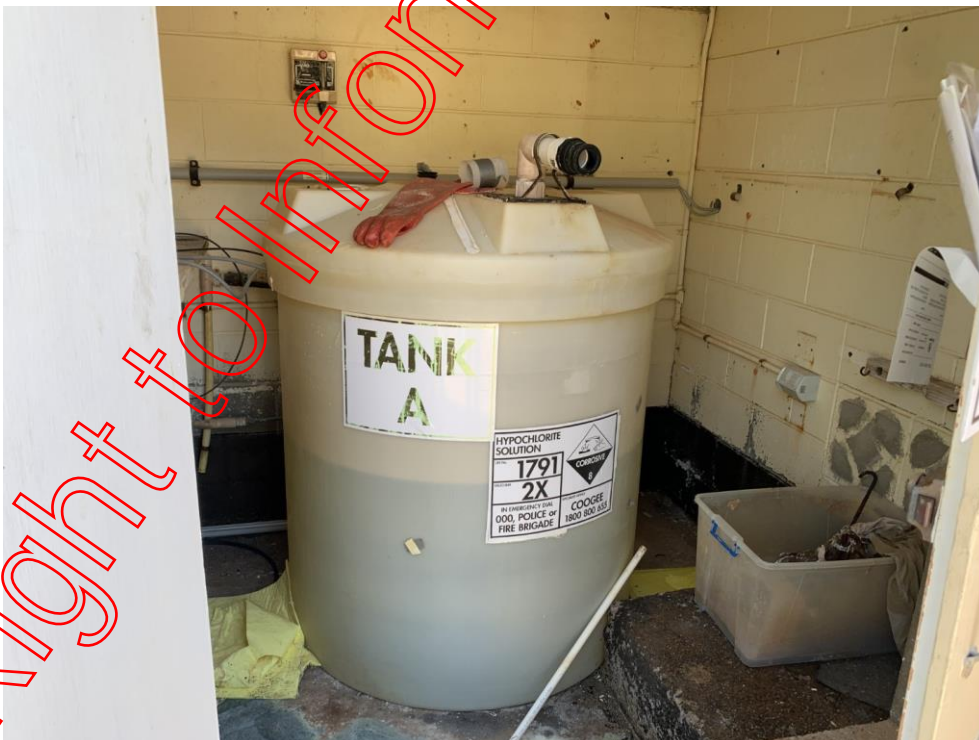
Figure 90: Tank with no level markings or solid plumbing connections

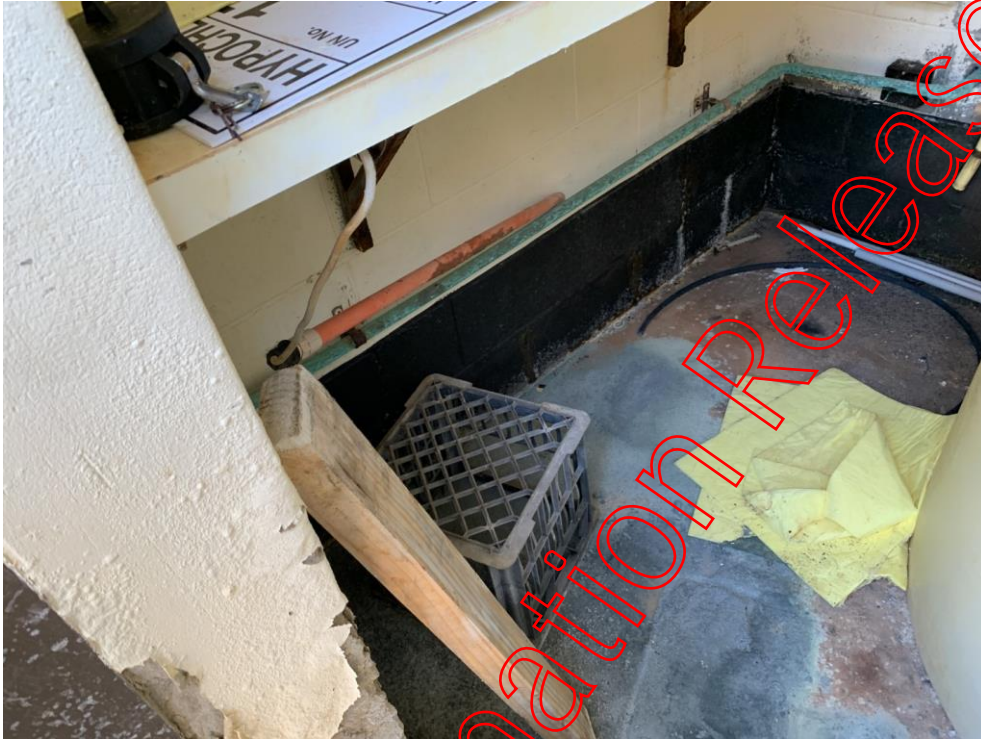
Figure 91: Poor condition bund with debris

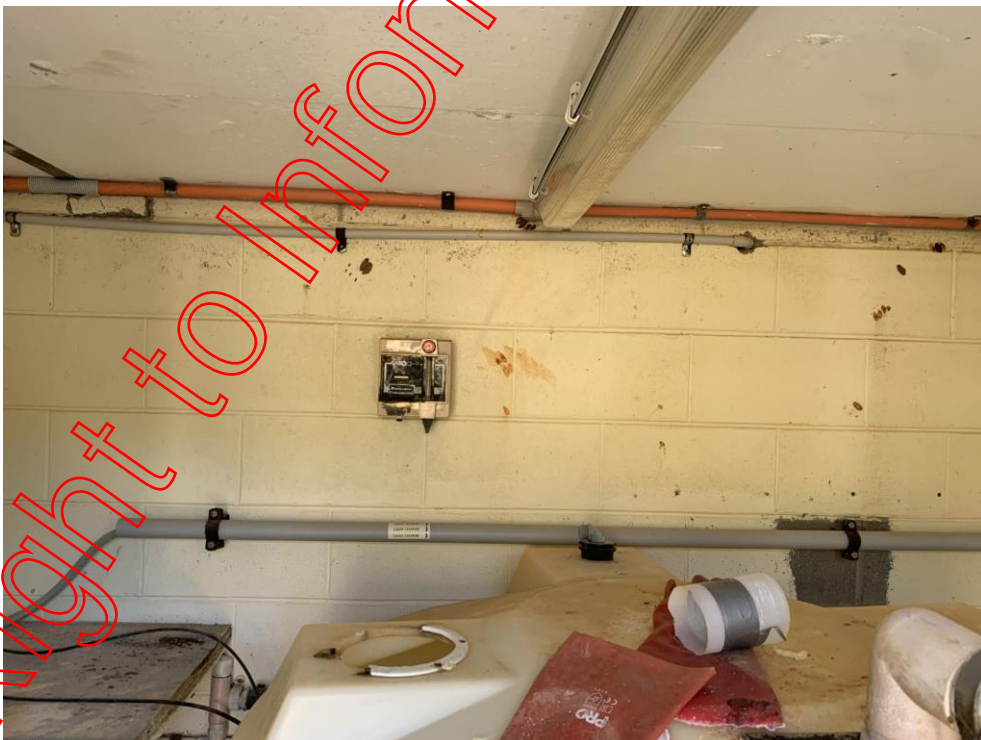
Figure 92: Disused equipment, open inlet to tank

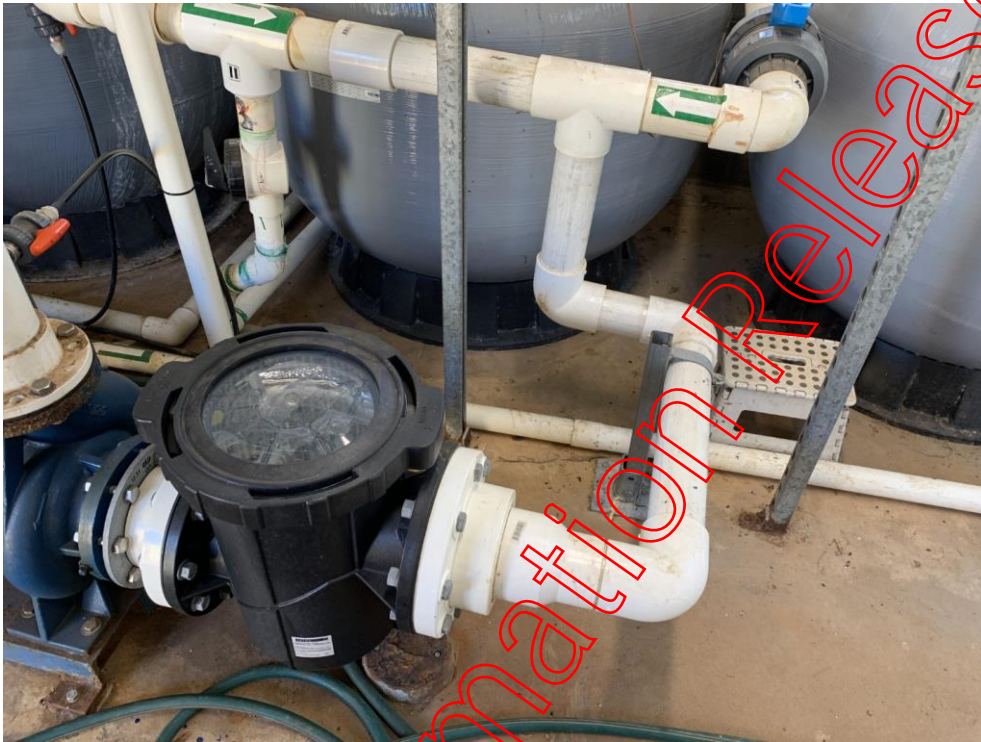
Figure 94: Restriction in filtration pump inlet

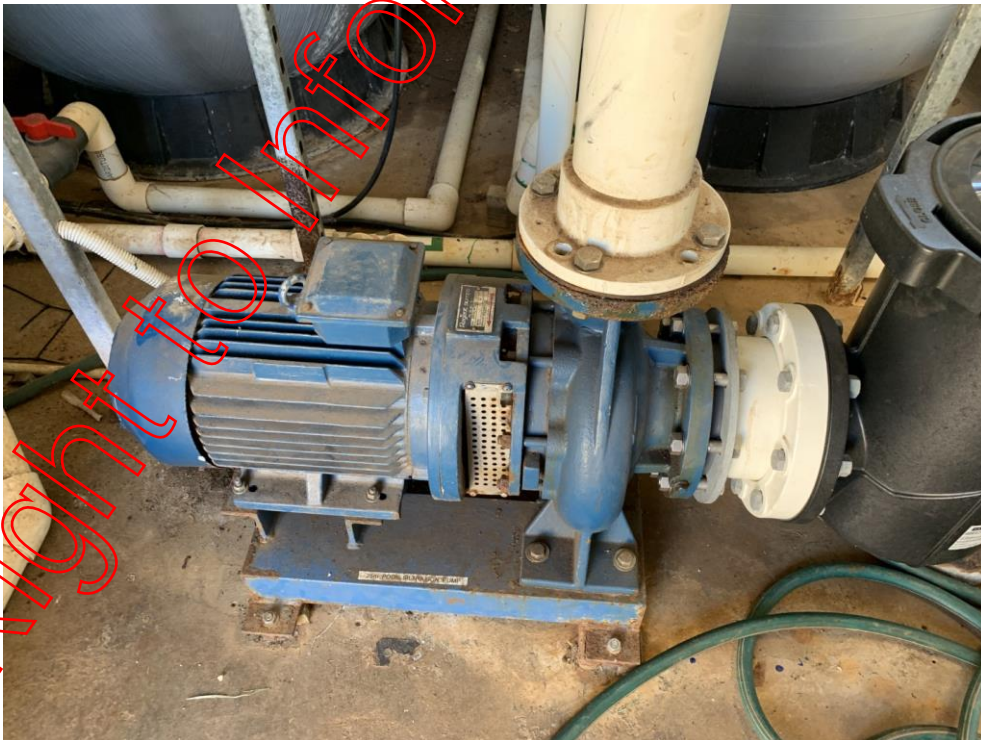
- The filtration pump baseplate is rusty. The pump is not provided with no-flow protection, which may result in a pump burnout.
- The backwash lines from the filters discharge to a floor waste in the equipment room instead of the backwash holding tank. It's not known where this floor waste drains to.

Figure 95: Filtration pump installed direct to slab, rusty baseplate

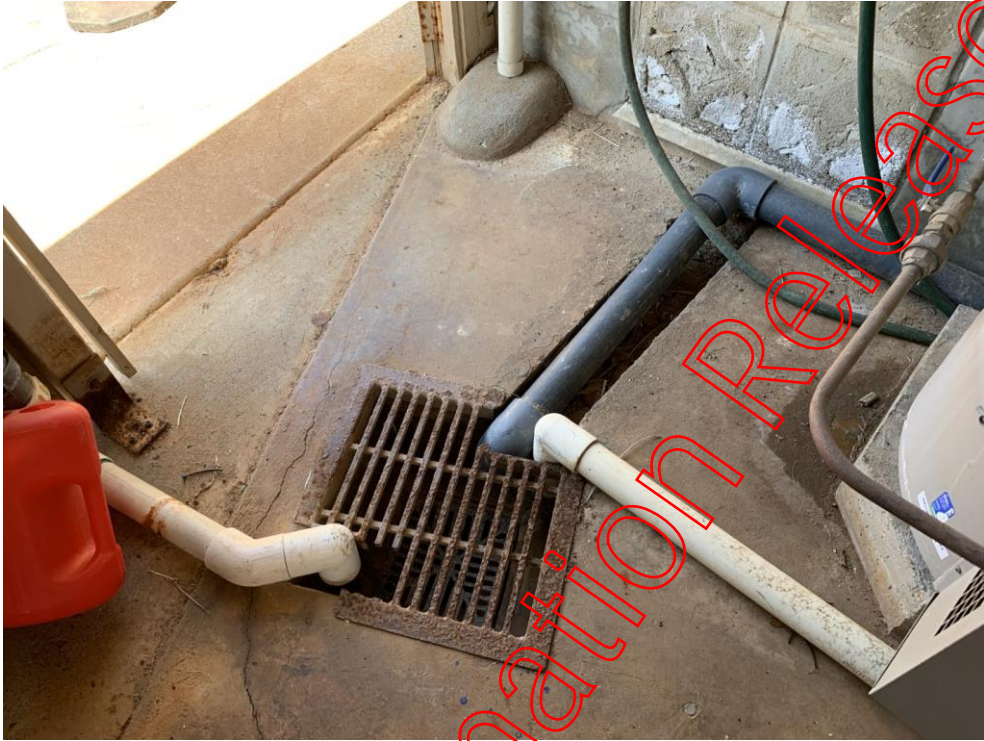
Figure 96: Backwash to floor drain, trip hazards

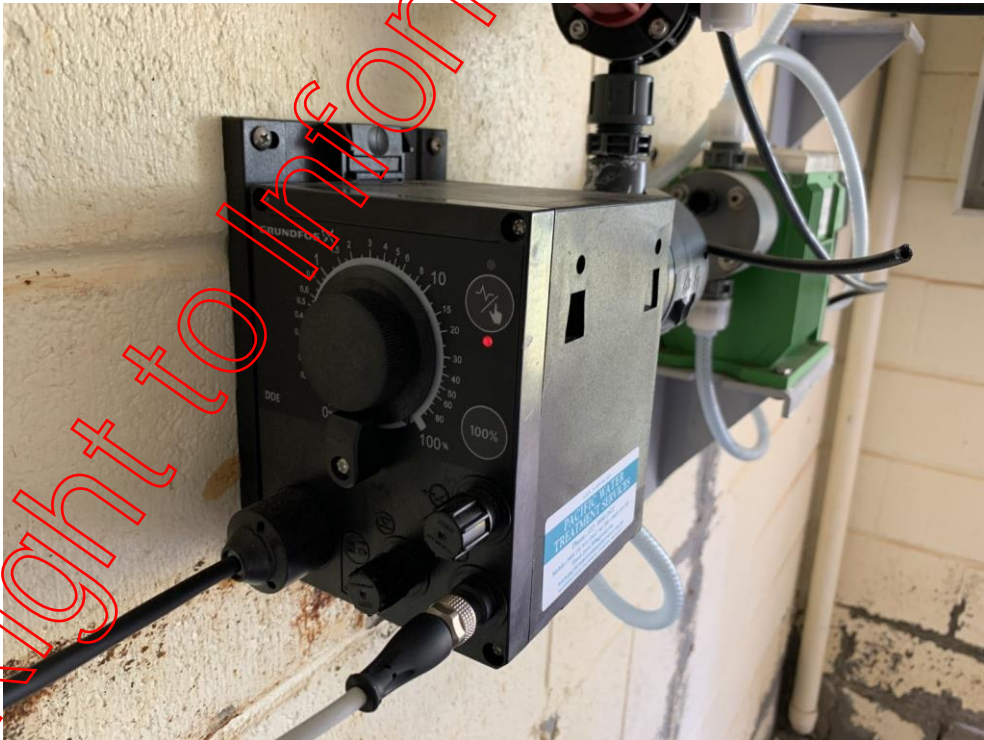
Figure 97: Chlorine dosing pump, overpressure line discharging to room

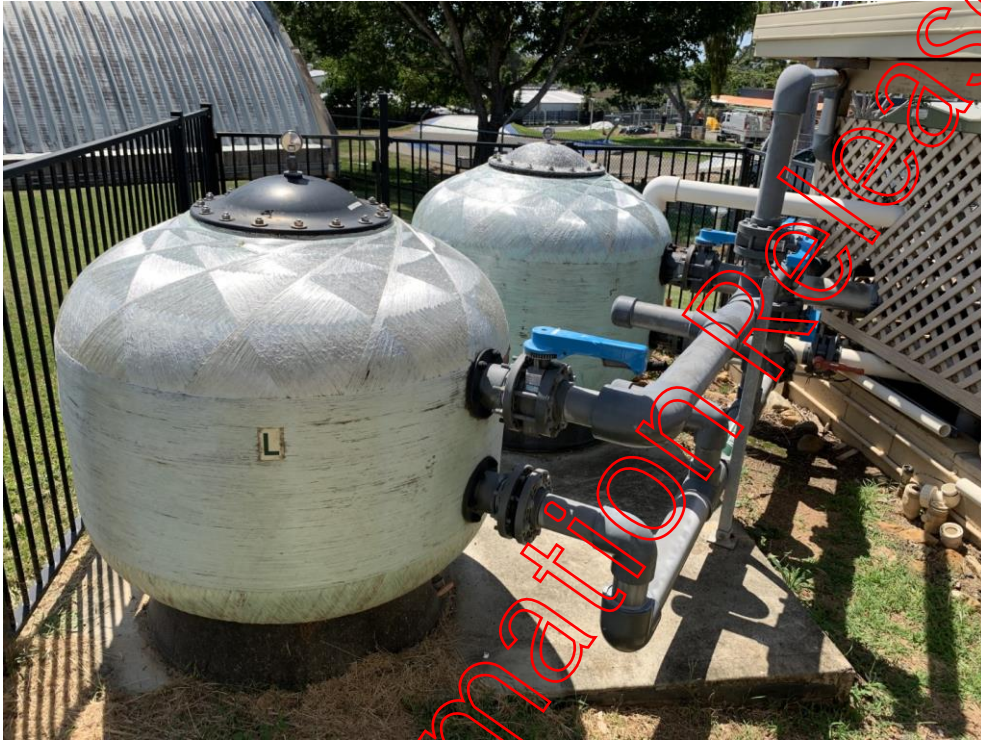
*Figure 100: Pool filters with unsafe access, UV degradation to filters*

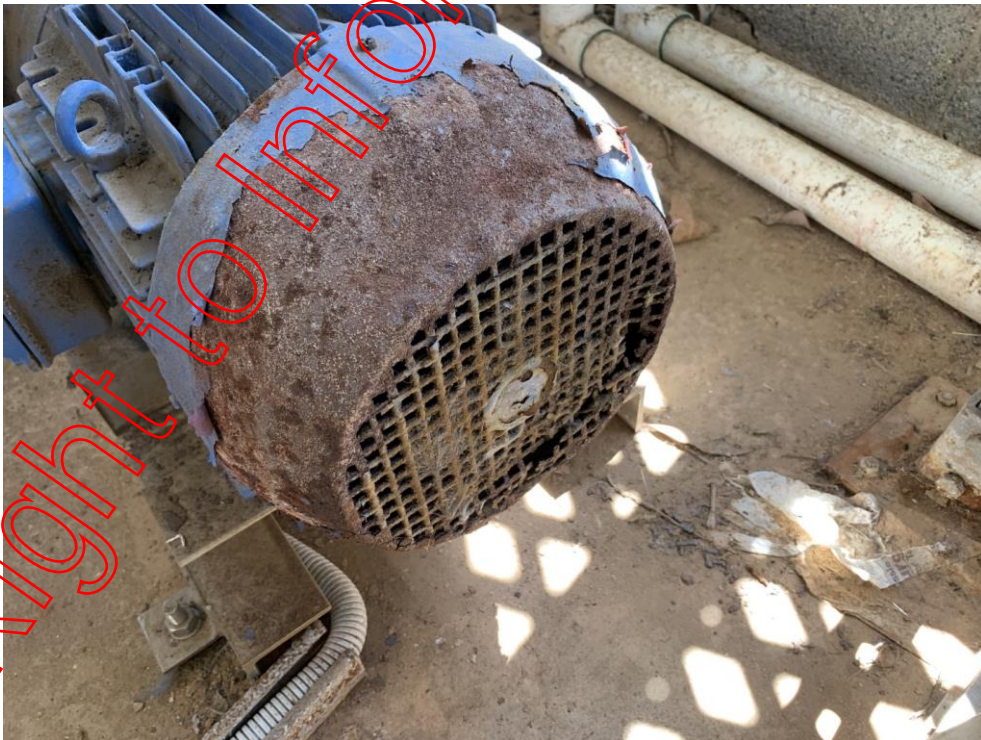
*Figure 101: Poor condition pump motor*

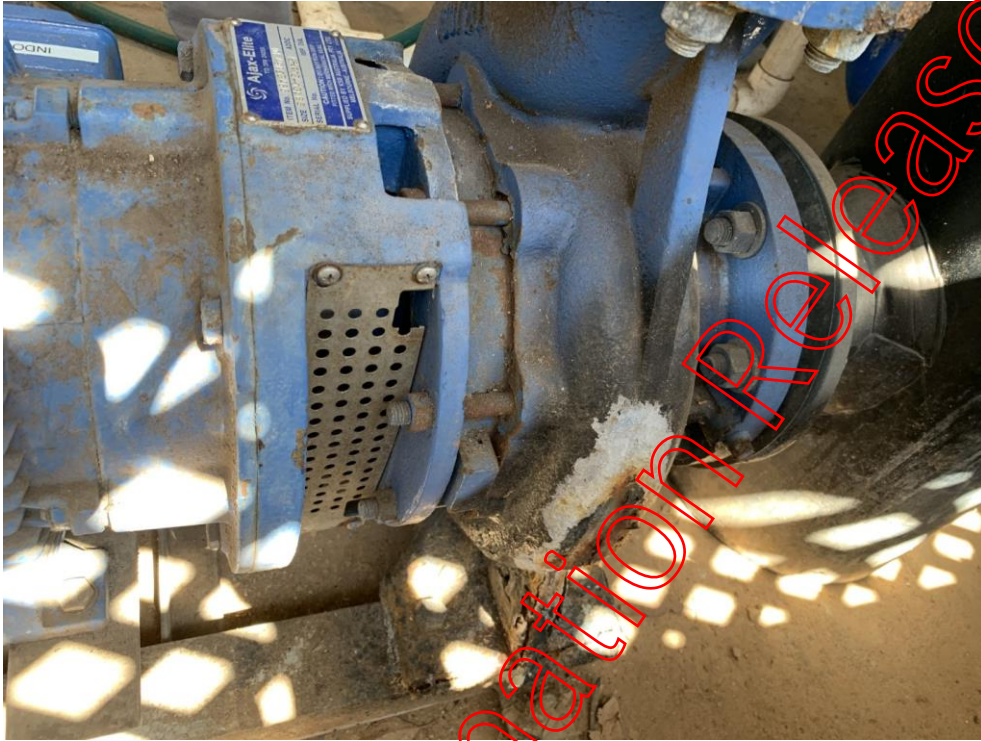
Figure 102: Poor condition pump housing
