# Aquatic Facility Audit

AQ1-0224-DR1, Revision A

## Cleveland Aquatic Centre

**REDLAND CITY COUNCIL**

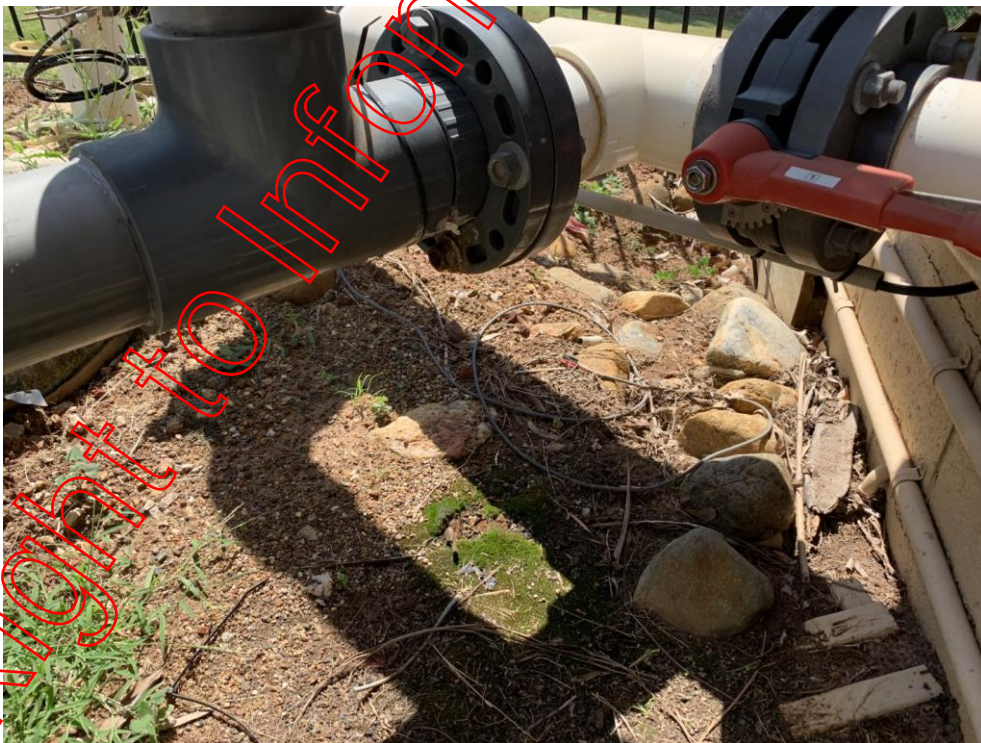
Figure 103: Leak in pipework

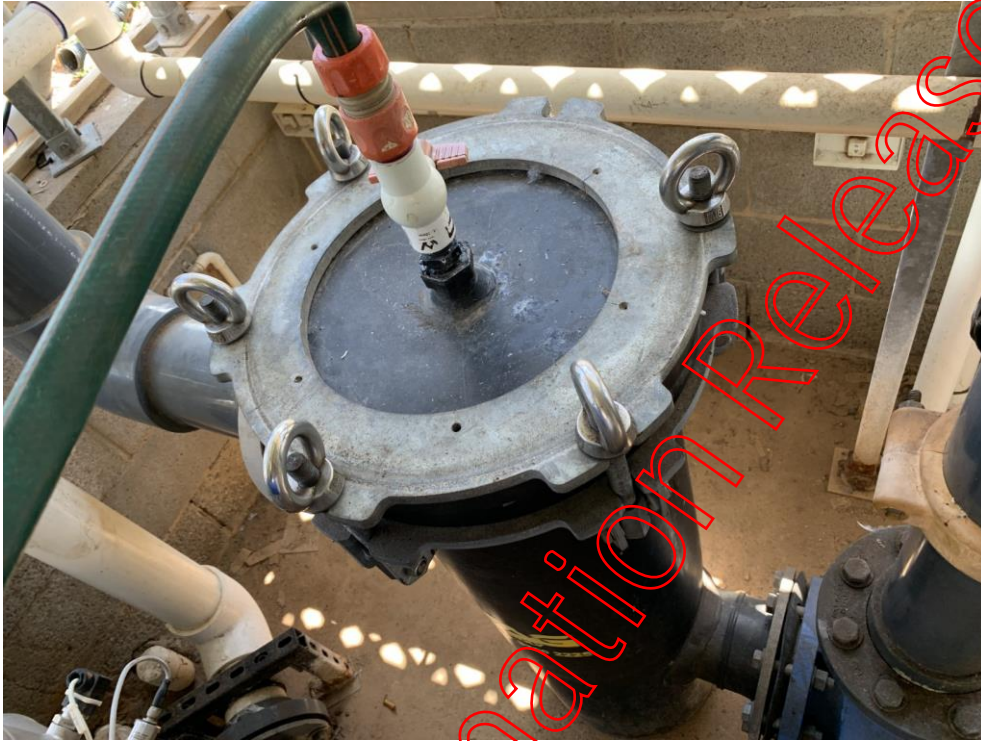
Figure 104: Solid lid on strainer

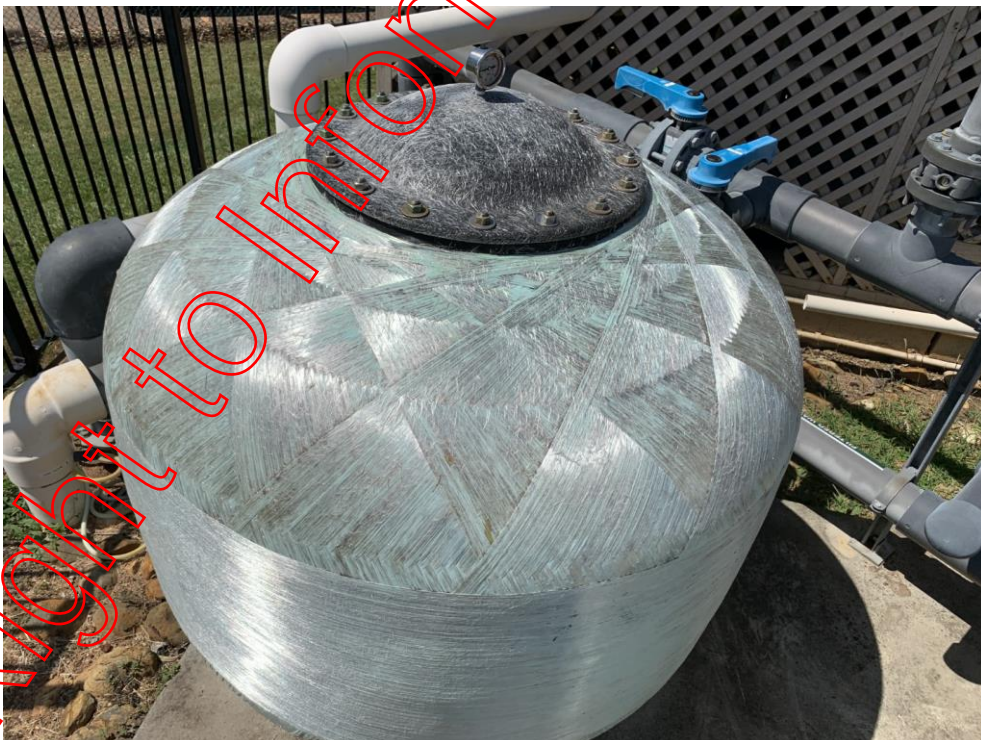
Figure 107: UV degraded filter

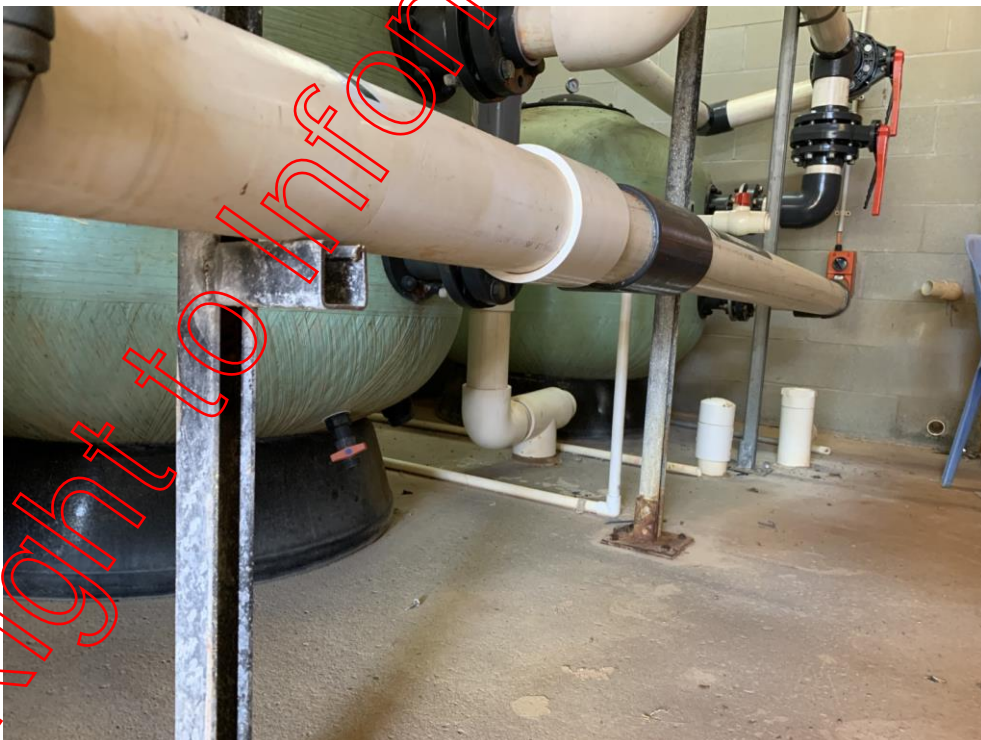
- Pipework support is inadequate, with filter manifolds practically unsupported.
- No positive ventilation system is present to the plant room. Many items inside are corroded.

*Figure 118: Inadequate pipe supports in filter manifold*

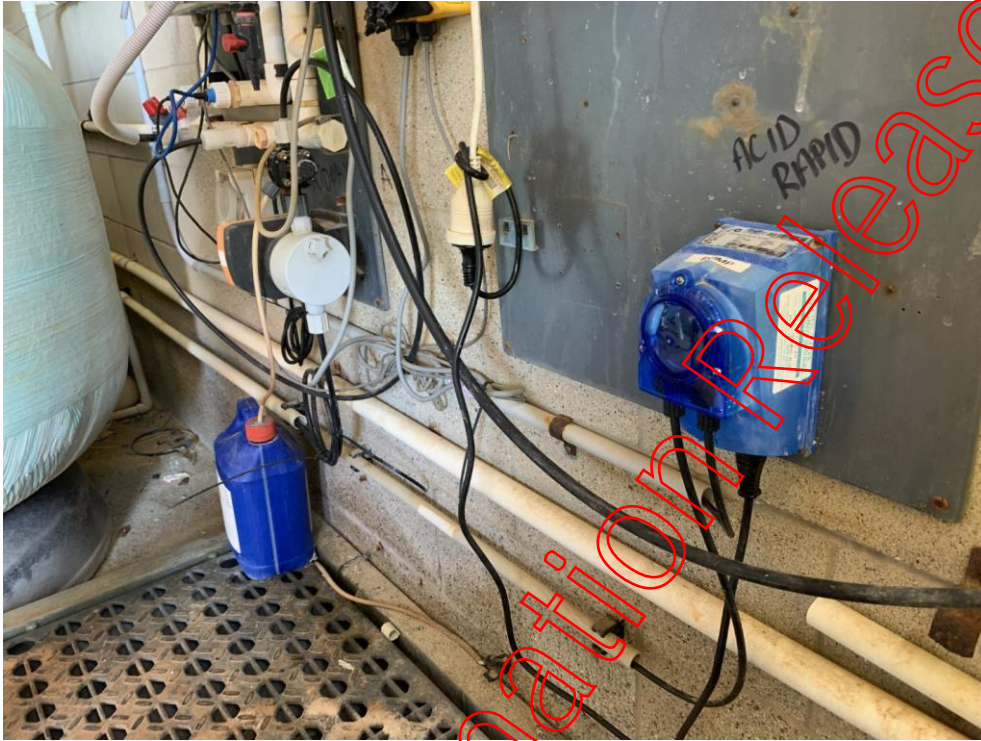
Figure 119: Poorly labelled and installed equipment

- Label all pipes with their flow direction and contents.
- Engage an electrical contractor to provide a full internal condition and compliance audit on the boards and electrical installation.

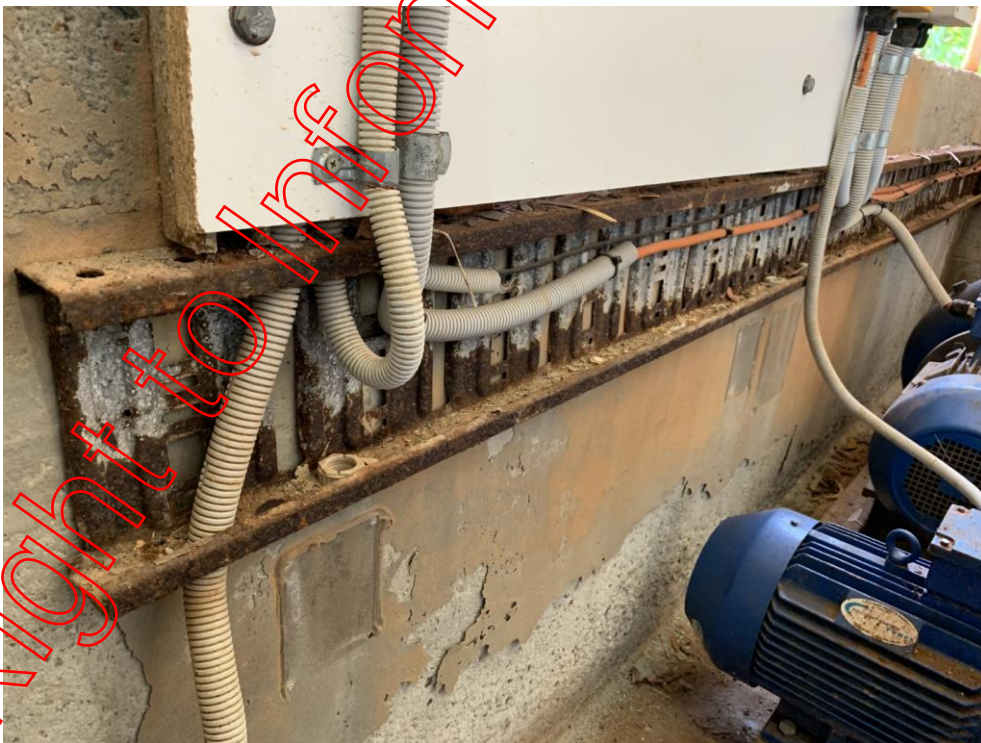
- The electrical installation is poor in general, with inadequate signage, disused equipment and aged components. Cable trays are rusting and the switchboard contains obsolete equipment.

Figure 120: Rusty cable tray

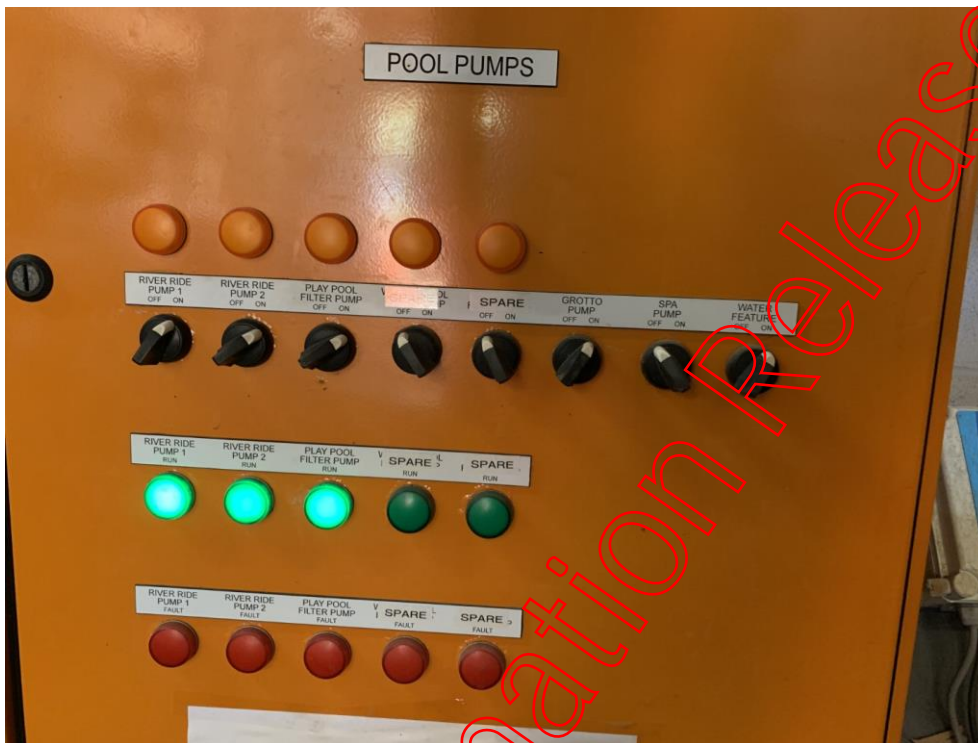
Figure 121: Obsolete switchgear for spa in board

- Remove all obsolete equipment.
- Fill around the concrete step.
- Replace the flow meters and provide in the correct locations to measure full flow of the systems.

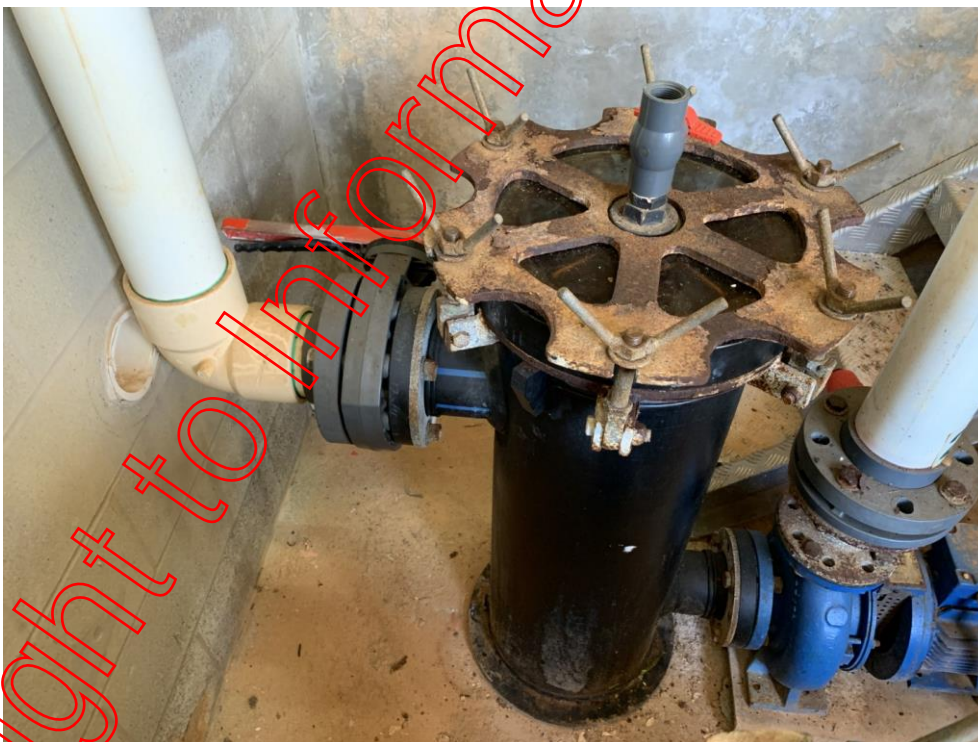
Figure 128: Filtration pump and strainer, poor condition, poor access, disused pipe

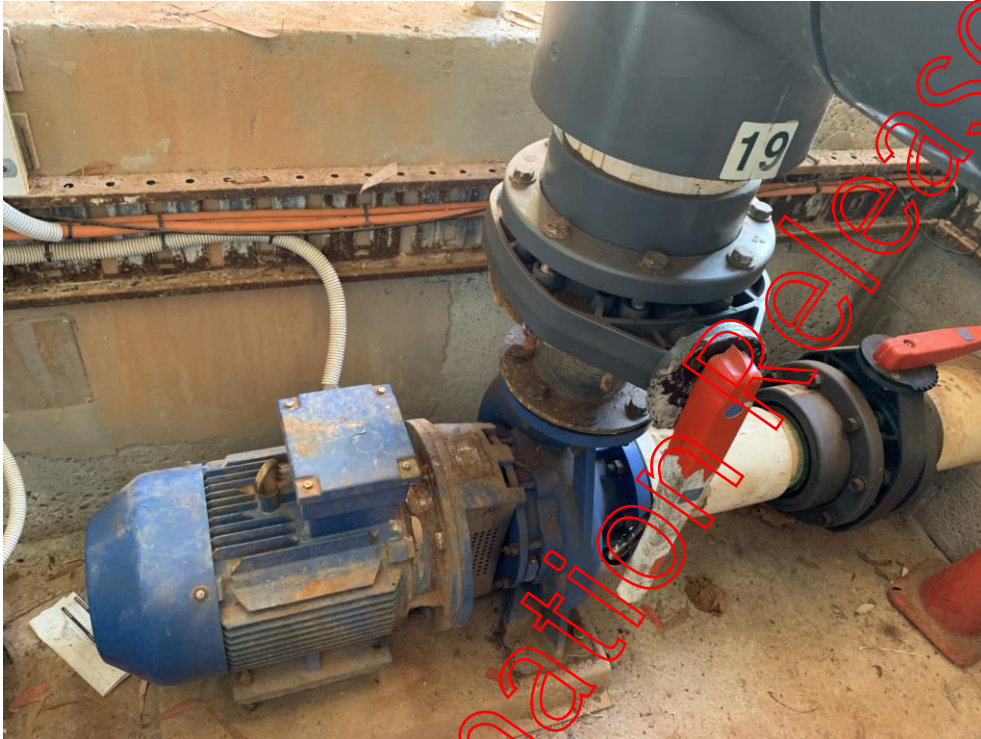
Figure 129: River pump 1, poor access

- Provide reliable flow monitoring equipment and confirm the system flow.
- Consider relocation of the pumps to a more appropriate location as discussed above.
- Relocate the chlorine dosing pump.
- Relocate acid dosing pumps, lines and storage to the opposite end of the equipment room and neaten up overall.
