Aquatic Centre Condition Audit

Condition and compliance audit for an existing aquatic centre

Cleveland Aquatic Centre, July 19, 2023

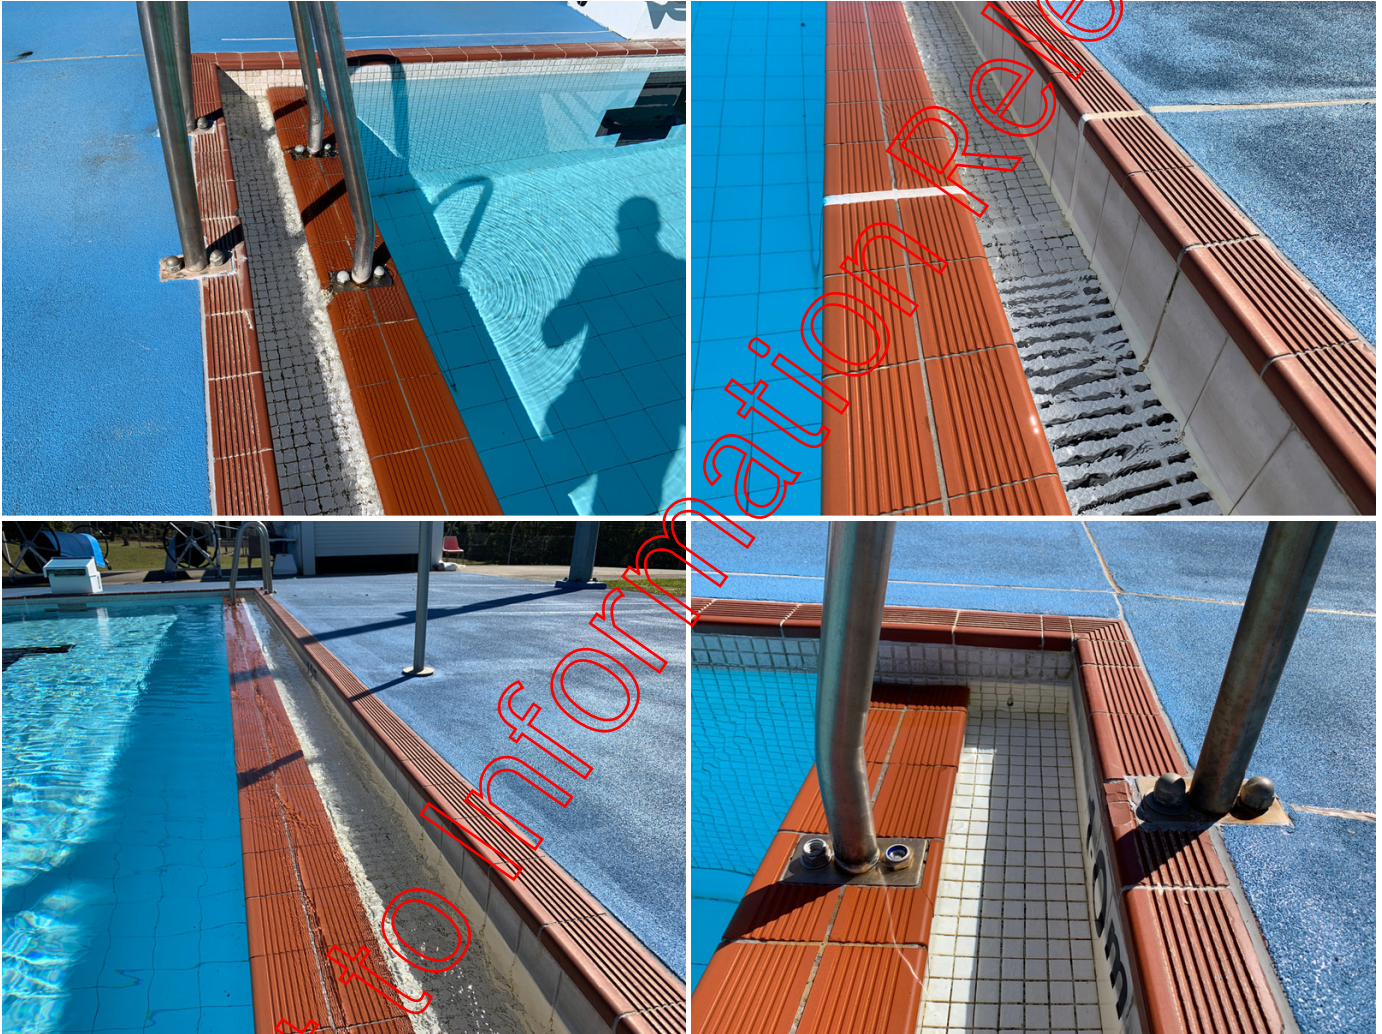
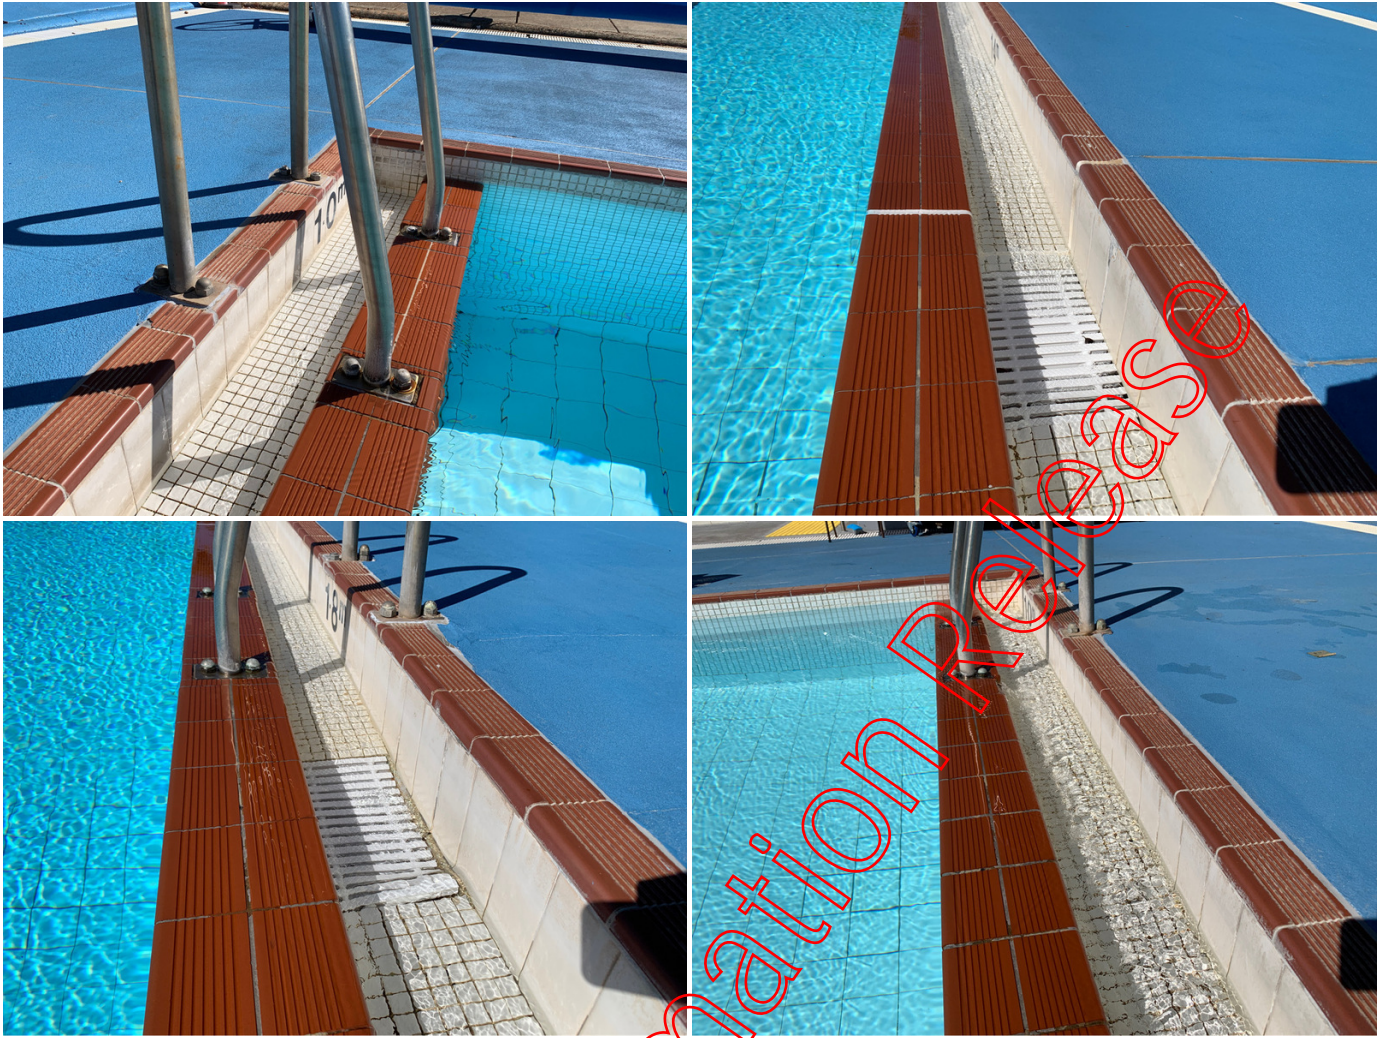
Observation Description	Scum Gutter
Observation Details	The scum gutter is of an aged design. The system is running full, indicating the flow is at maximum capacity. Additionally, more water is flowing over the northern wet edge, with this side being out of level along the length indicating structural movement of the pool.
Recommendations	Consider an upgrade to the 50m pool
Critical Item?	No

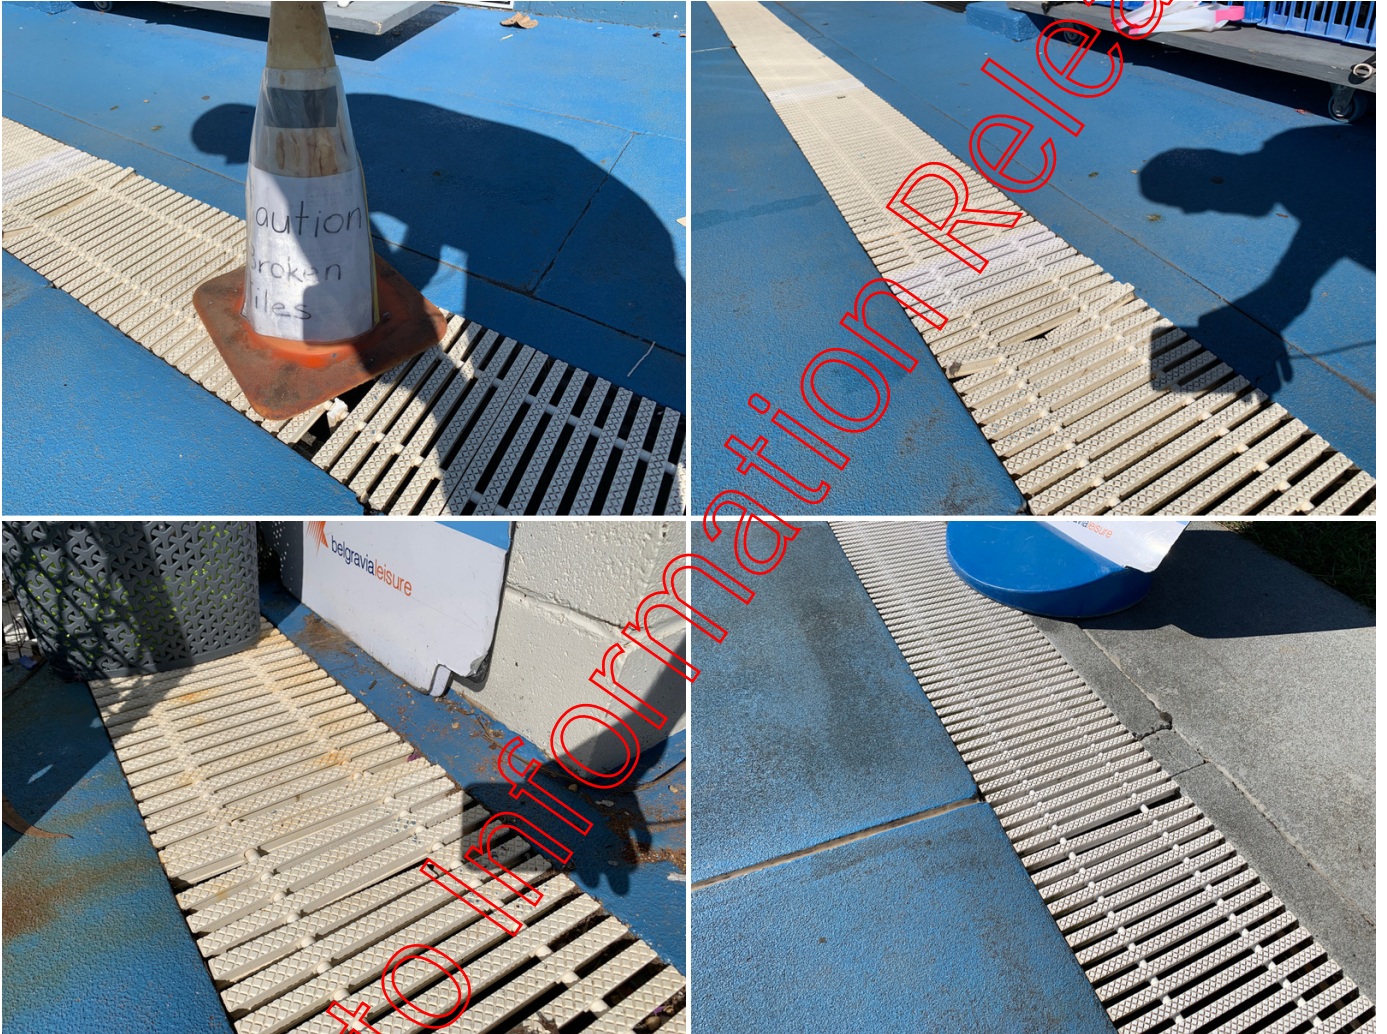
Observation Description	Drain Grating
Observation Details	Wet deck grating covering the drain adjacent the pool is aging and broken in places
Recommendations	Replace the grating
Critical Item?	Yes

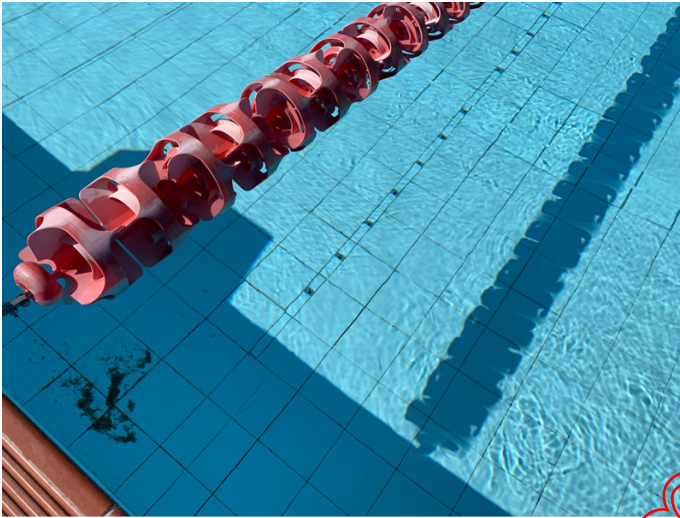
Observation Description	Filtered Water Return
Observation Details	Filtered water is delivered to a central channel along the pool which is fitted with small holes in the top to deliver water. This type of return will have little impact on pool circulation beyond the outlets.
Recommendations	Undertake a dye circulation test in accordance with the model aquatic health code to visualise and confirm the circulation. Undertake rectification works as required.
Critical Item?	No

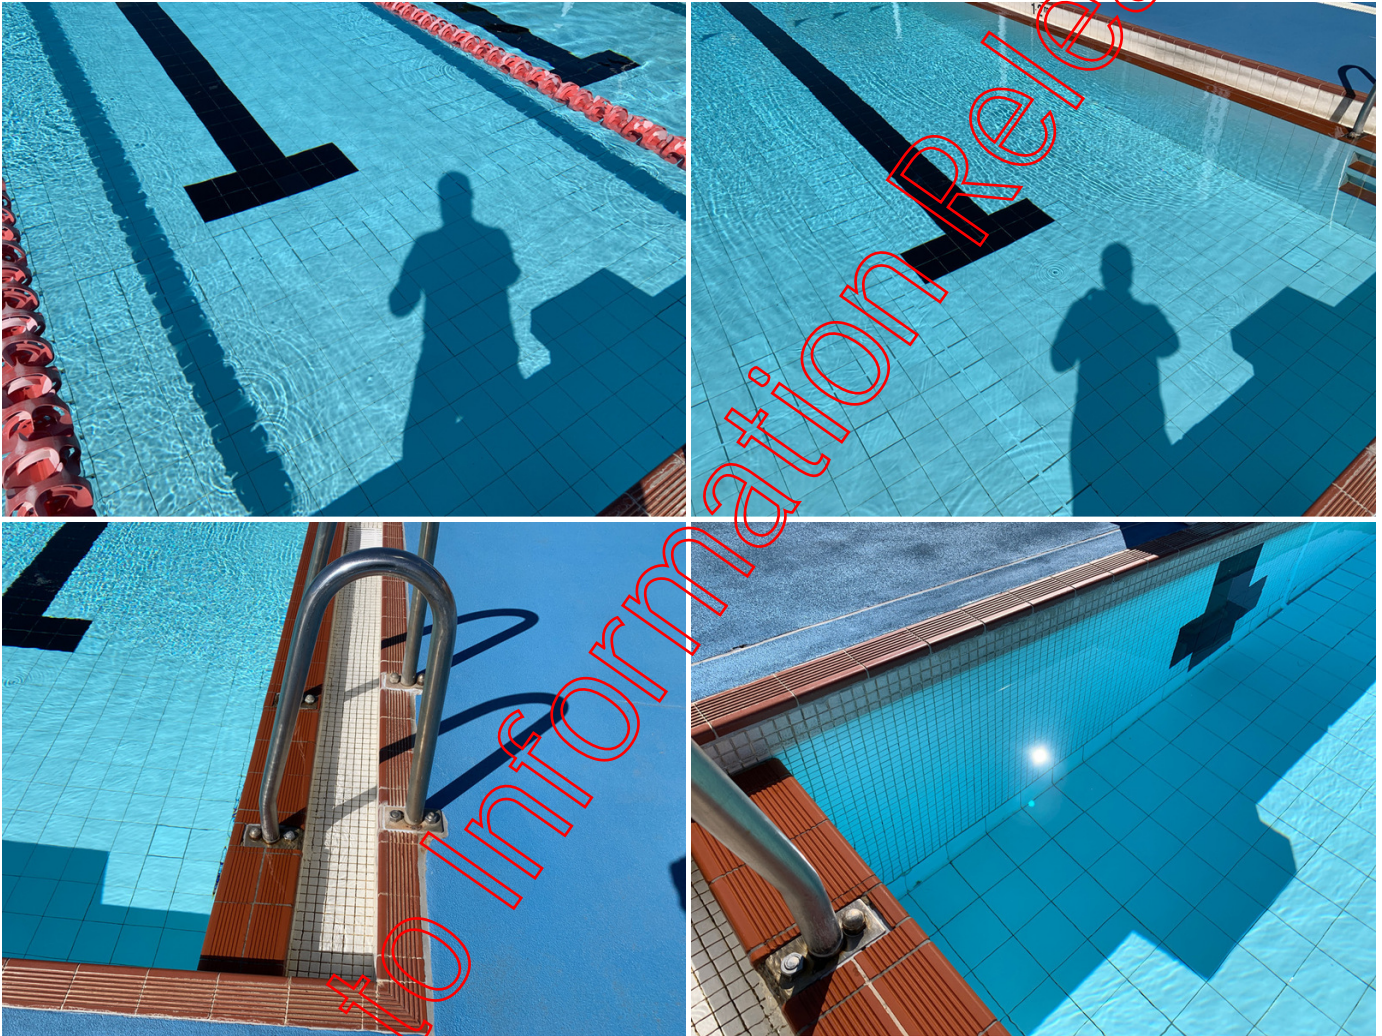
Observation Description	Tiling
Observation Details	The tiling provided in the pool is aging and not slip resistant. This is an issue for activities requiring grip on the pool floor
Recommendations	Replace the pool tiling
Critical Item?	No

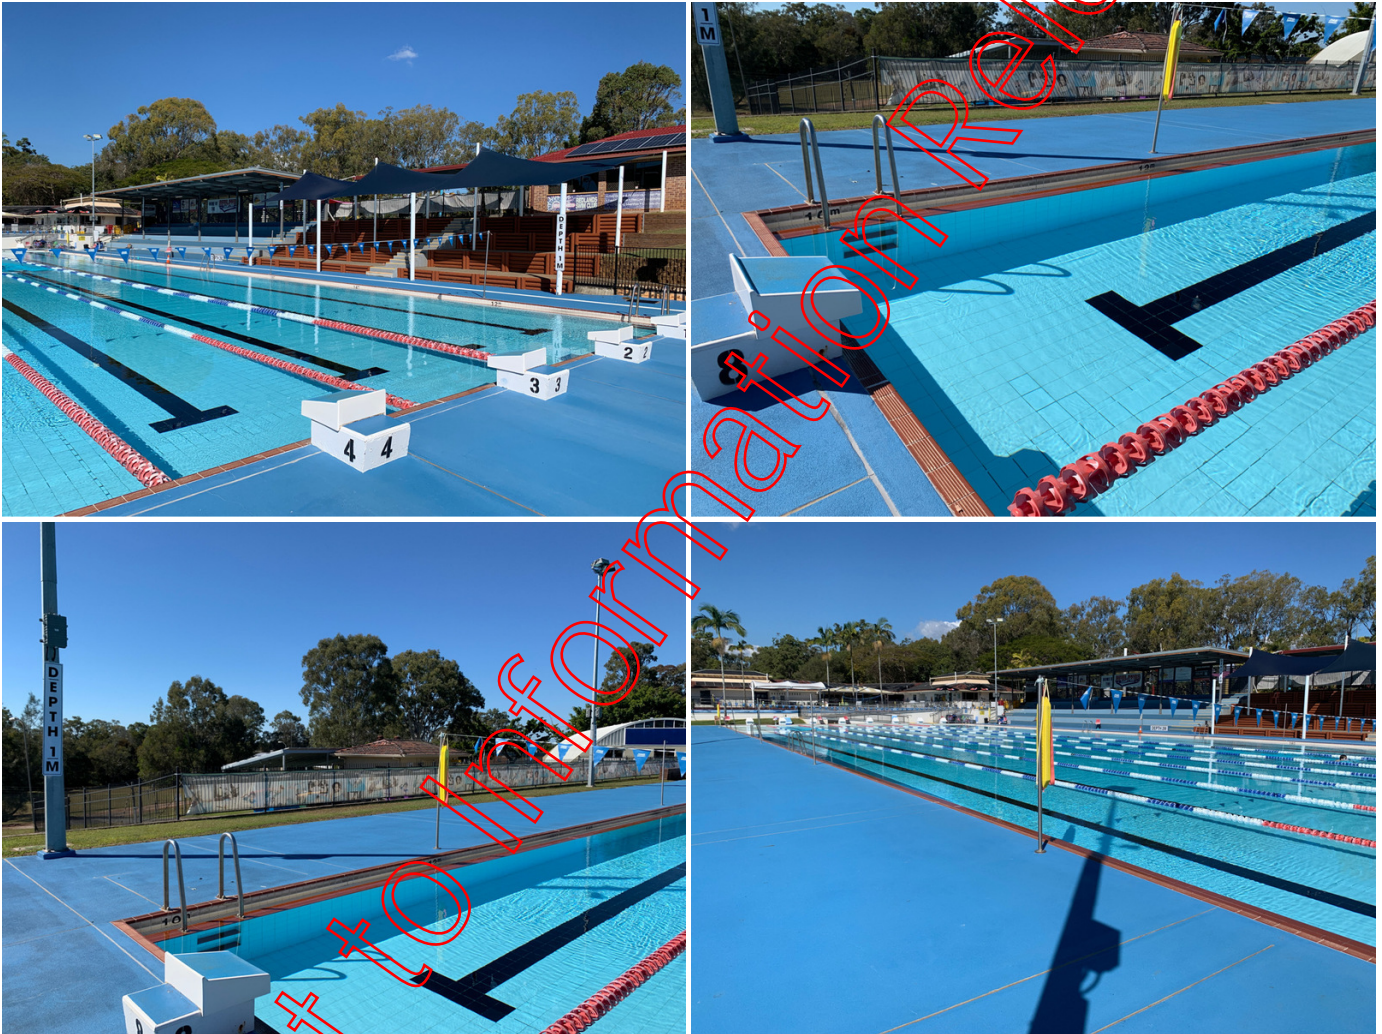
Observation Description	Depth and Warning Signage
Observation Details	Applicable to all the pools onsite, current signage does not comply with the Royal Lifesaving guidelines. Depth markers are inconsistent or not legible whilst advisory signage is not provided.
Recommendations	Engage Royal Lifesaving to undertake a signage audit at the facility including pools and plant rooms
Critical Item?	Yes

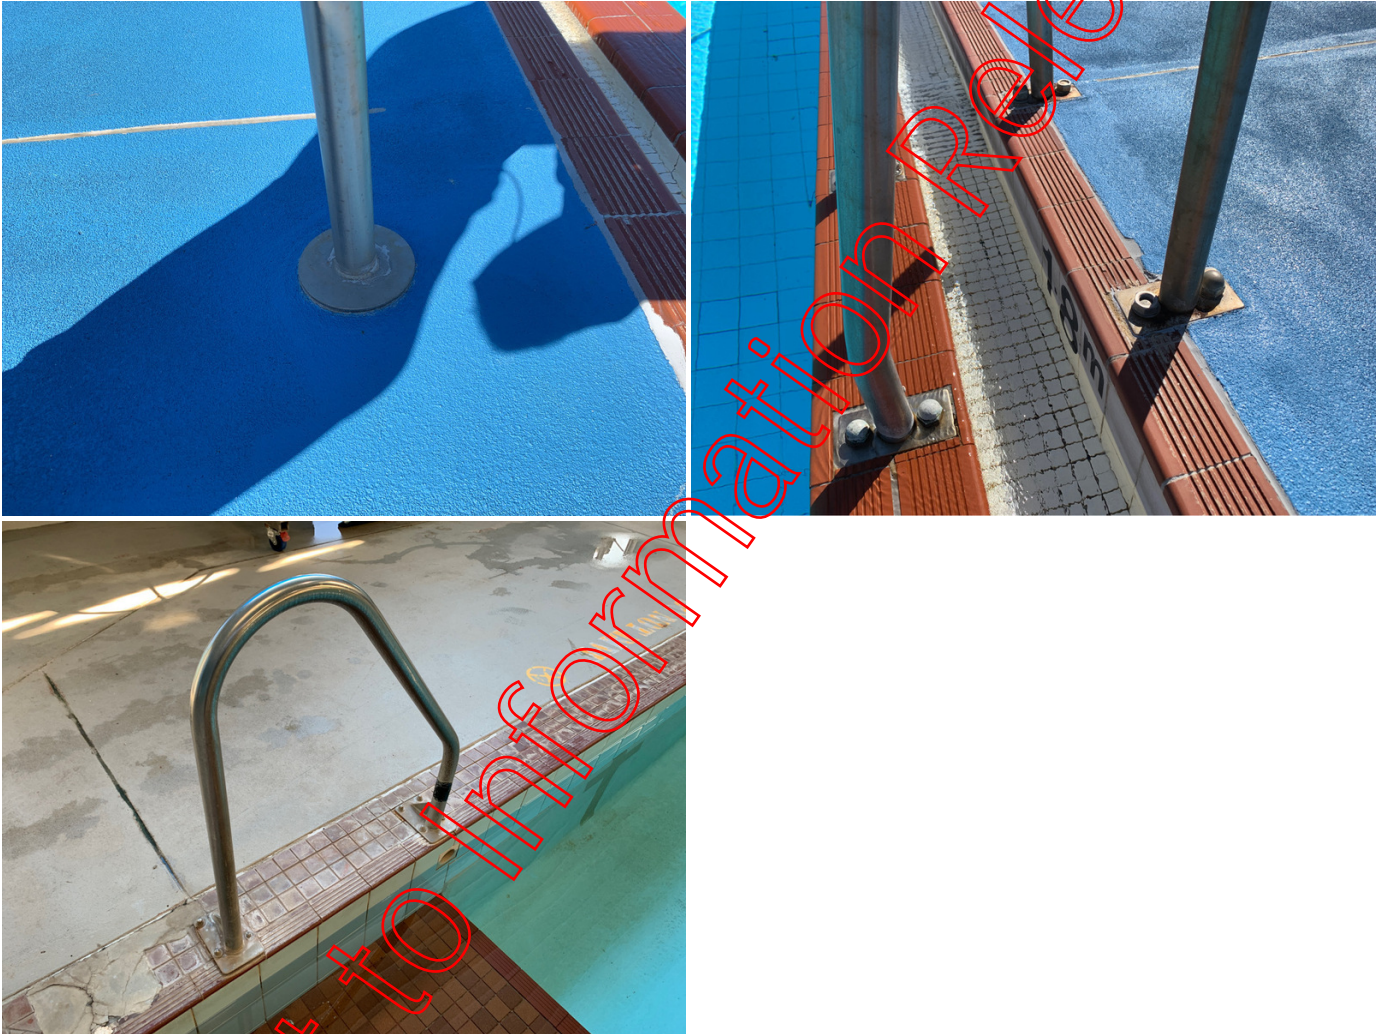
Observation Description	Equipotential bonding
Observation Details	Conductive items are present within arms reach of most pools, requiring equipotential bonding. This extends to all pools.
Recommendations	If not provided within the past 12 months, engage an electrician to undertake an earth bonding test of all items as required by AS3000
Critical Item?	Yes

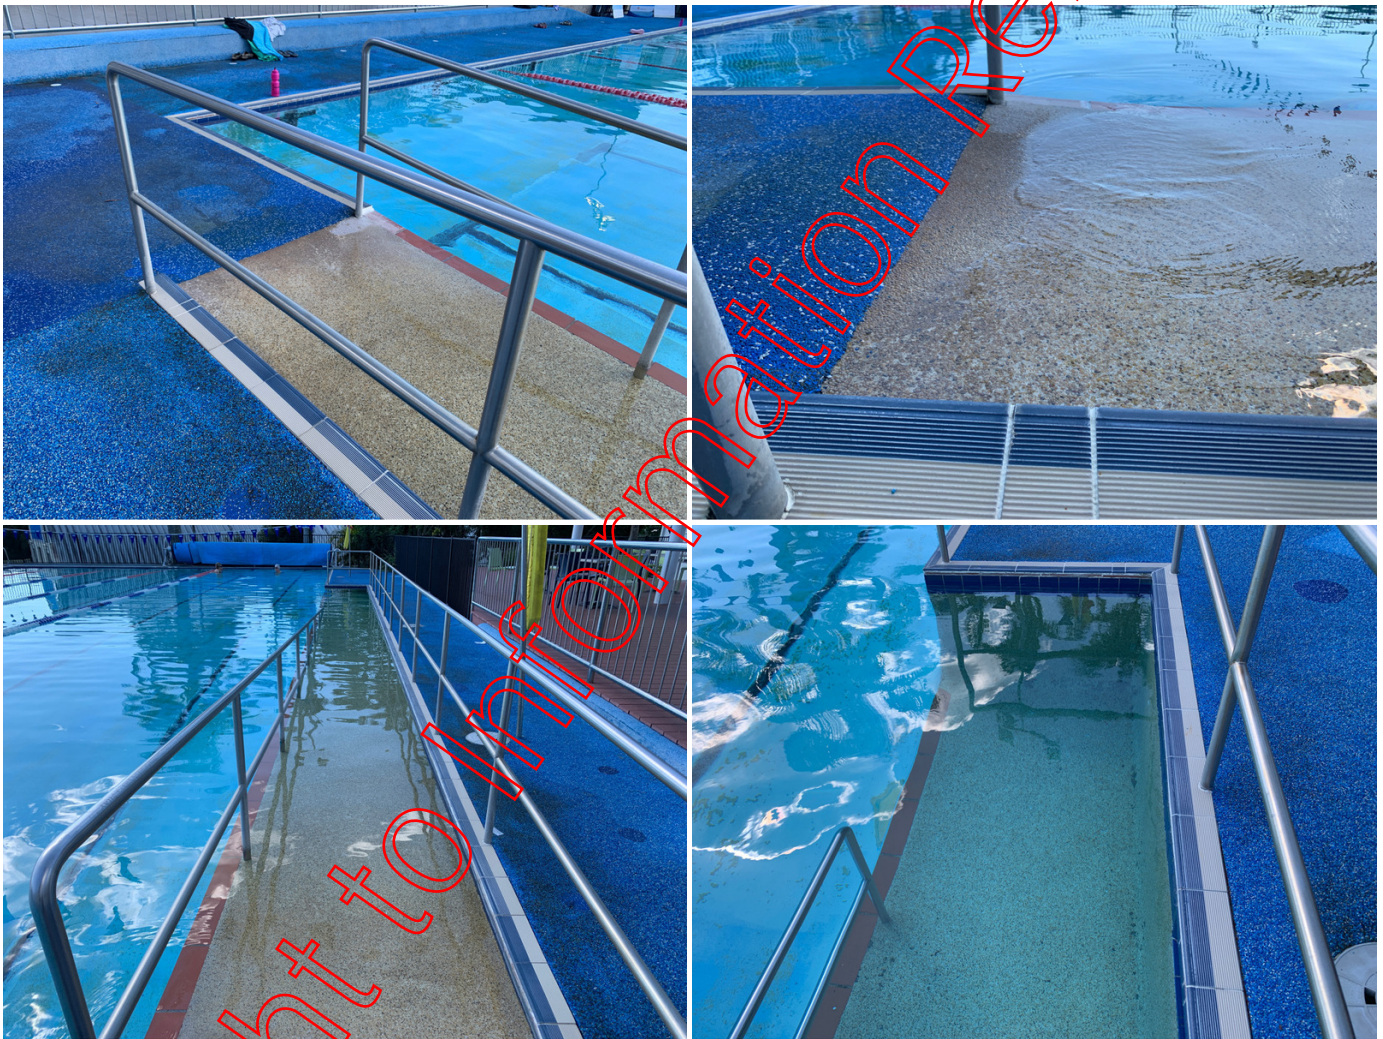
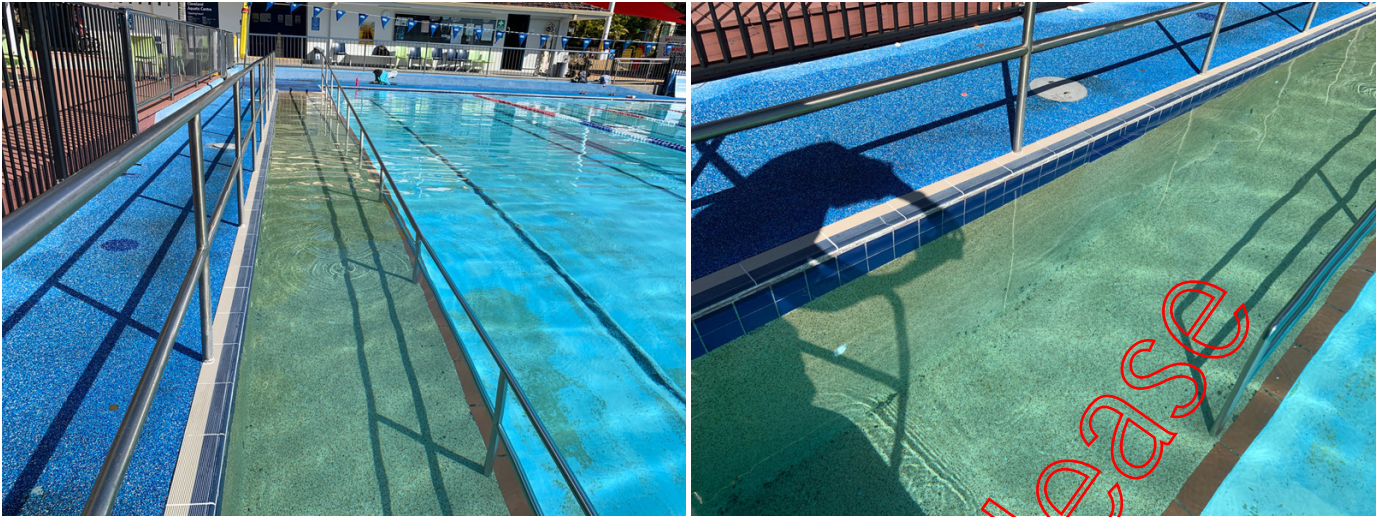
Observation Description	Ramp Compliance
Observation Details	The disabled access ramp is not compliant with AS1926.3: <ul style="list-style-type: none">o No mid landing is providedo Only one handrail is provided, with the other handrail being non-complianto The entry to the ramp is too steepo The ramp delivers too deep
Recommendations	Replace the ramp. In the interim, provide signage to inform patrons of the issues with the ramp.
Critical Item?	No

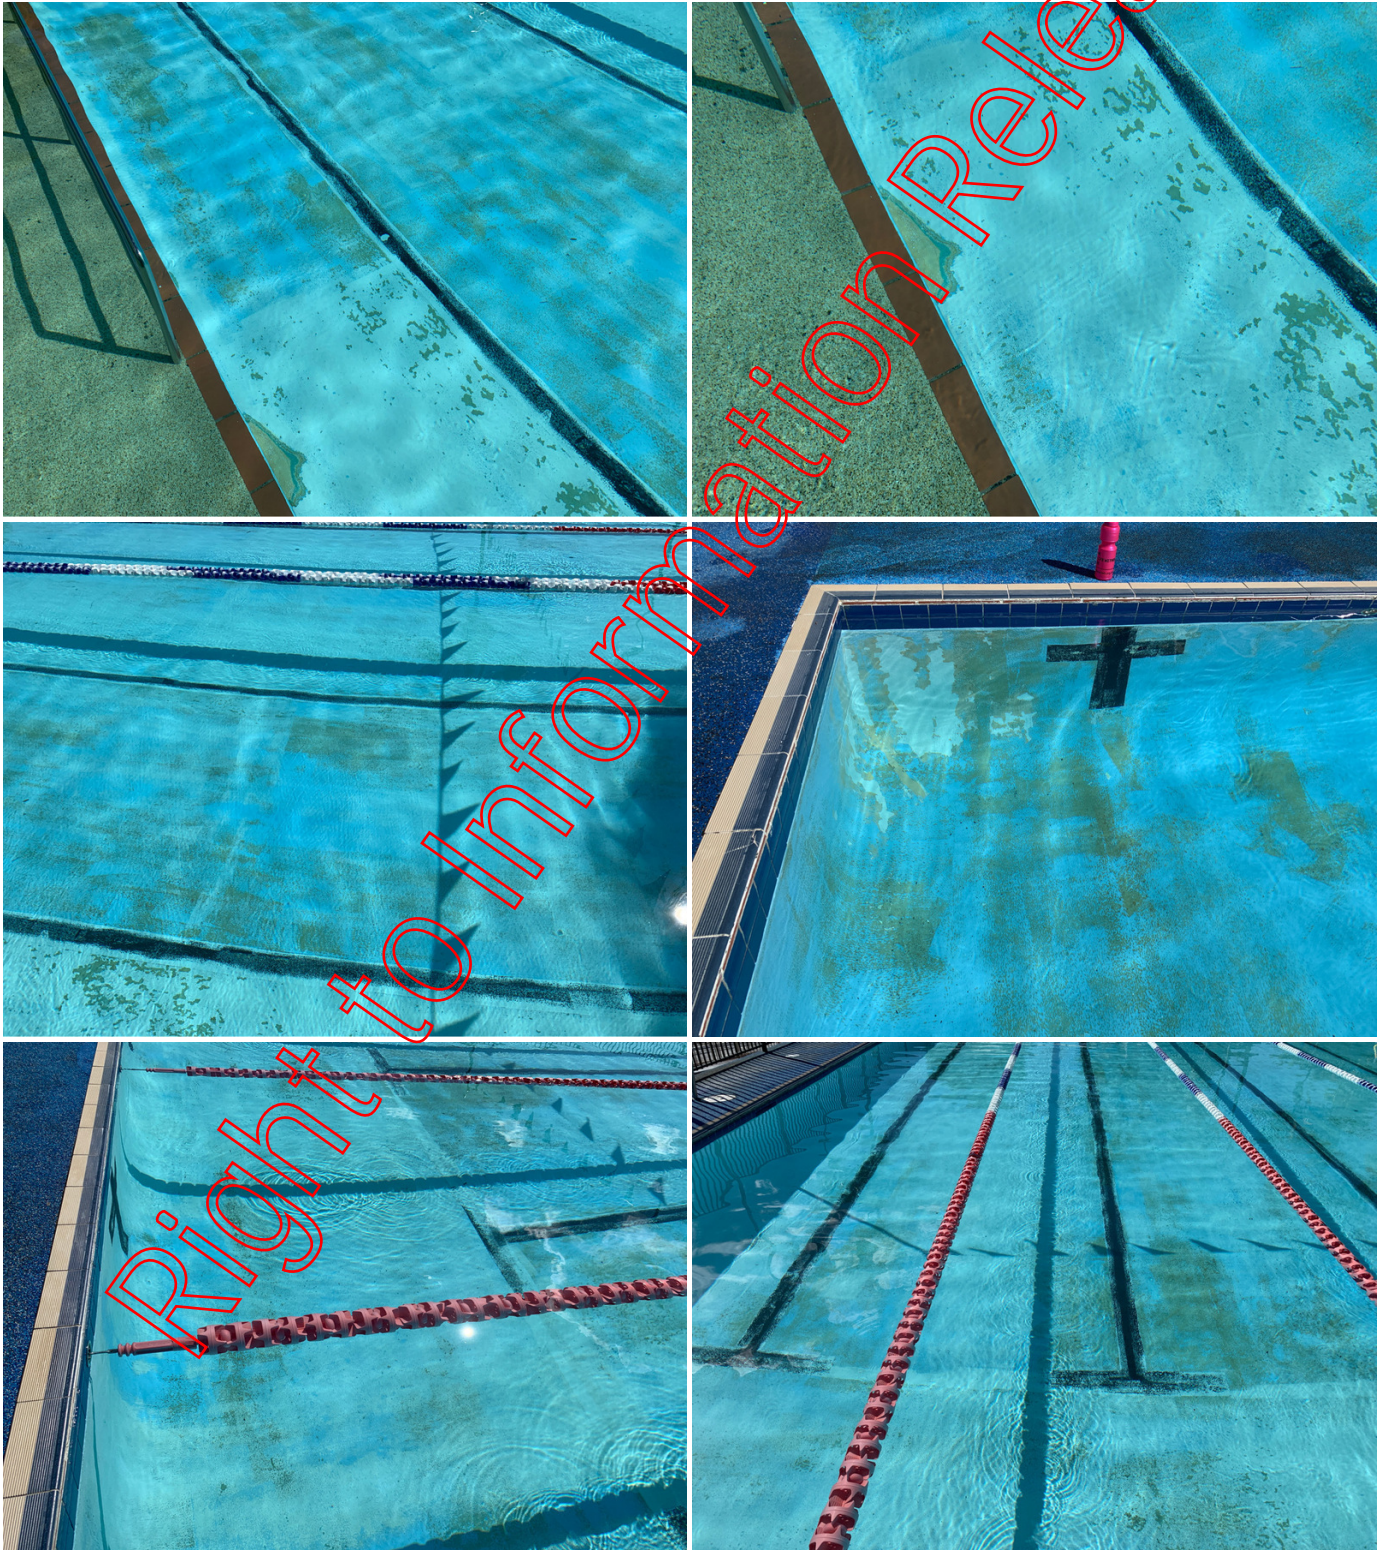
Observation Description	Pool Finish
Observation Details	The painted finish is in very poor condition with the underlying fibreglass liner appearing very worn in places.
Recommendations	Remove the fibreglass liner and refinish the pool
Critical Item?	No

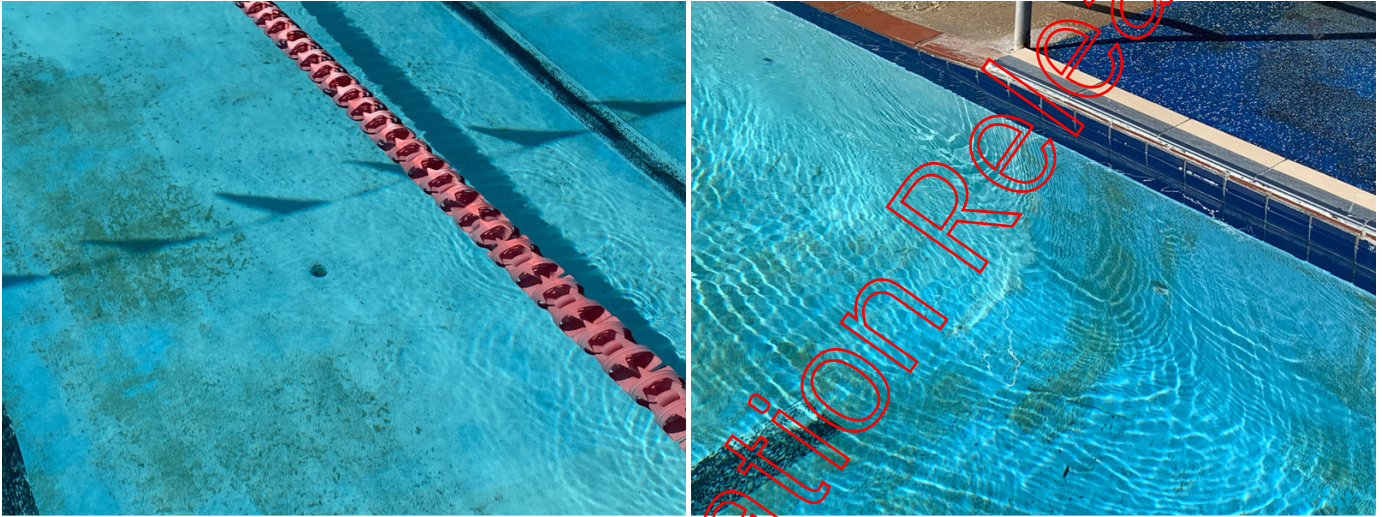
Observation Description	Circulation Fittings
Observation Details	The marjority of circulation fittings are missing in the pool with just bare pipe showing
Recommendations	Provide eyeball and floor rerun fittings to all bare pipes
Critical Item?	Yes

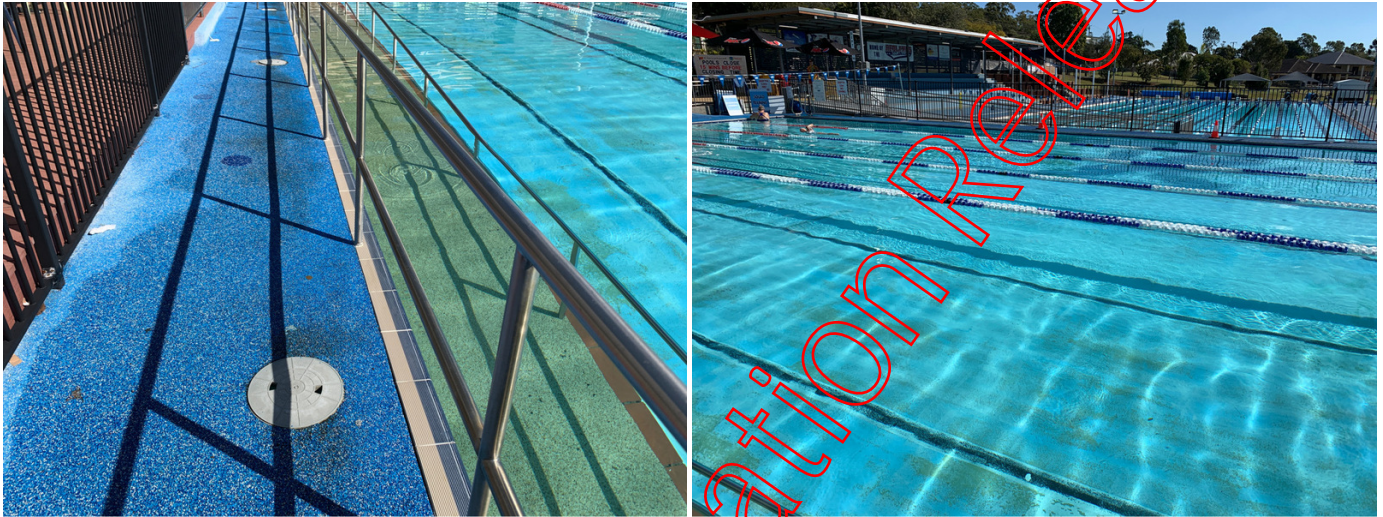
Observation Description	Pool Circulation
Observation Details	Circulation through the pool is likely poor due to the low flow and the poor number of fittings
Recommendations	As with the 50m pool, provide a circulation dye test
Critical Item?	No

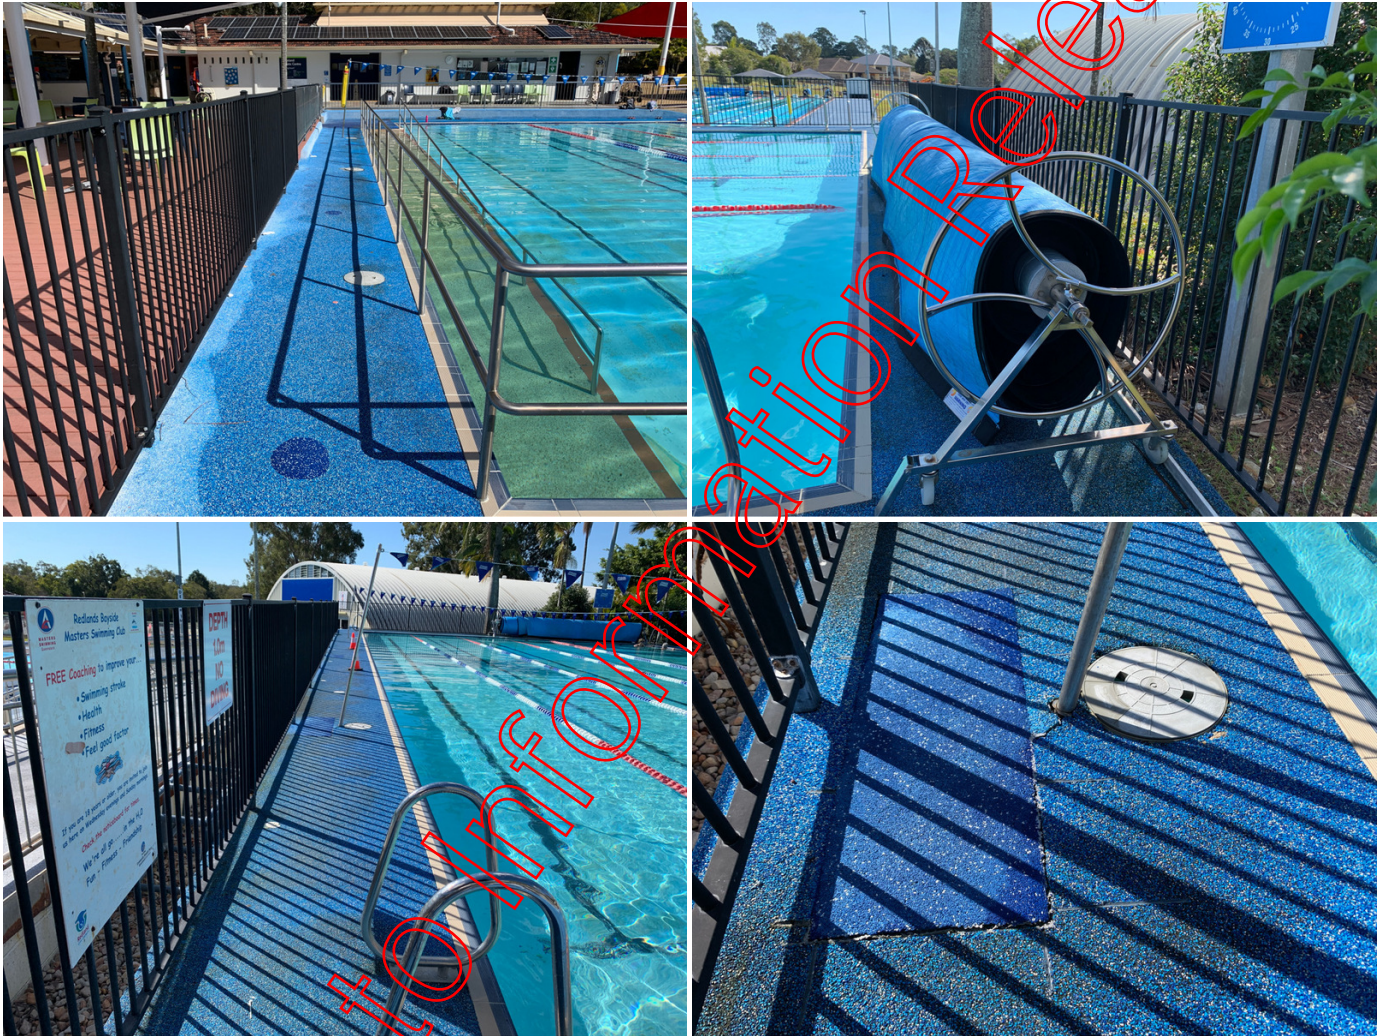
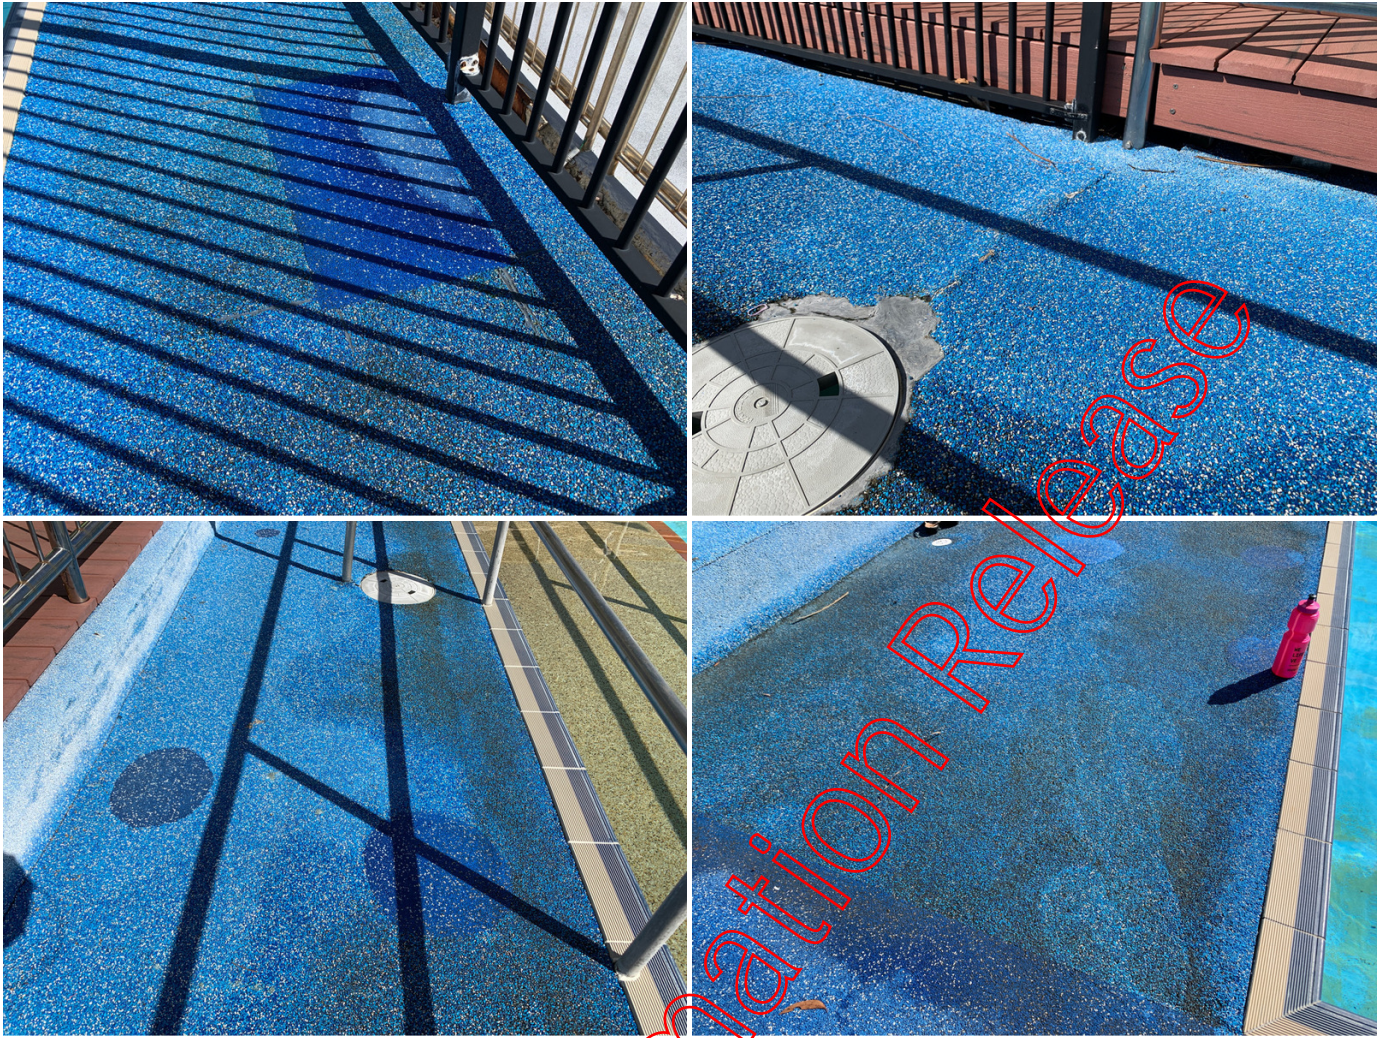
Observation Description	Concourse Circulation and Condition
Observation Details	Concourse circulation space is very tight, especially with instructions from blankets. Additionally the rubberised coating is in poor conditions
Recommendations	Review circulation around the pool and look to improve. Replace the rubberised coating.
Critical Item?	Yes

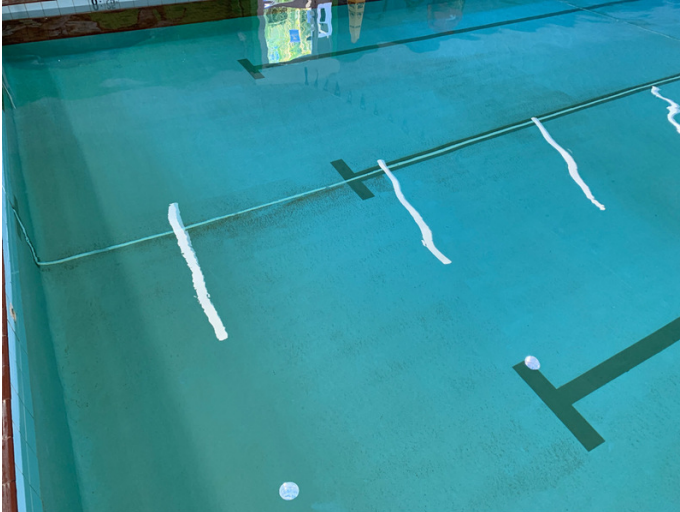
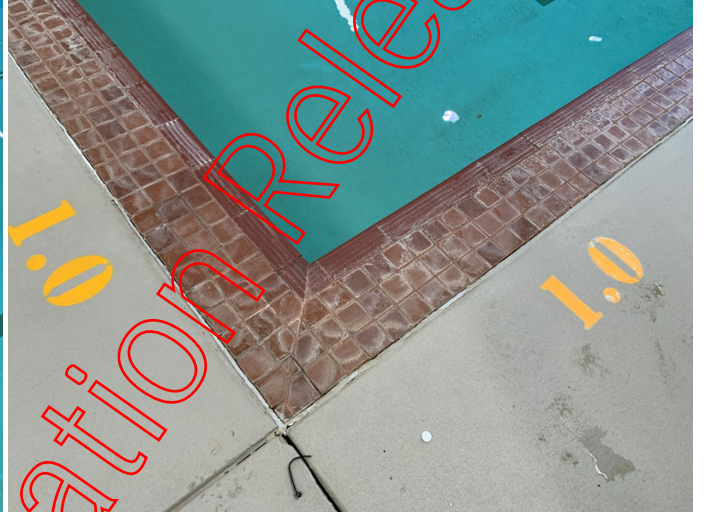
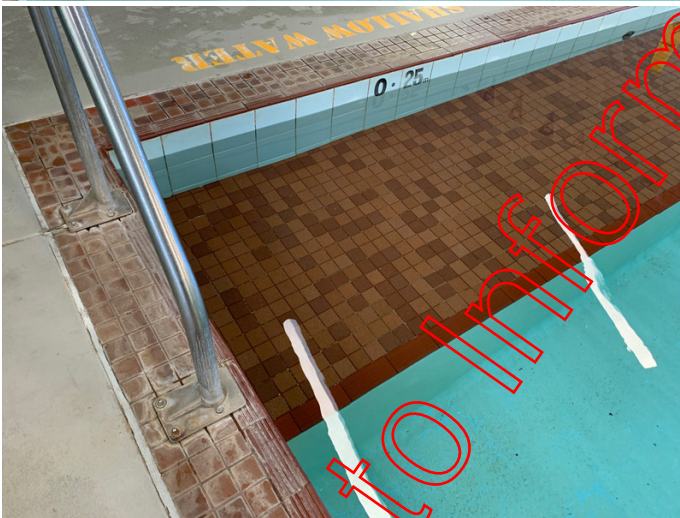
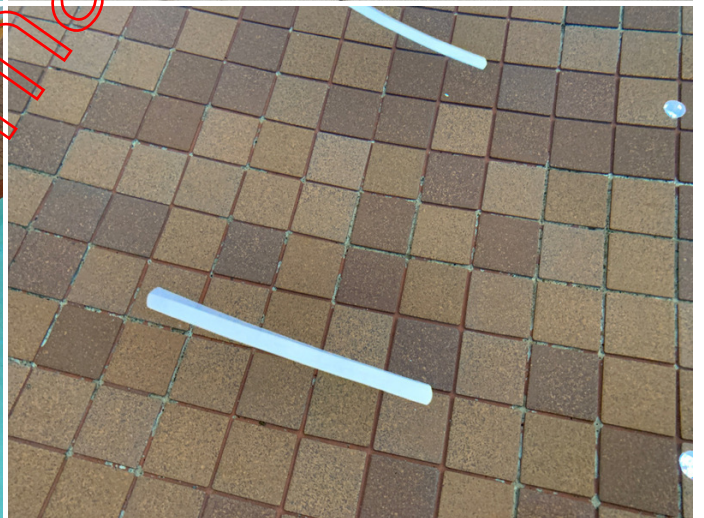
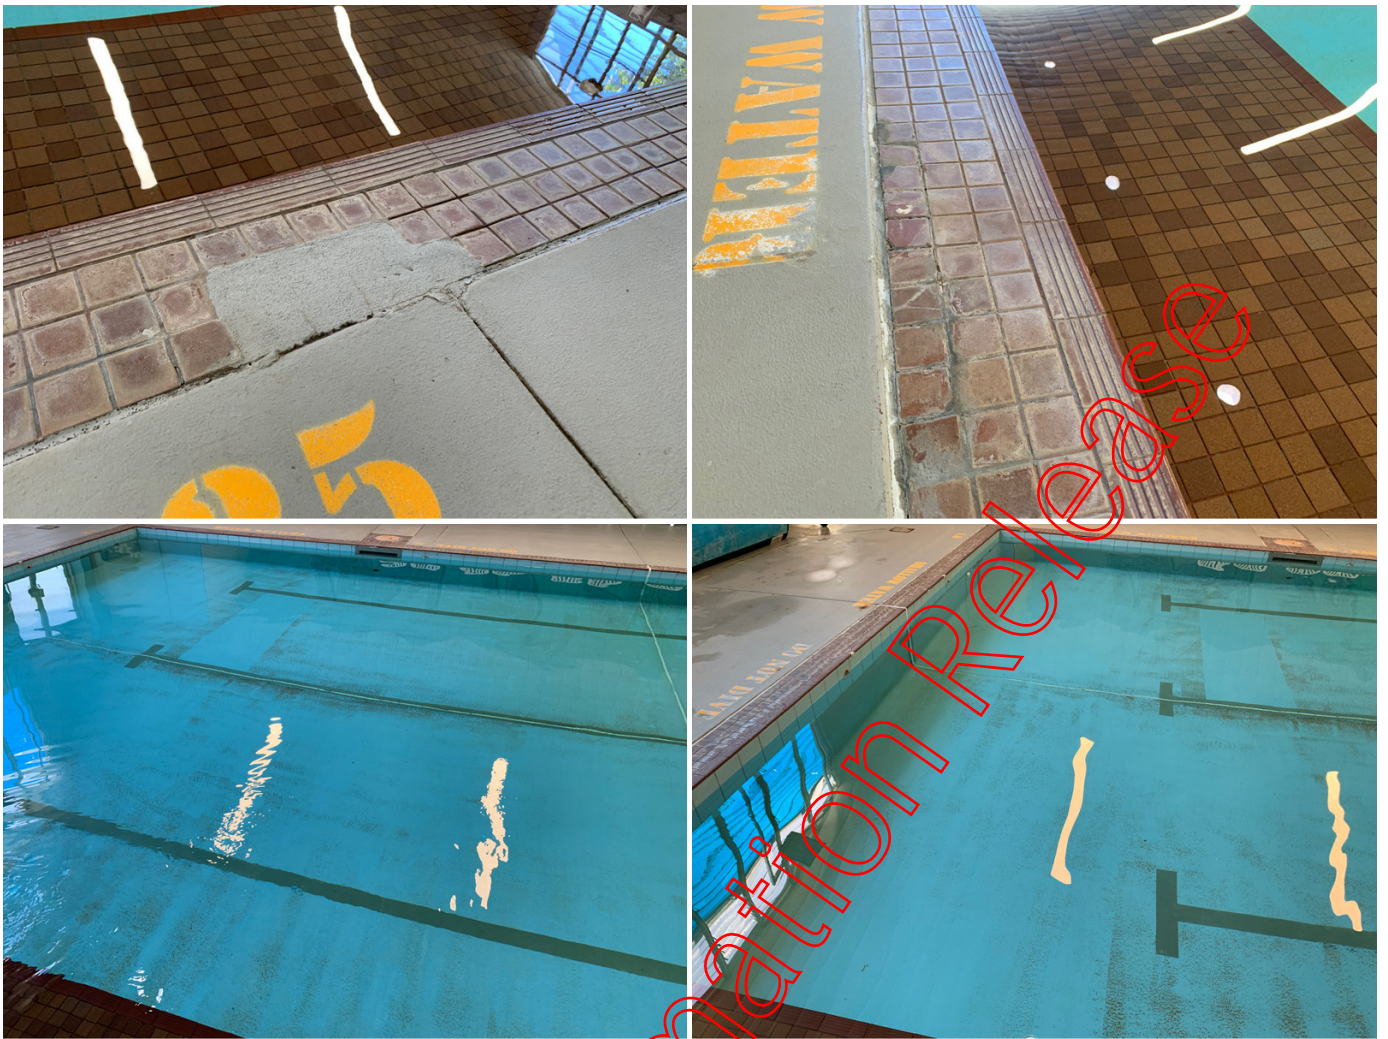
Observation Description	Finishes Condition
Observation Details	The finishes are in poor condition overall. The painted finish has failed with fibreglass visible through. Grout on the bench is generally missing whilst coping tiles are stained.
Recommendations	Replace the pool finishes
Critical Item?	No
