Aquatic Centre Condition Audit

Condition and compliance audit for an existing aquatic centre

Cleveland Aquatic Centre, July 19, 2023

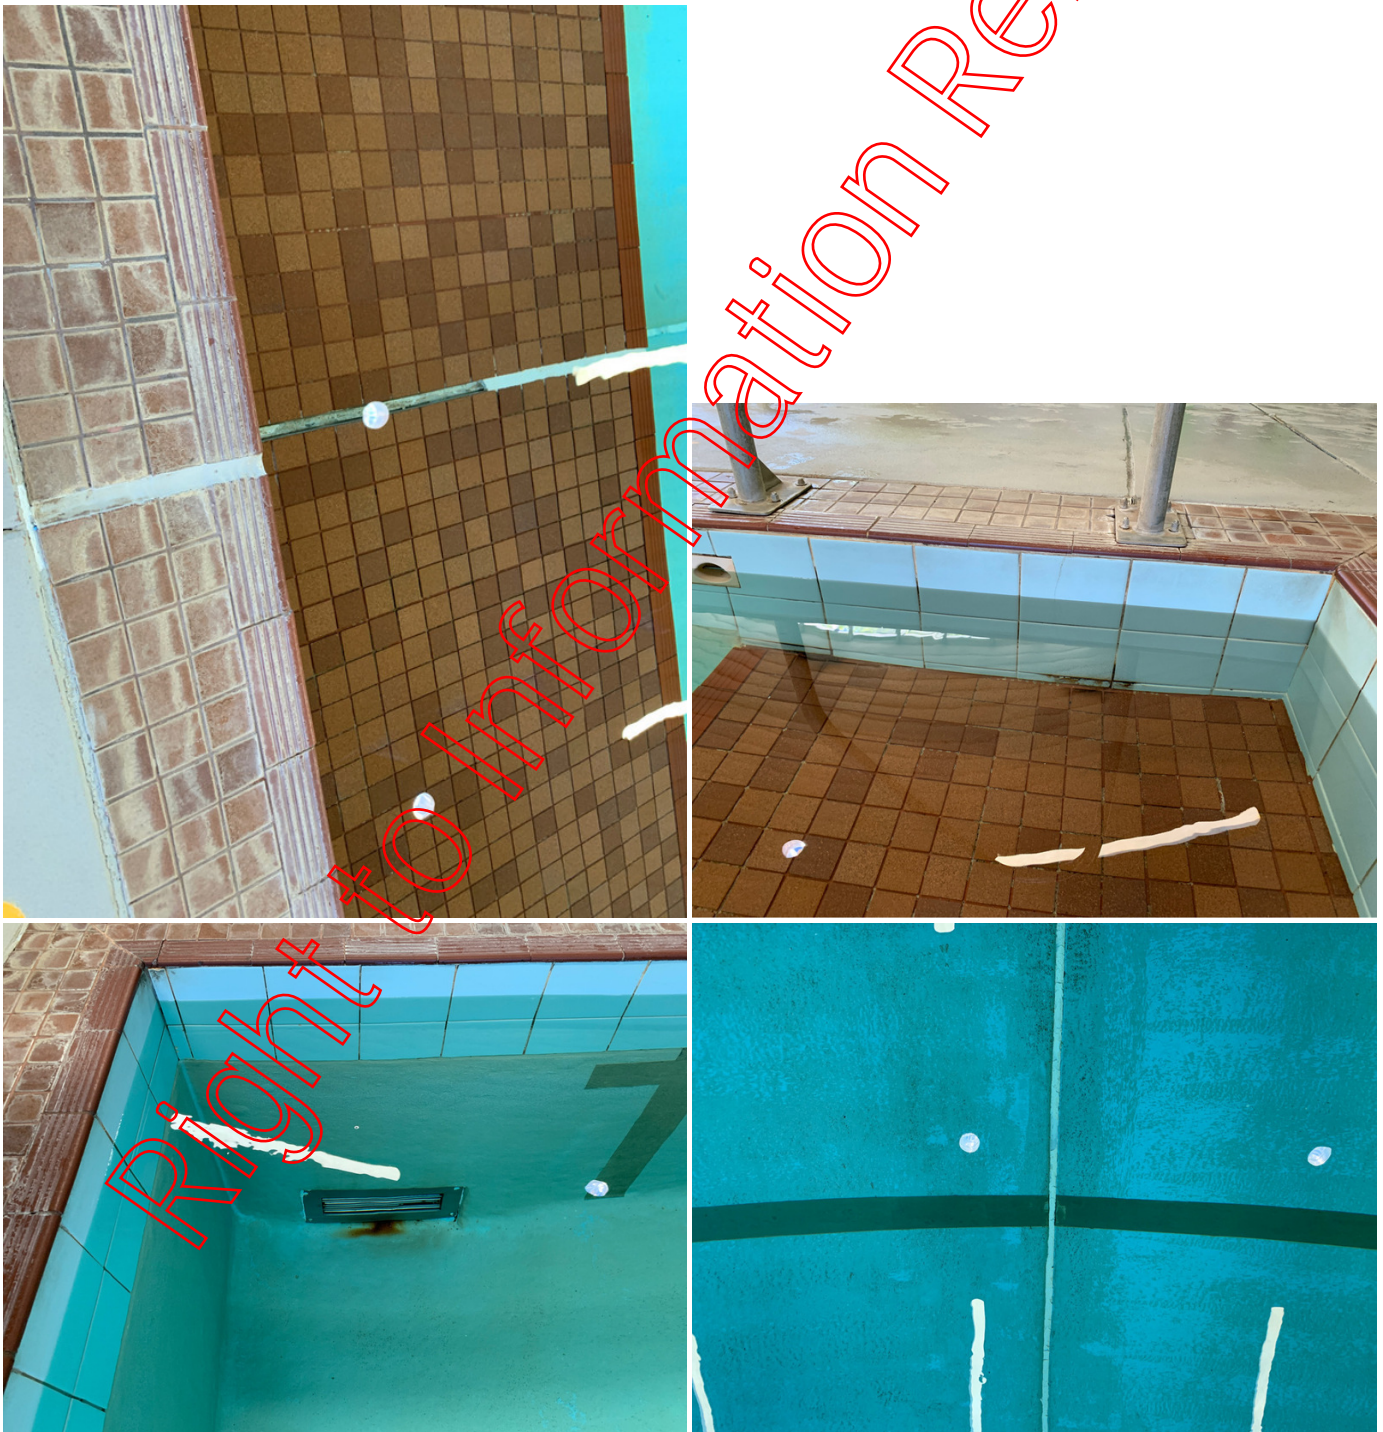
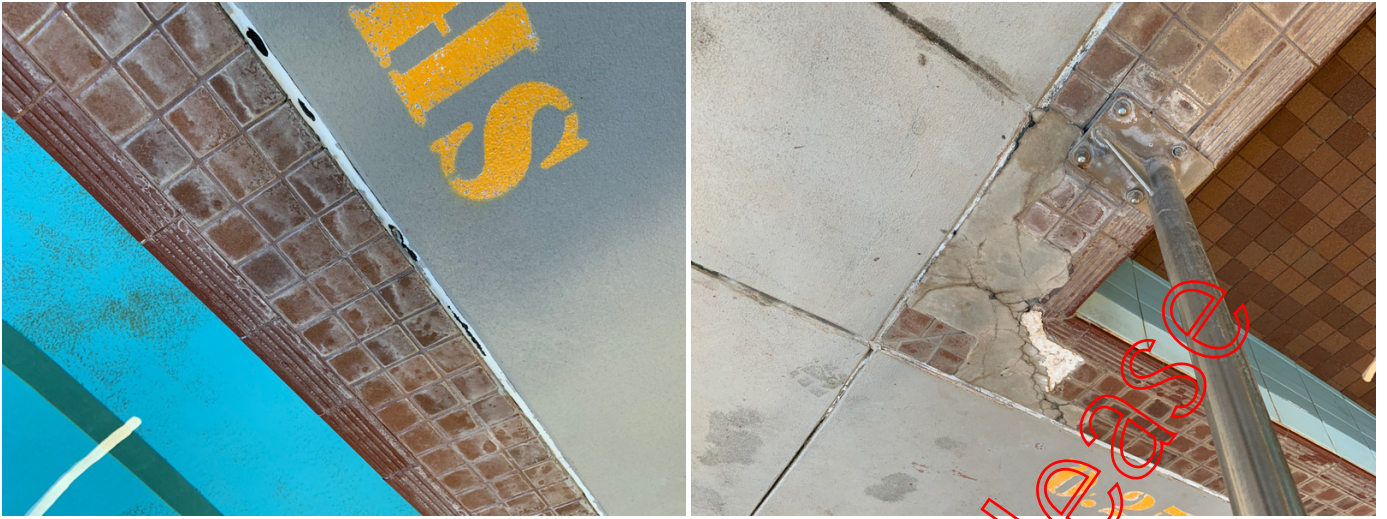
Observation Description	Structural Condition
Observation Details	Concerns are raised regarding the structural condition of the pool. The pool is reported to leak by the operators, with the water level dropping noticeably on shutdown. Damage is observed to one corner of the pool whilst rust is observed from the end of the bench and the floor drain. Silicon in joints is in bad condition.
Recommendations	As a short term approach, replace silicon and investigate leaks. The presences of the fibreglass liner makes inspection of the concrete substructure difficult. In the long term, allow to replace the pool.
Critical Item?	No

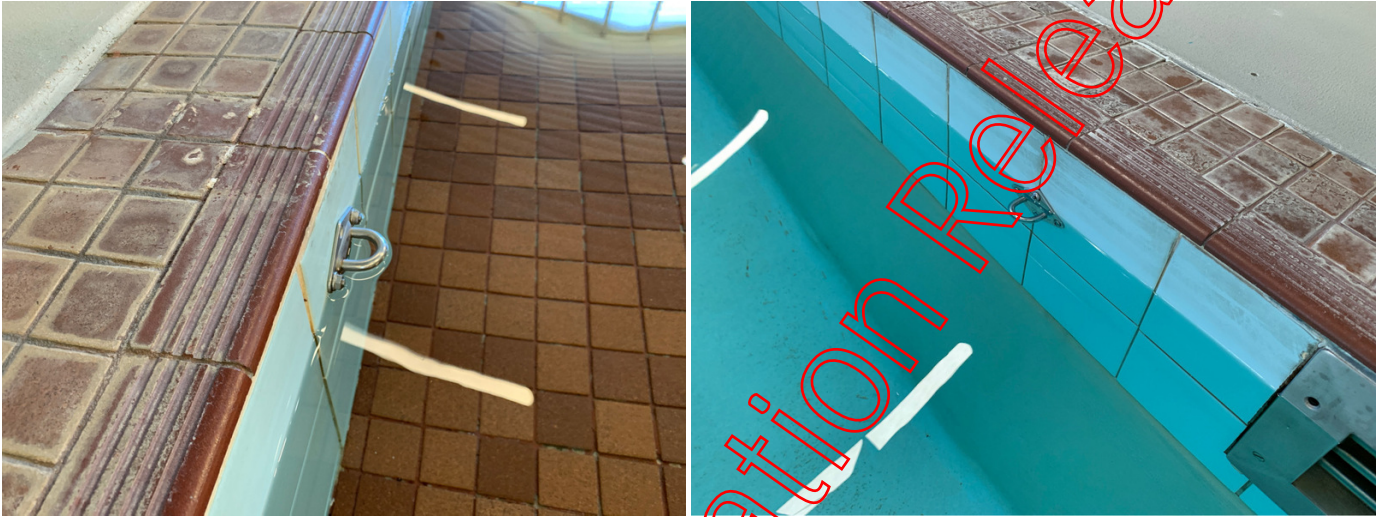
Observation Description	Anchors
Observation Details	Lane rope anchors protrude from the wall which create a finger and toe entrapment risk
Recommendations	Replace with flush anchors
Critical Item?	Yes

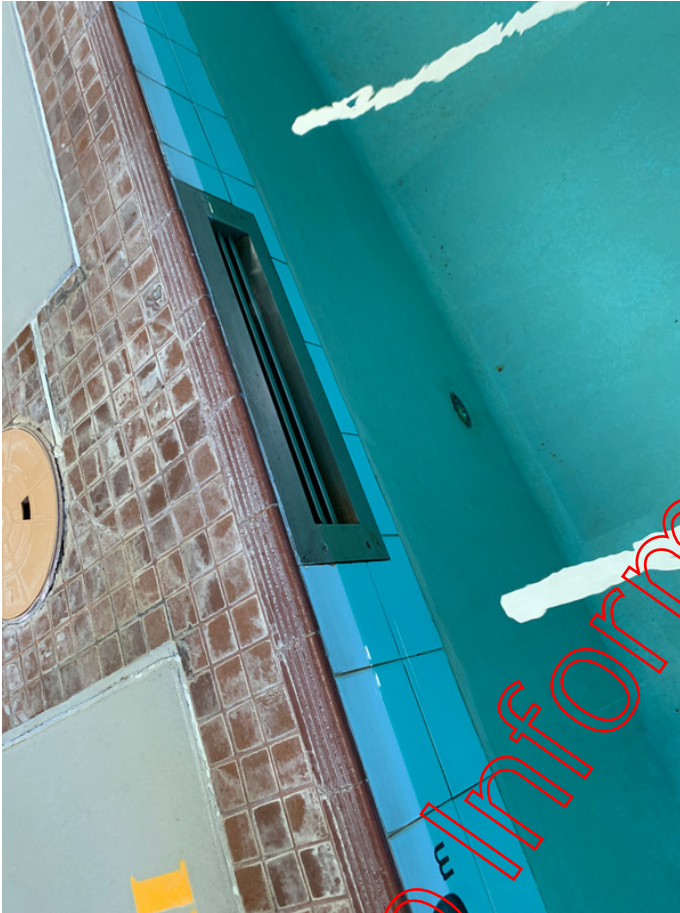
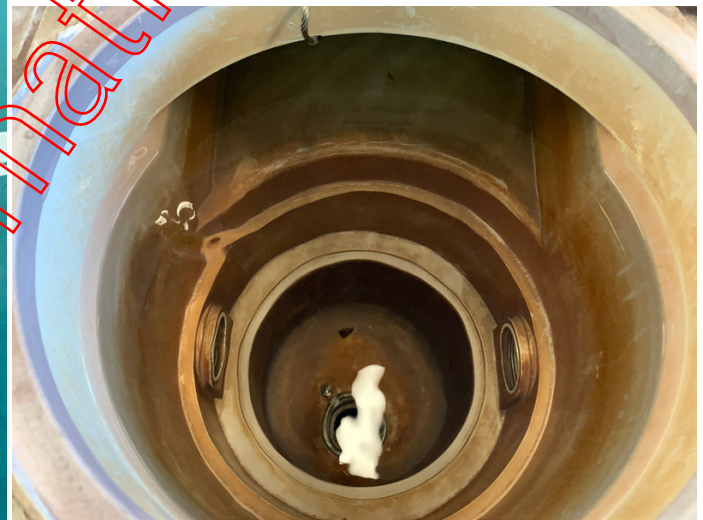
Observation Description	Skimmer Suction Fittings
Observation Details	Each skimmer appears to be connected to a suction fitting in the wall which is not fitted with an AS1923 compliant cover. This creates a suction entrapment risk and requires rectification urgently.
Recommendations	Block off fittings or provide compliant fittings.
Critical Item?	Yes

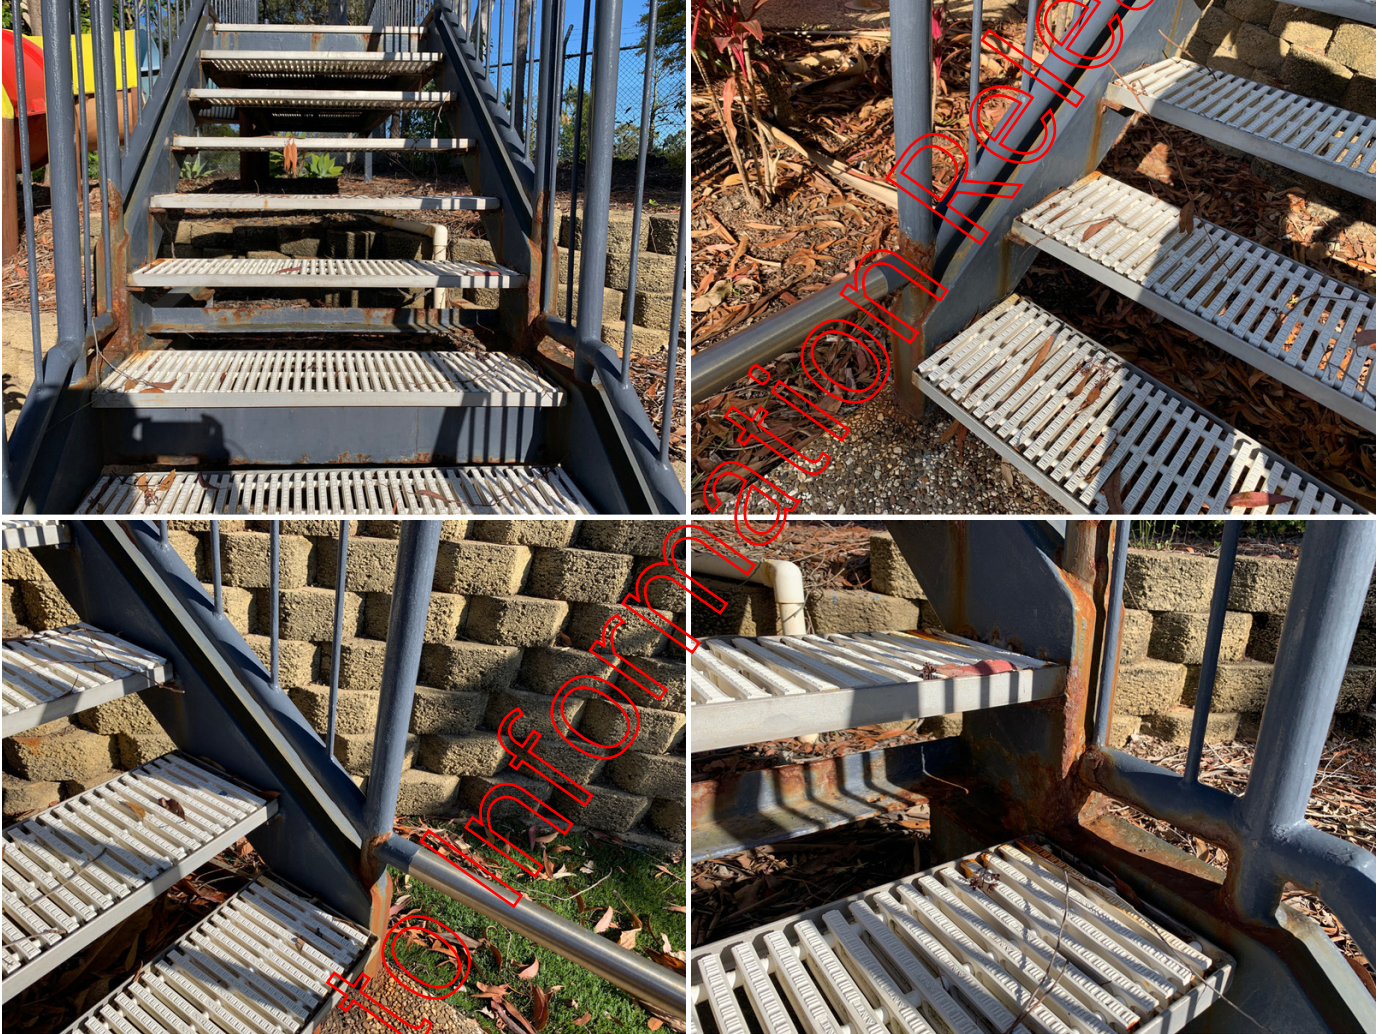
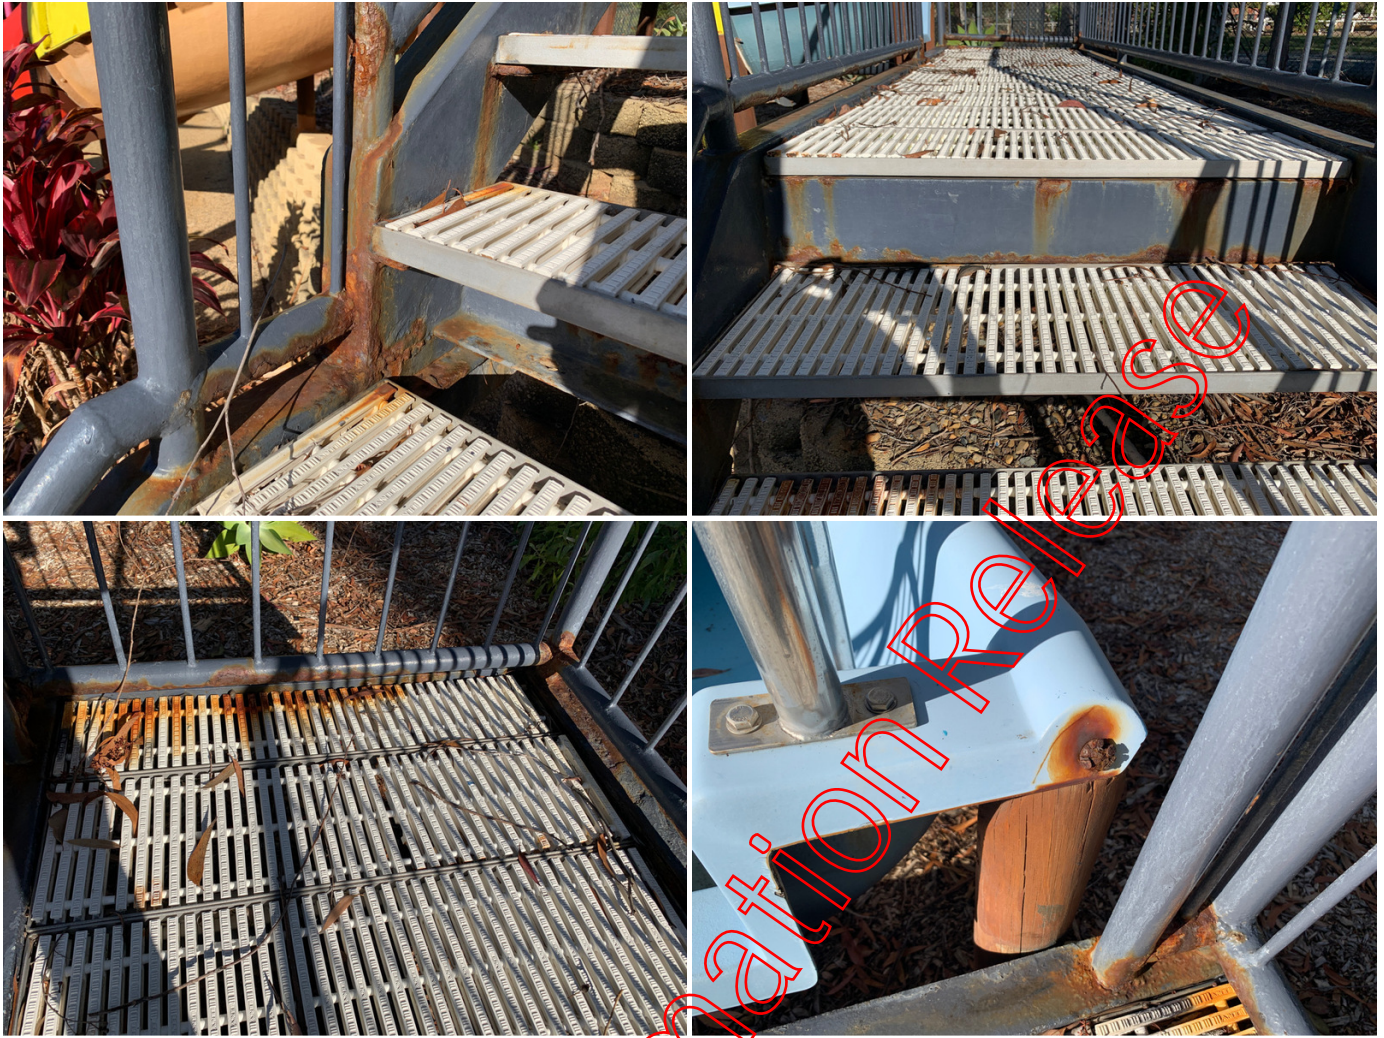
Observation Description	Waterslide Start
Observation Details	A significant amount of rust is still present in the stairs leading to the waterslide start. This rust has increased in magnitude since the previous inspection.
Recommendations	Repair the rust as a priority
Critical Item?	Yes

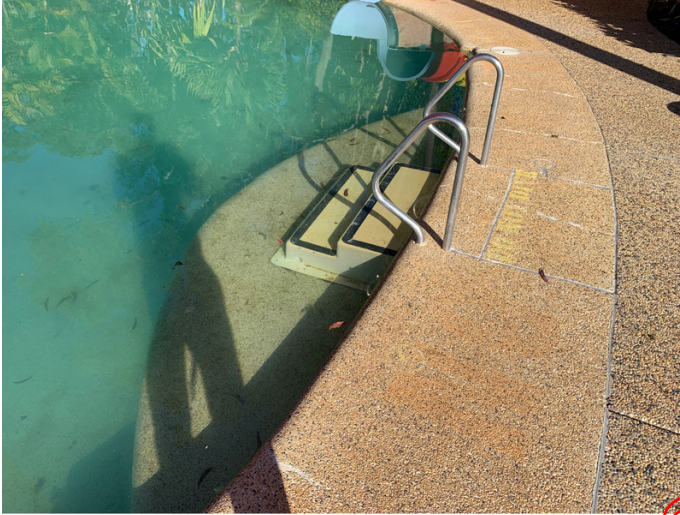
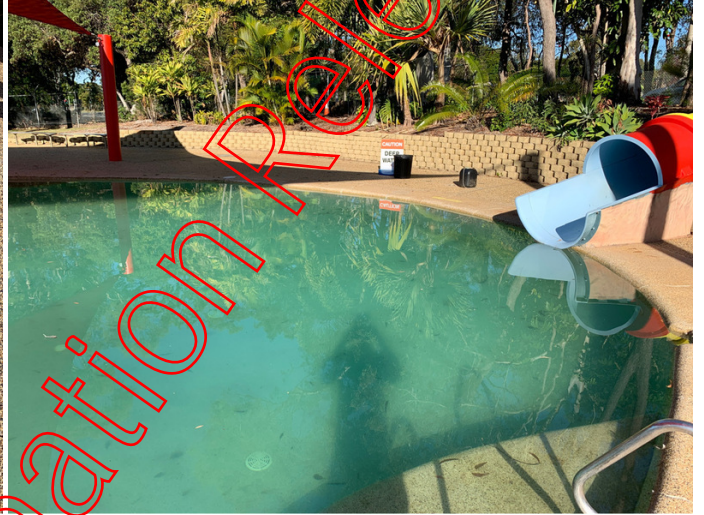
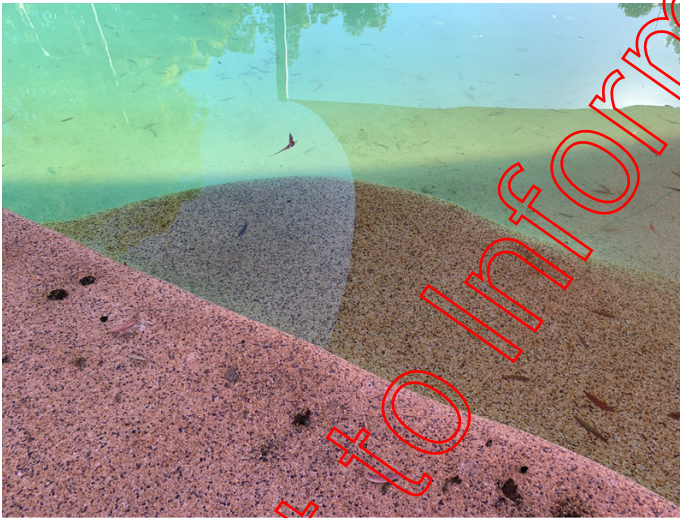
Observation Description	Pool Access
Observation Details	No compliant access point is provided in the deep end. A fibreglass step is present onto a swimout, however access does not continue to the flood of the pool nor are edge delineators provided to any steps or swimouts in the pool.
Recommendations	Add compliant ladders. Add edge delineation markers to all underwater edges.
Critical Item?	Yes

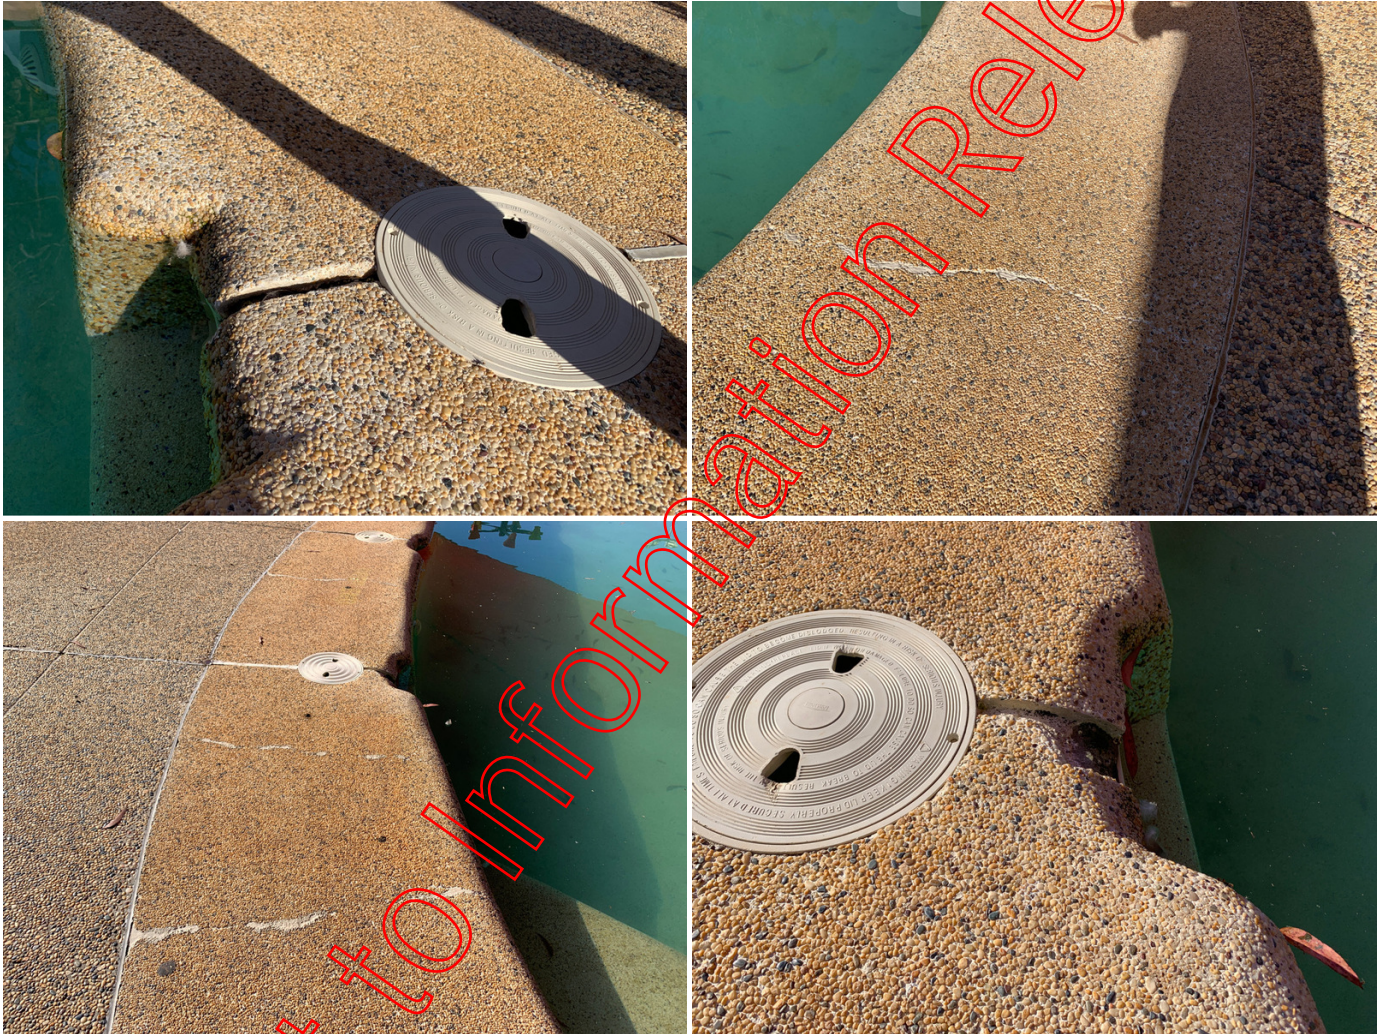
Observation Description	Coping Finishes Condition
Observation Details	The coping finishes condition is poor, with notable cracking observed in the finishes. In some areas sections of the finish are missing or delaminated.
Recommendations	Remove all finishes and inspect the sub grade for condition. Provide new finishes. In the interim, remove any loose areas and make good.
Critical Item?	Yes

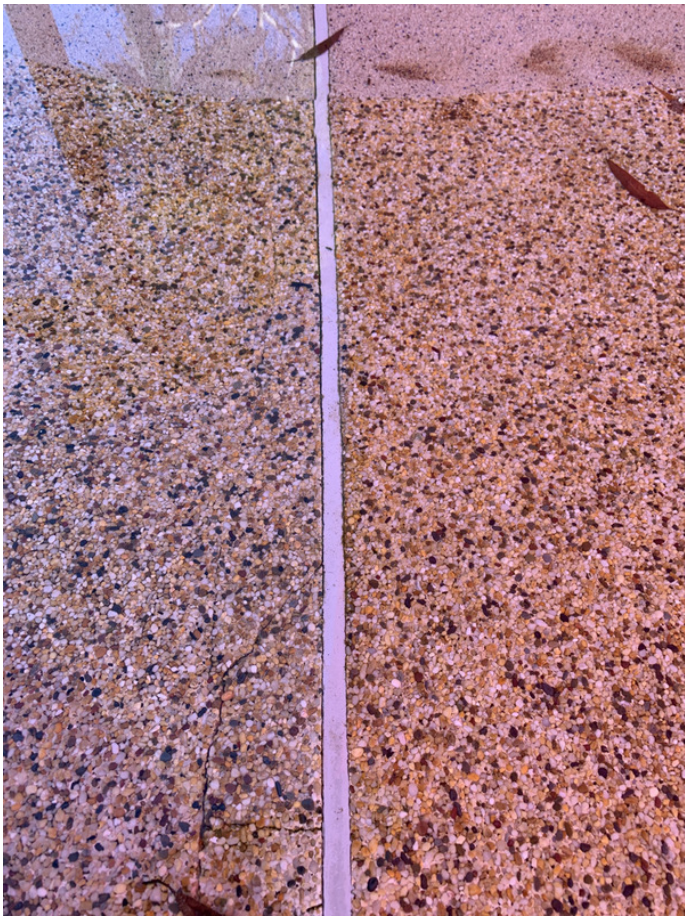
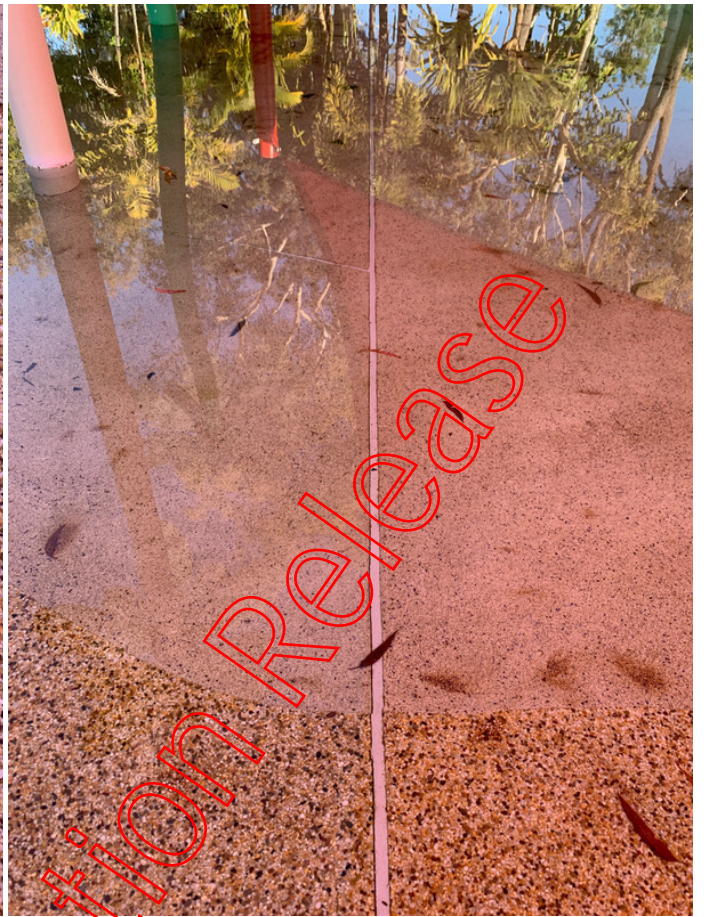
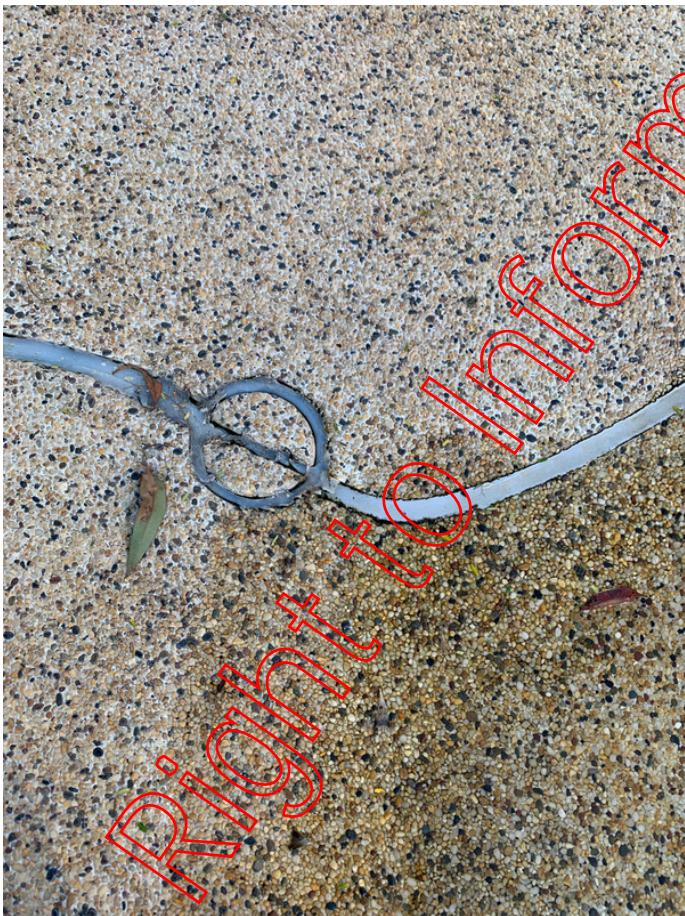
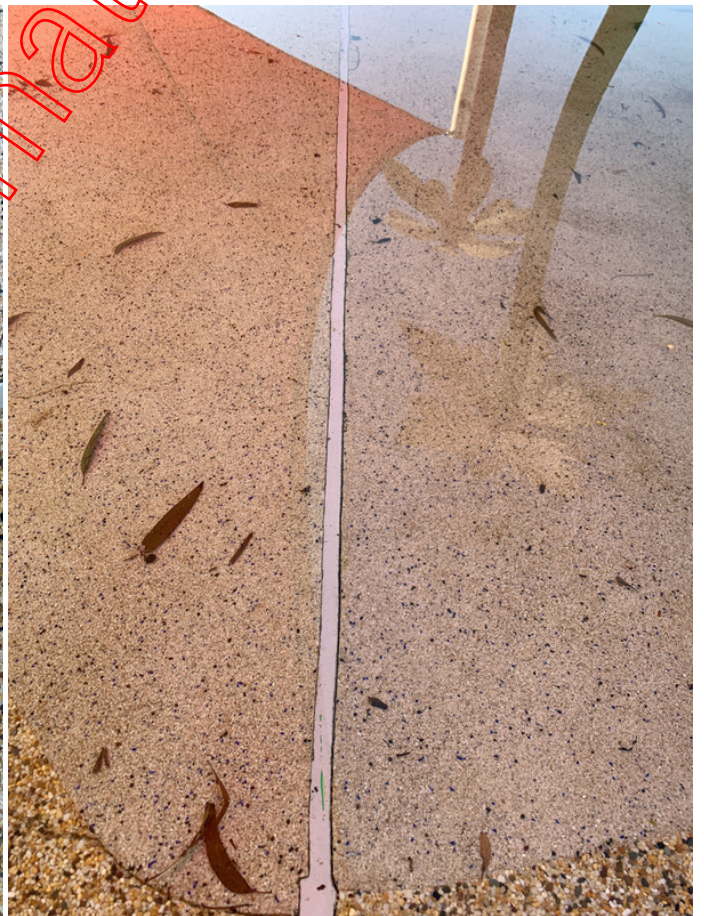
Observation Description	Pool Silicon
Observation Details	Pool silicon requires replacement
Recommendations	Leak test and replace.
Critical Item?	No
Observation Photos

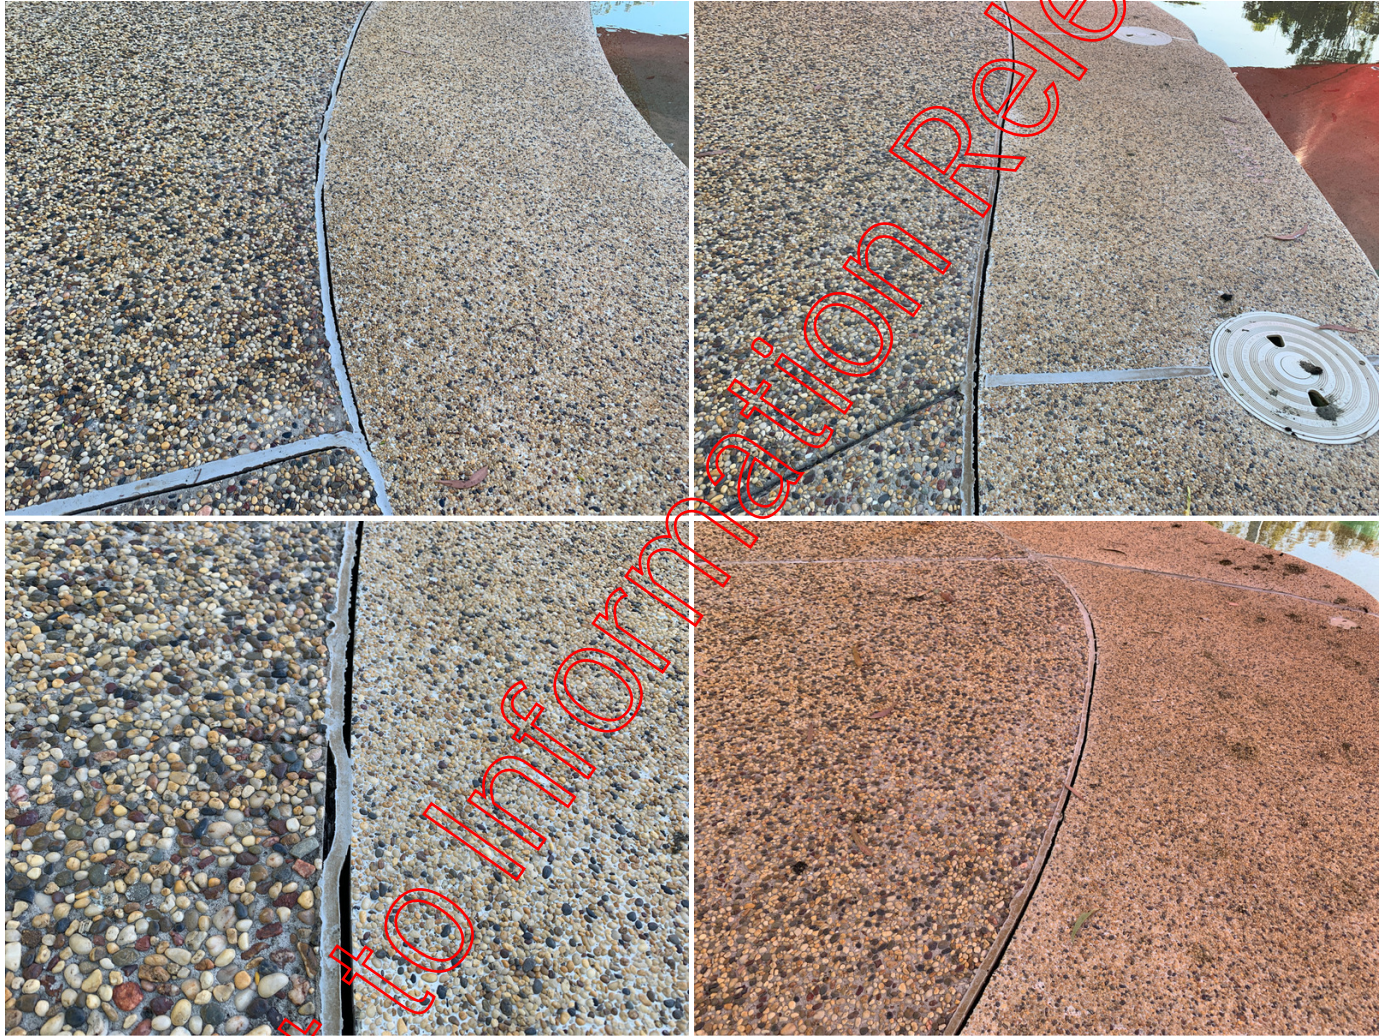
Observation Description	Concourse Movement
Observation Details	The concourse adjacent the small waterslide appears to have moved away from the pool approximately 10mm, indicating ground subsidence.
Recommendations	Reseal the joint and monitor for further movement or structural degradation of the concourse
Critical Item?	No

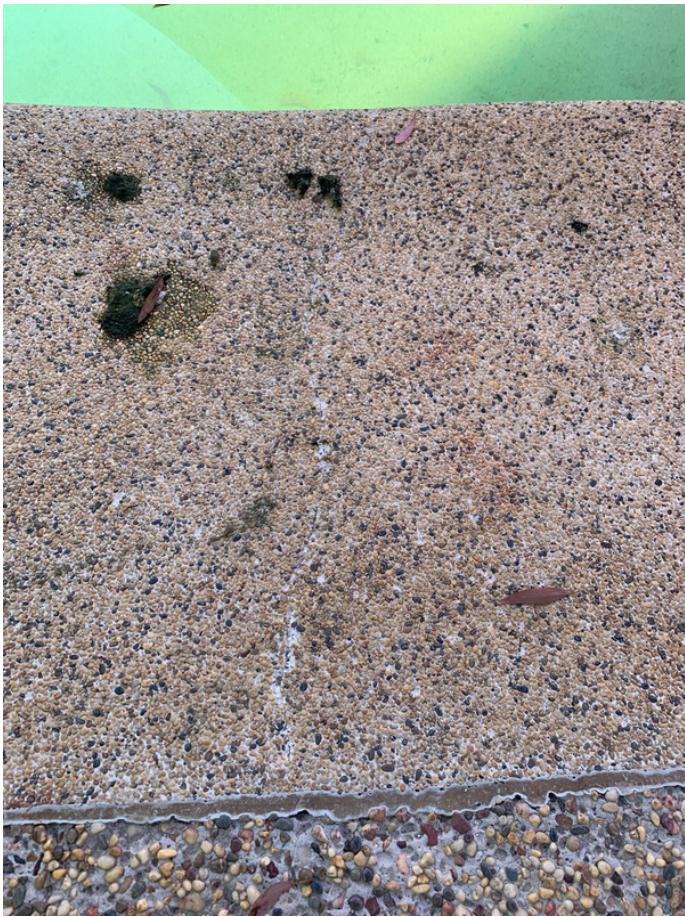
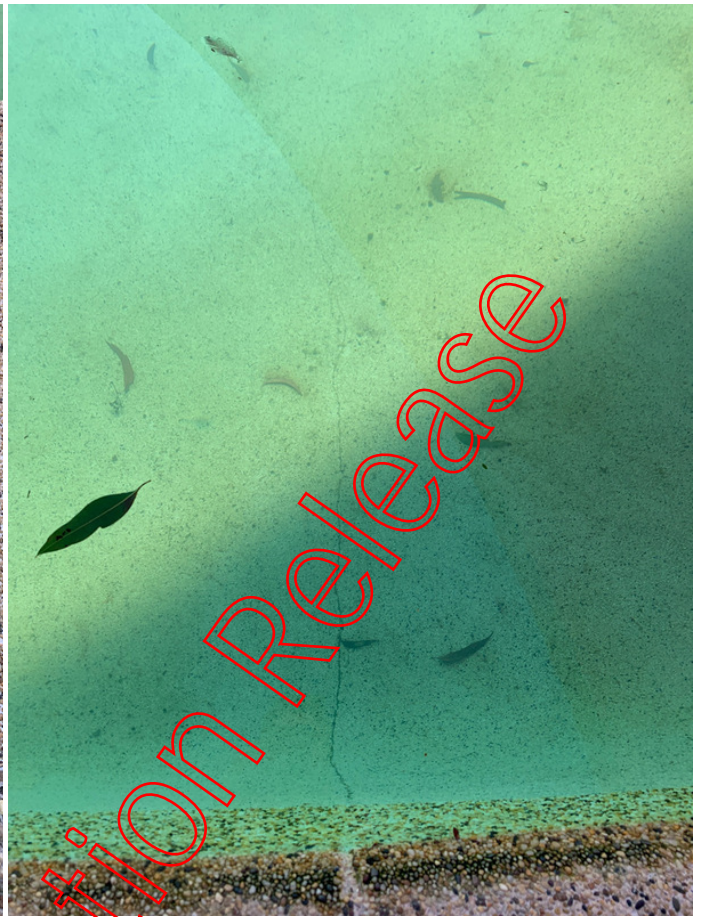
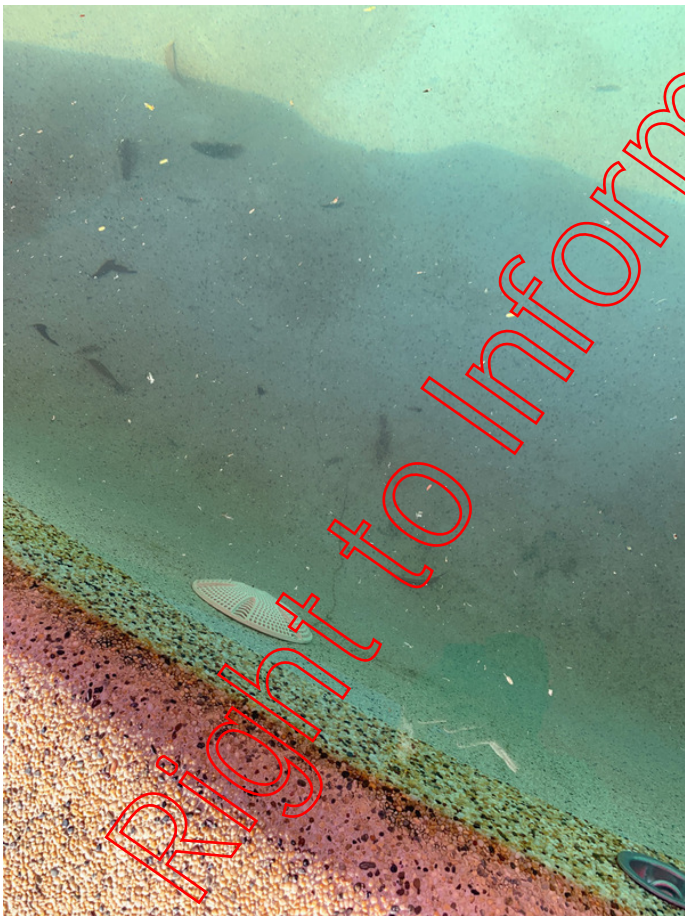
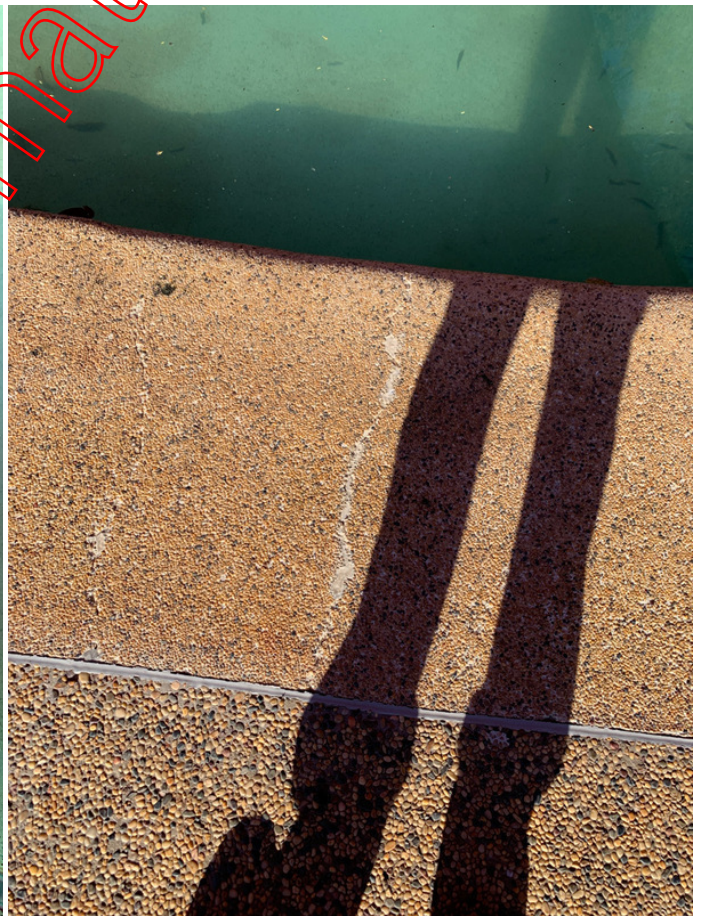
Observation Description	Structure Crack
Observation Details	A structural crack is observed running across the deep end of the pool
Recommendations	Inspect the crack for leaks and seal the crack
Critical Item?	Yes
Observation Photos

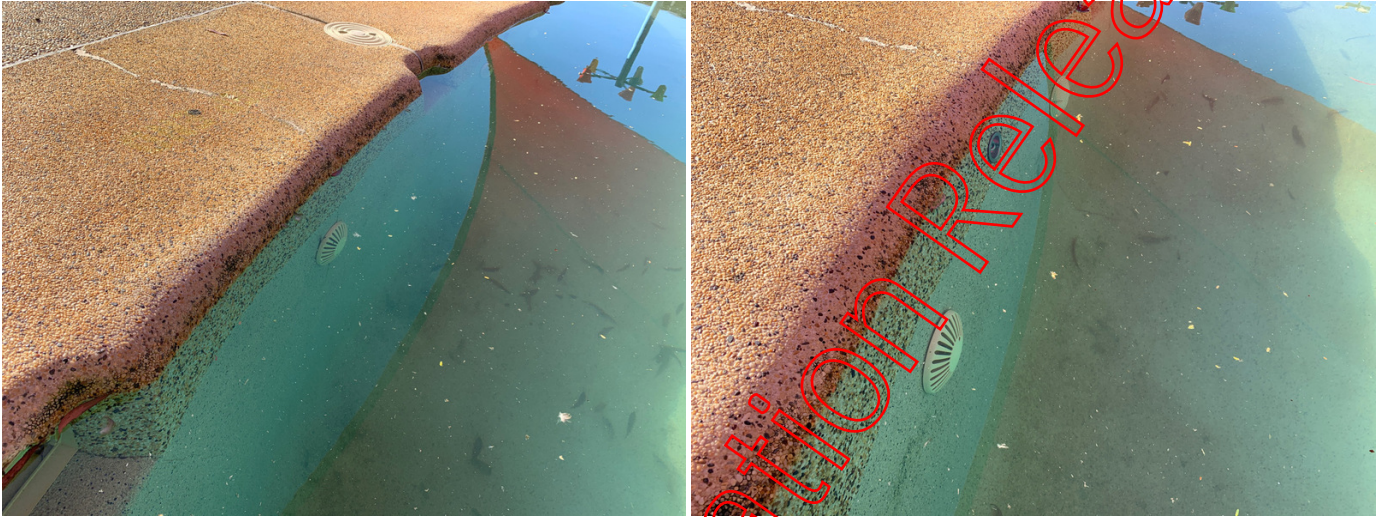
Observation Description	Suction Fittings
Observation Details	Old suction fittings are present in the wall of the pool.
Recommendations	Remove the fittings and replace with new AS1926.3 compliant items
Critical Item?	Yes

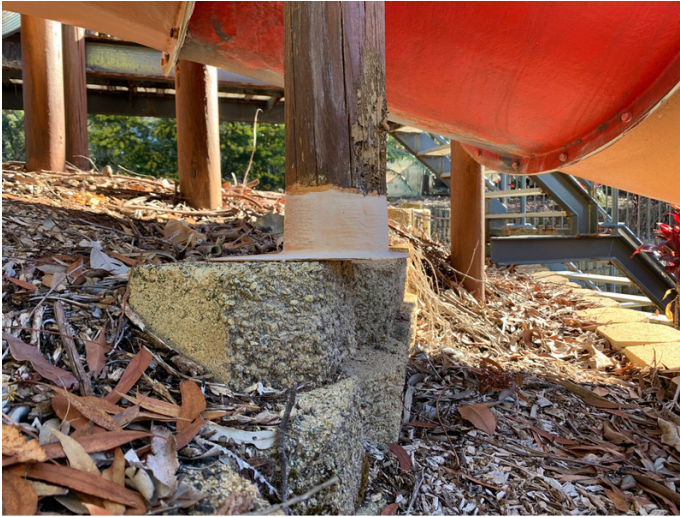
Observation Description	Waterslide Support
Observation Details	One of the legs of the waterslide is poorly supported half on a brick
Recommendations	Rectify the support
Critical Item?	Yes

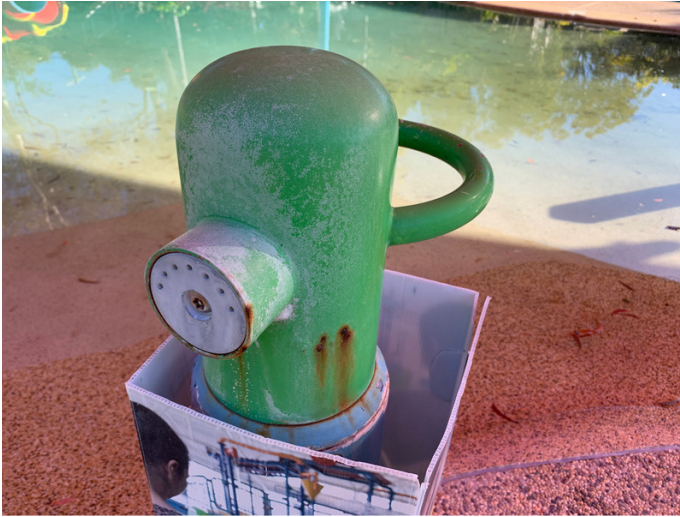
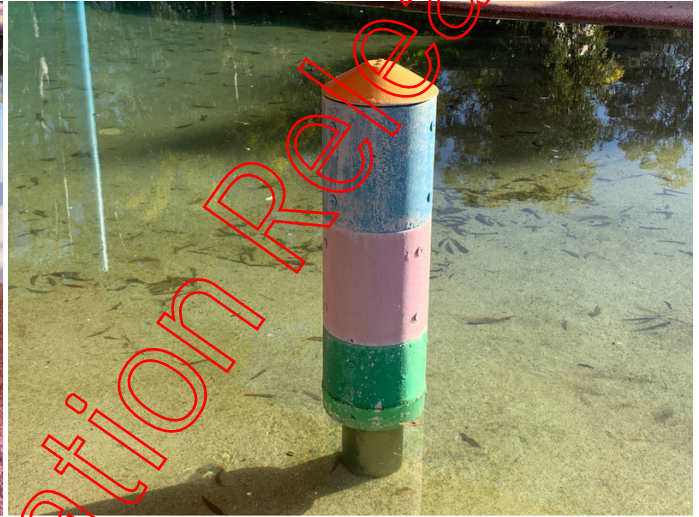
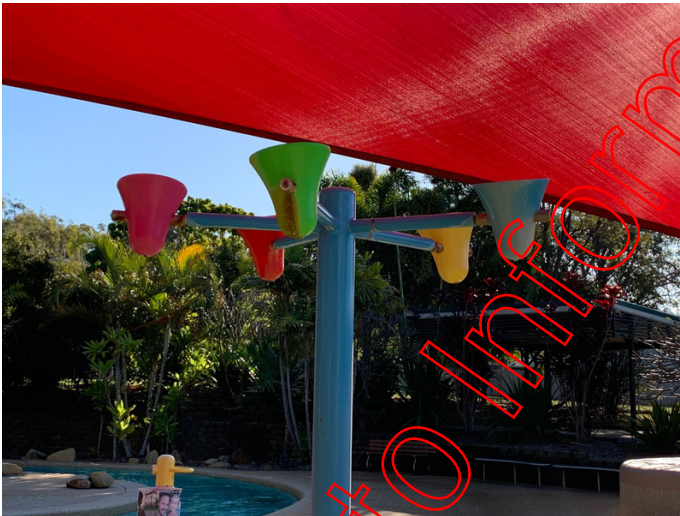
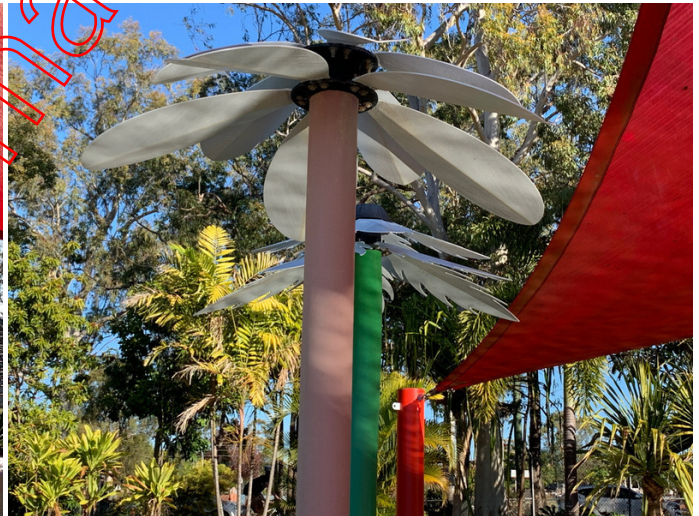
Observation Description	Water Toy Condition
Observation Details	The water play toys are aging
Recommendations	Refurbish the Waterplay toys
Critical Item?	No

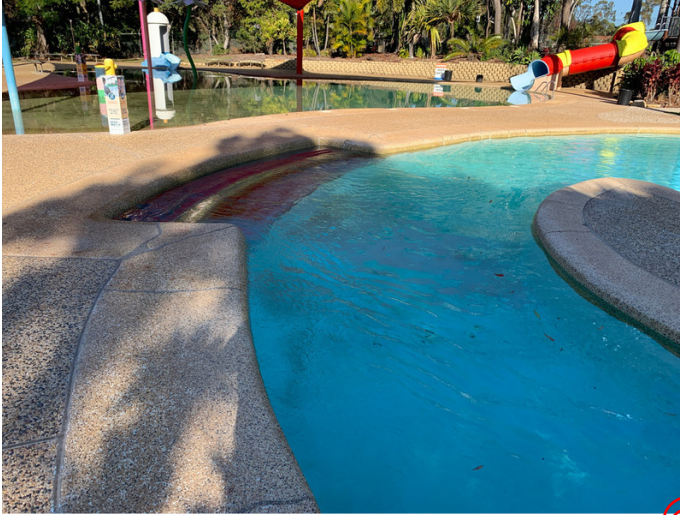
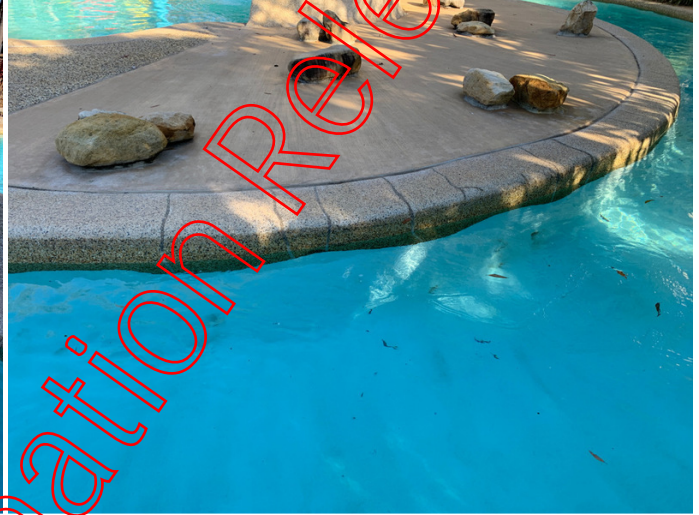
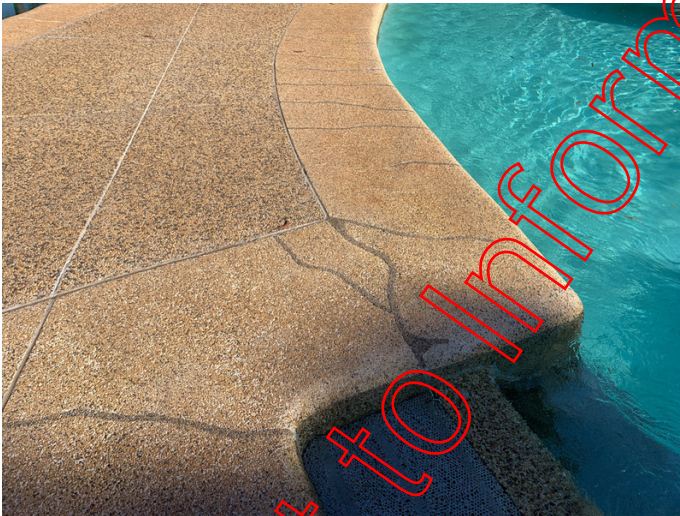
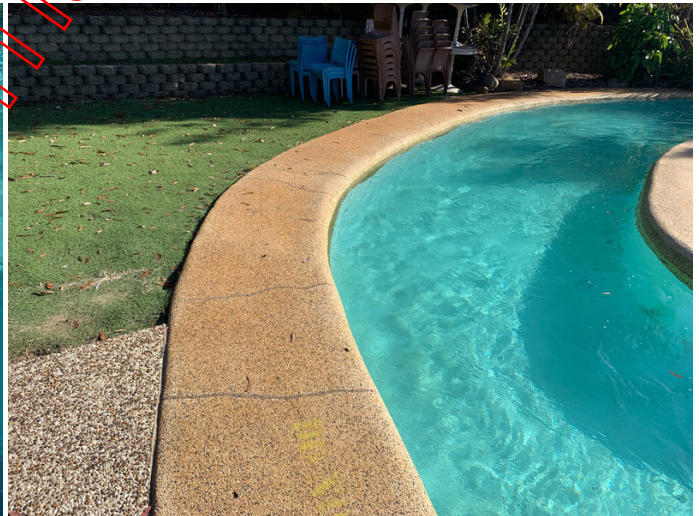
Observation Description	Structure cracks
Observation Details	Numerous cracks are present in the structure, with many repairs observed. Whilst the majority of the cracks appear to be in the coping, some of the cracks continue down through the pool structure itself.
Recommendations	Consider replacement of the pool
Critical Item?	No

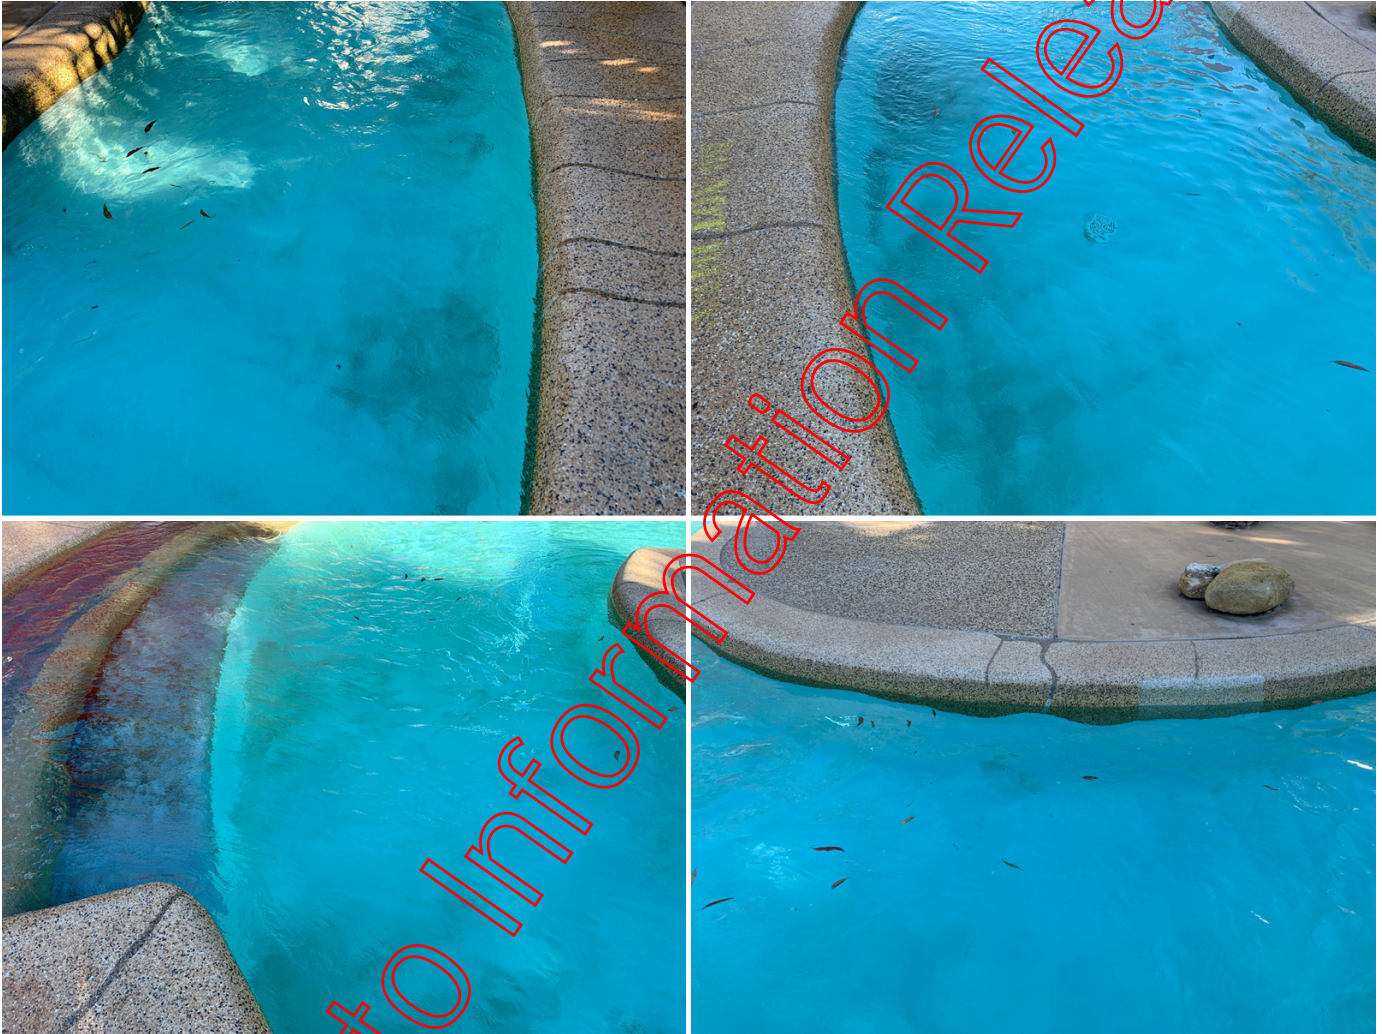
Observation Description	Finishes condition
Observation Details	The painted finish has failed
Recommendations	Replace the painted finish
Critical Item?	No
