Aquatic Centre Condition Audit

Condition and compliance audit for an existing aquatic centre

Cleveland Aquatic Centre, July 19, 2023

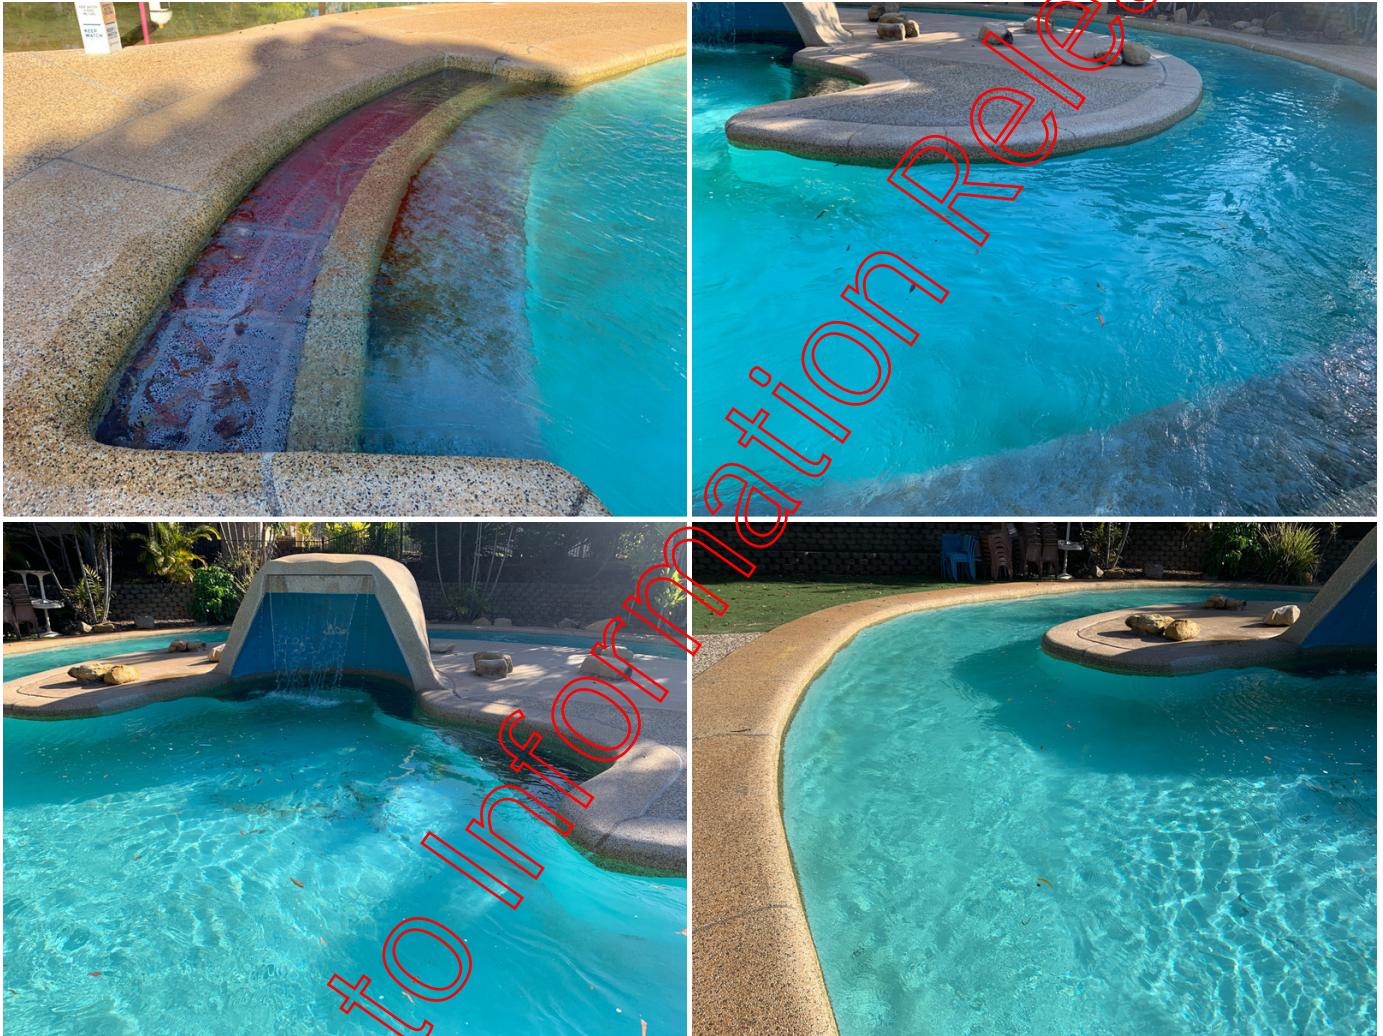
Observation Description	Surface Skimming
Observation Details	The outlet chamber is flooded at the time of the inspection. No surface skimming takes place. A large amount of leaf matter remains suspended in the pool
Recommendations	Consider replacement of the pool
Critical Item?	No
