# Aquatic Facility Audit

AQ1-0224-DR1, Revision A

## Cleveland Aquatic Centre

**REDLAND CITY COUNCIL**

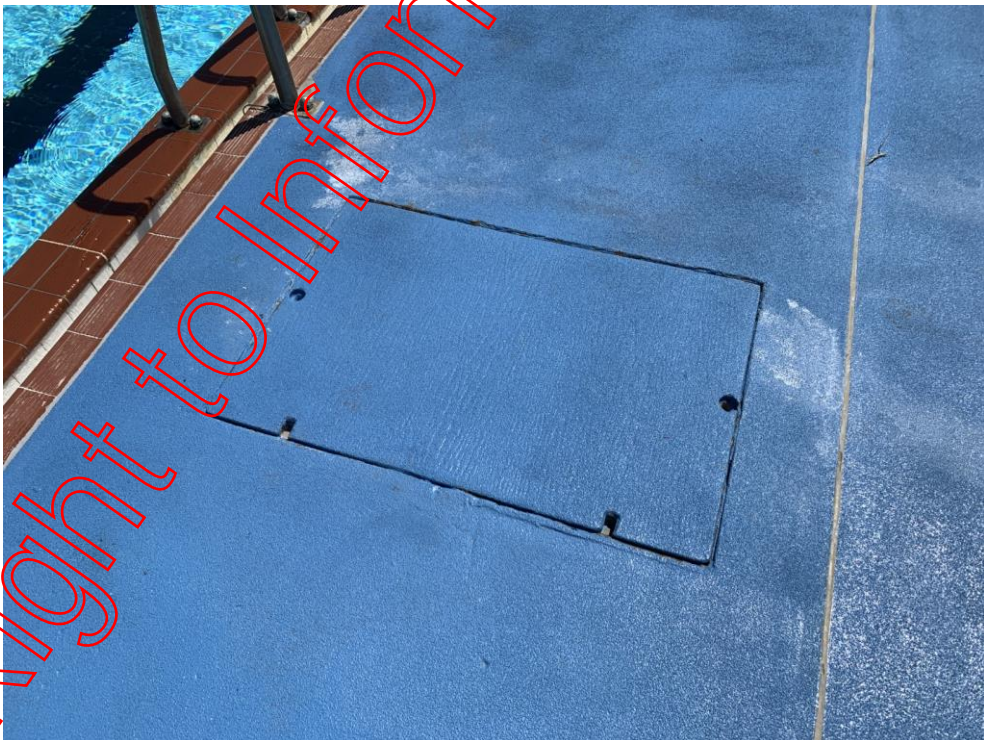
*Figure 8: Heavy balance tank lid*

- Undertake a survey of the pool wall levels and repeat in 12 months to determine if there is any movement.
- Replace the tank lids with lighter lockable items such as Terra Firma lids.
- Rectify failed tiling. Undertake a detailed grout inspection on the pool and repair / replace as necessary.
- Consult with operational staff regarding floor tiling slip level and identification of any operational issues experienced.
- Consider providing grated covers to the open channel wet decks.
- Undertake circulation dye testing in accordance with the Model Aquatic Health Code. If dead spots are identified, improvements may be required to the filtered water return system.

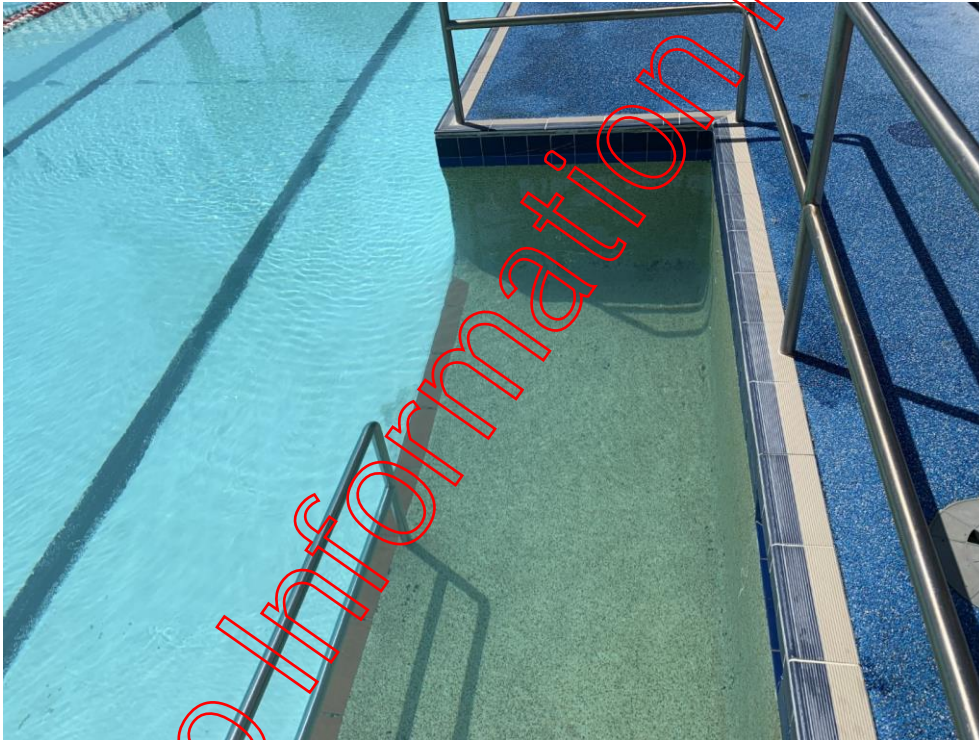
*Figure 17: Bottom landing of ramp*

- Modifying the ramp to comply involves significant reworks to the pool structure. For a long-term plan it is recommended to provide a compliant ramp, however in the short-term:

- The slip resistance of the ramp should be investigated
- The profile of the ramp should be confirmed (primarily the ramp gradient)
- A compliant access method (such as a platform lift) should be maintained.
- Appropriate signage should be adopted to inform patrons of the ramp compliance.

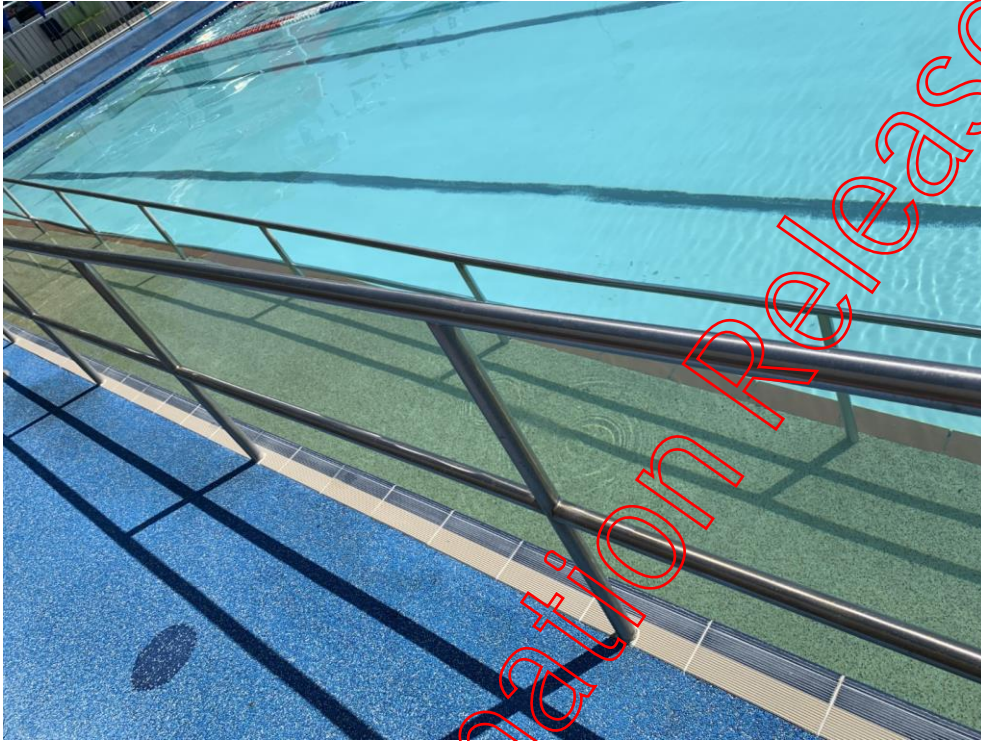
Figure 18: Lack of mid-landing in ramp

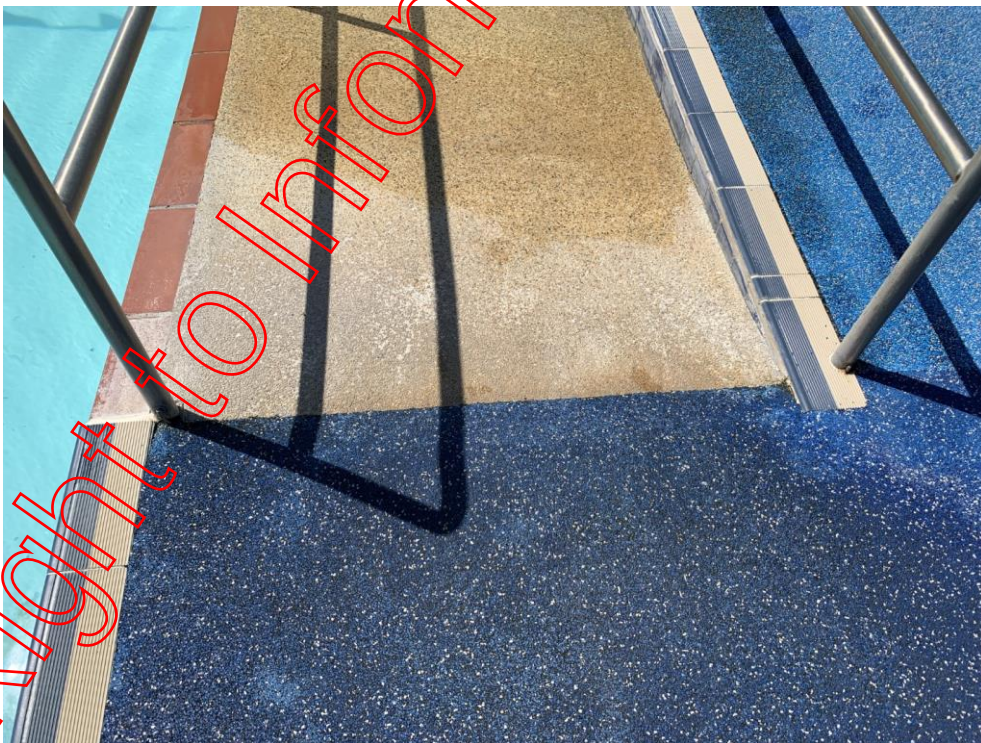
Figure 19: Initial transition into ramp identified as slippery

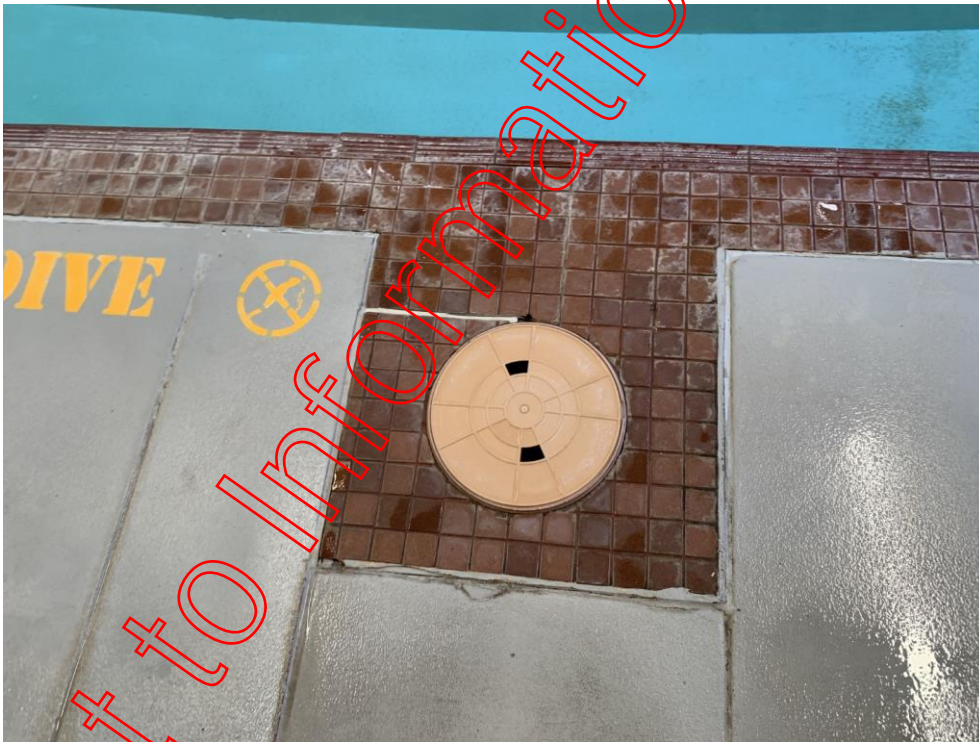
Figure 21: Skimmer in pool

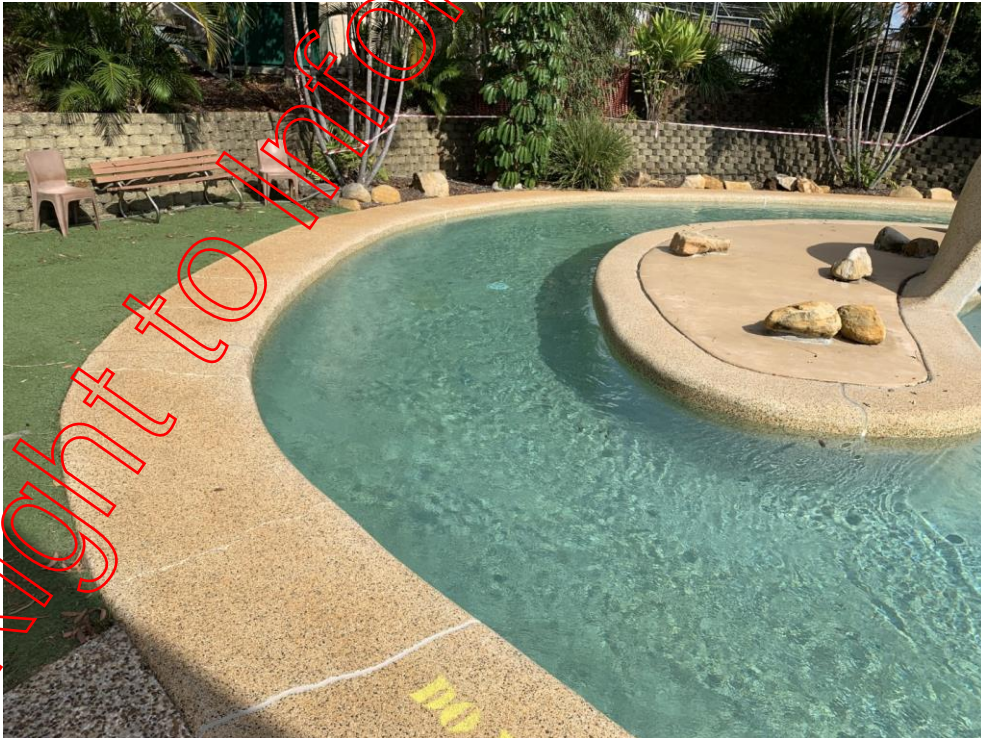
*Figure 48: Cracks in coping*

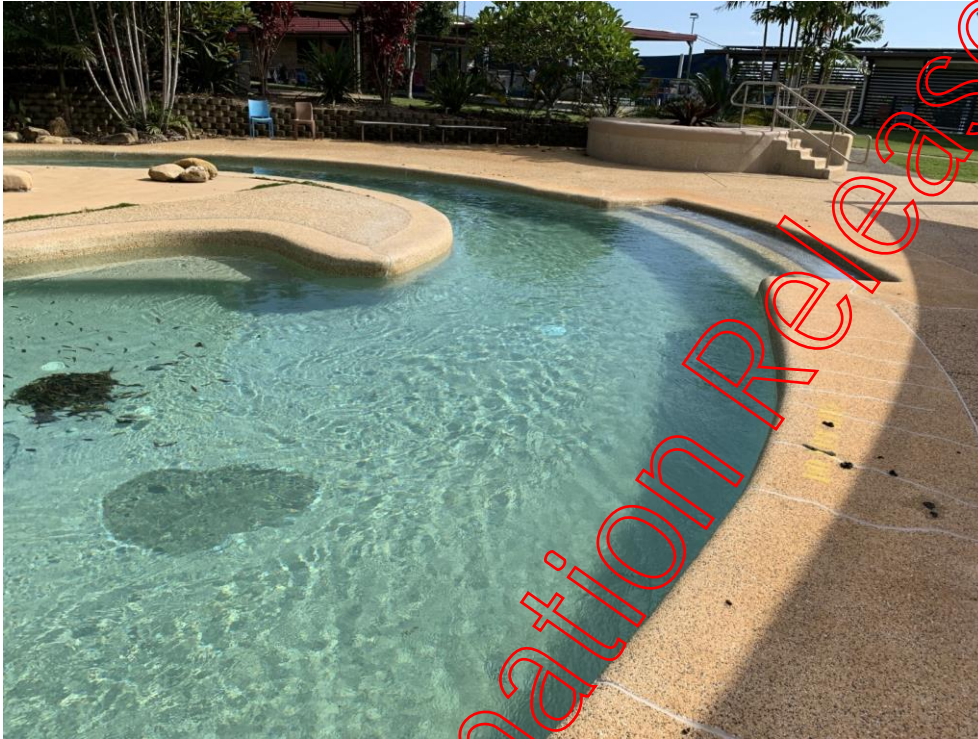
Figure 49: Cracks in coping, missing floor finish

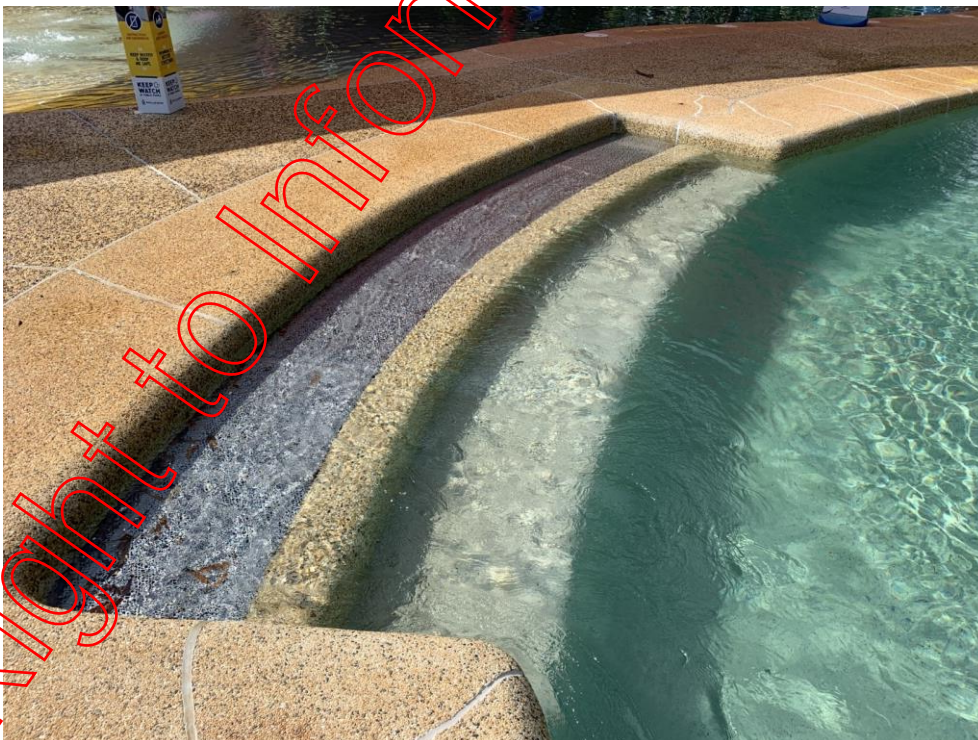
Figure 50: Overflow grate with bench in front

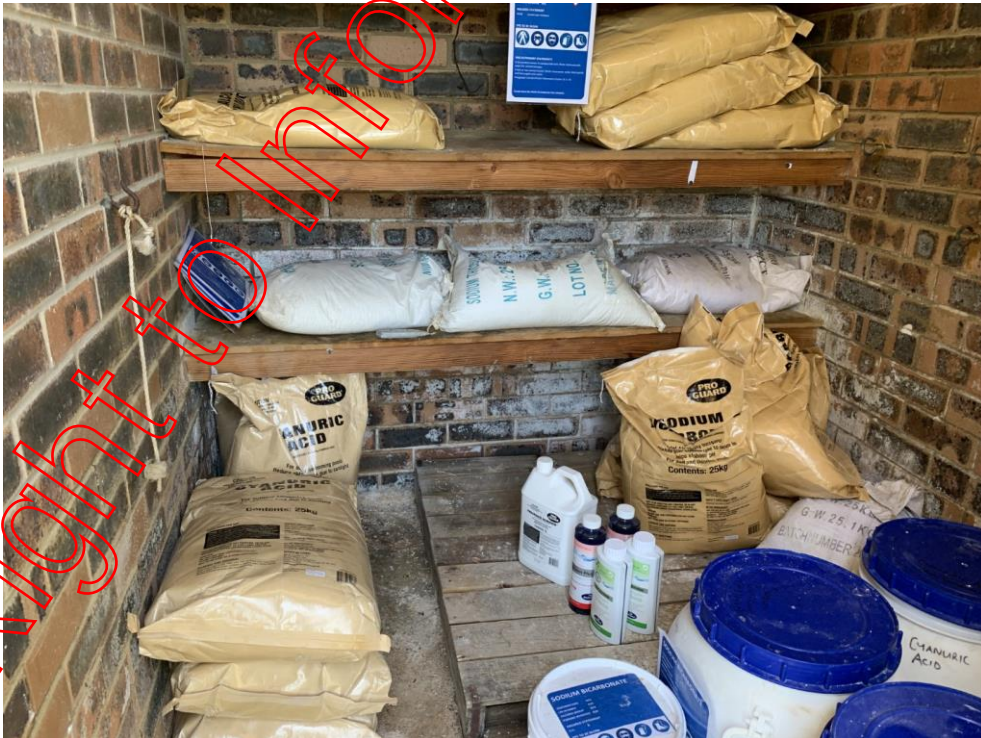
Figure 62: Crowded chemical storage, poorly labelled

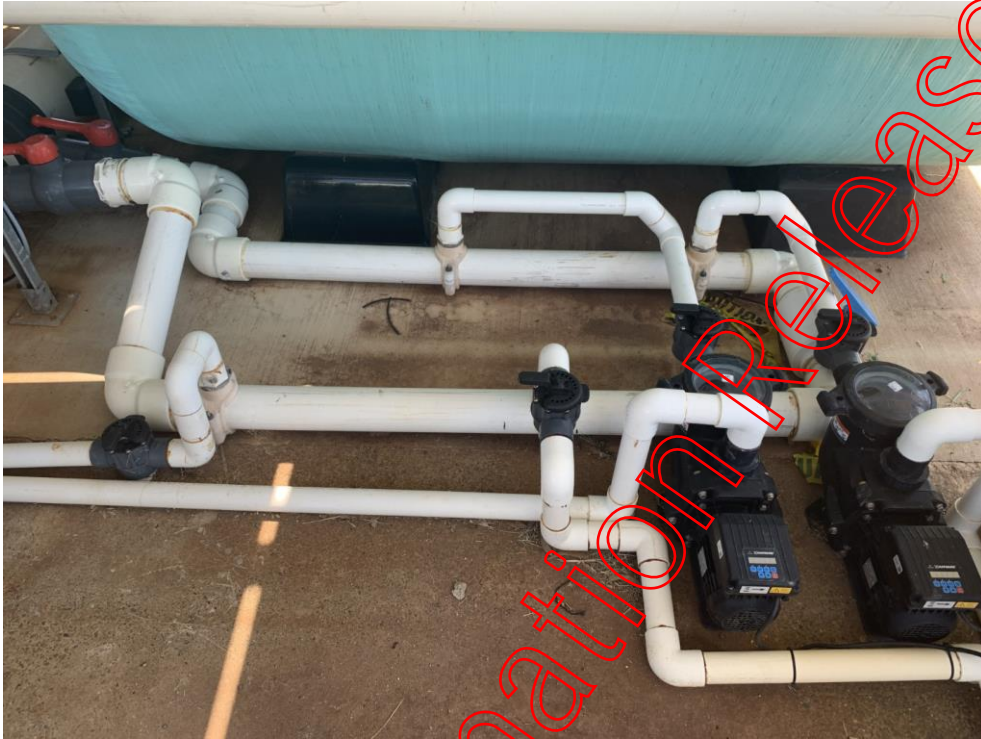
Figure 63: Unlabeled poorly configured heater pipework

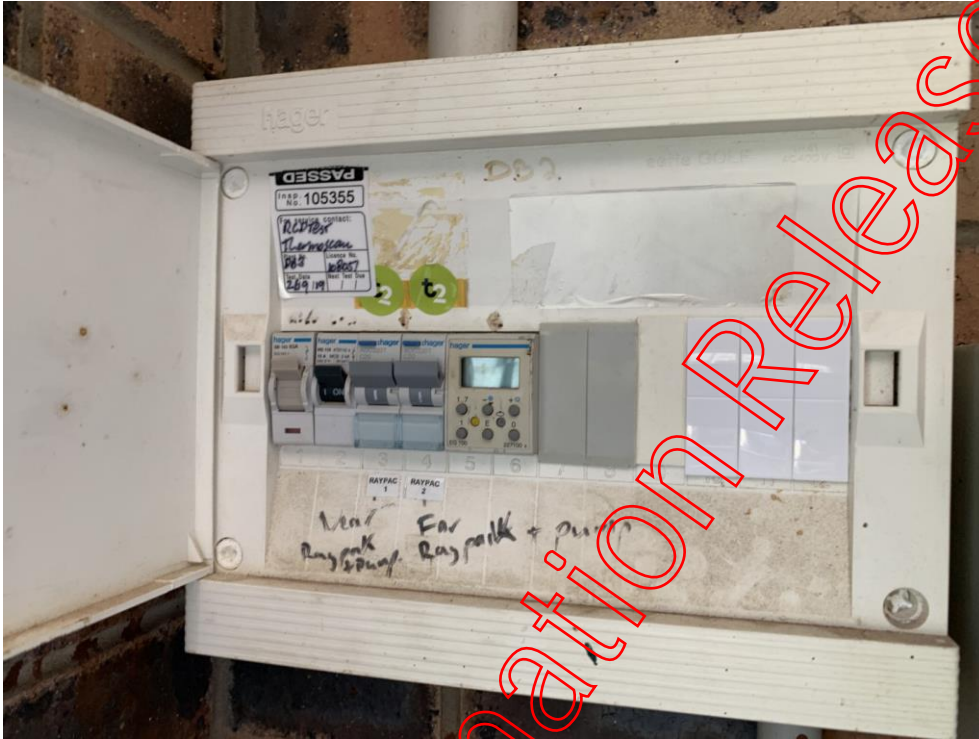
Figure 65: Poorly labelled control panel

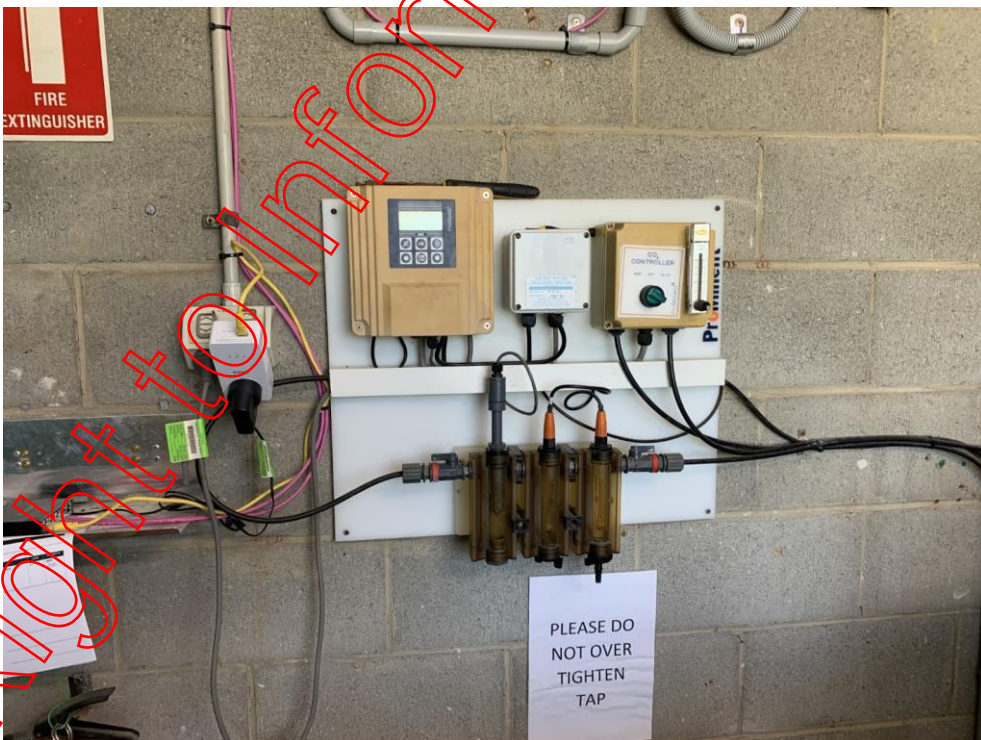
Figure 70: Obsolete chemical controller

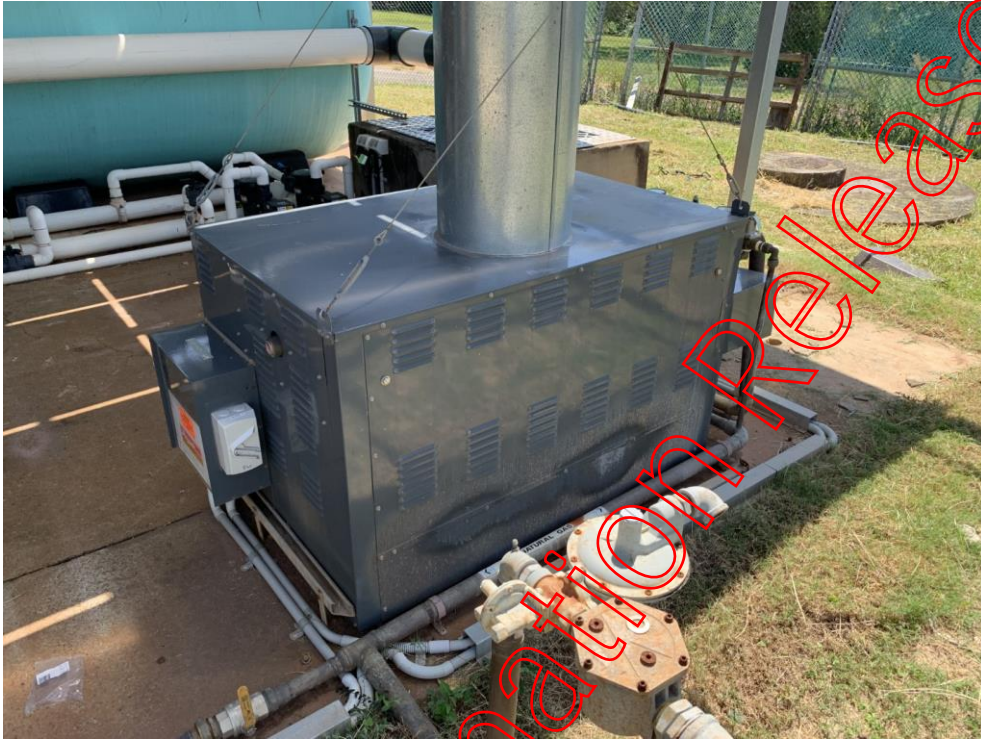
Figure 71: inefficient gas boilers

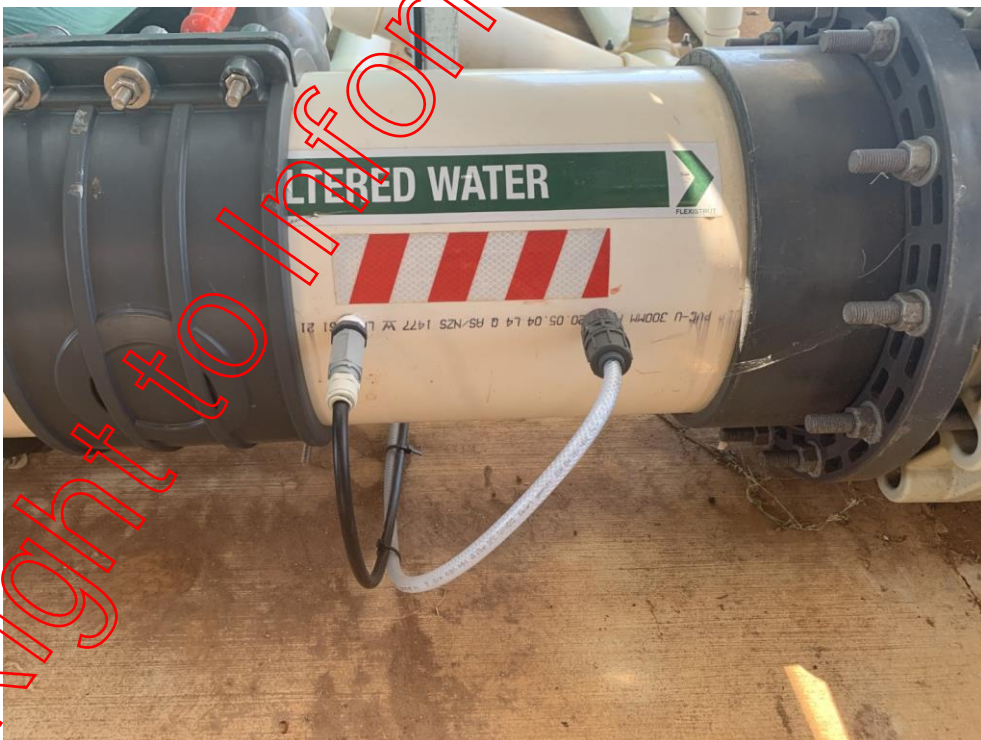
Figure 72: Unlabeled chemical injectors

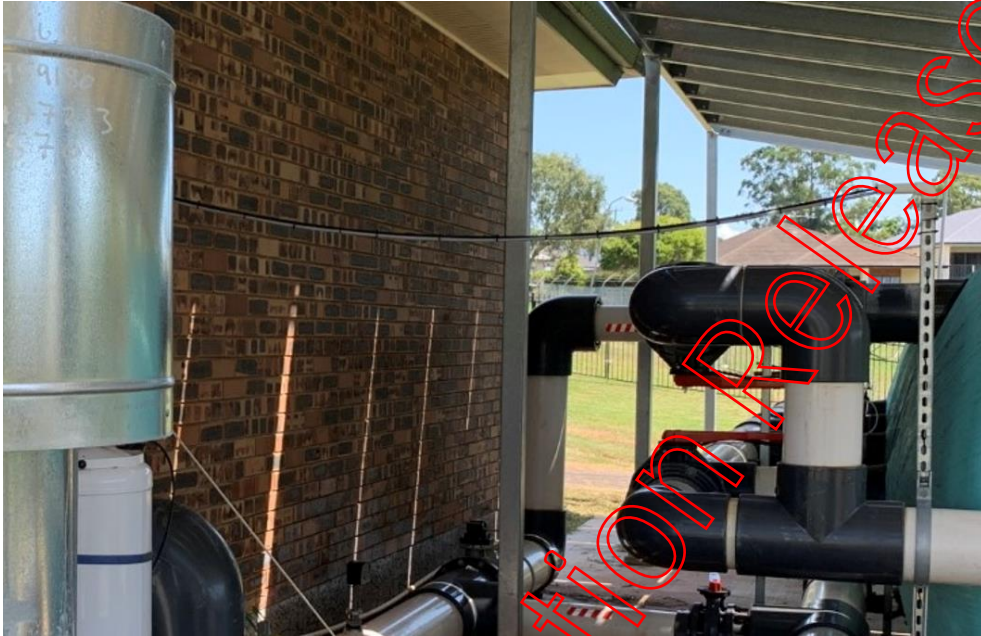
*Figure 73: Unprotected dosing line suspended between wall and bracket*

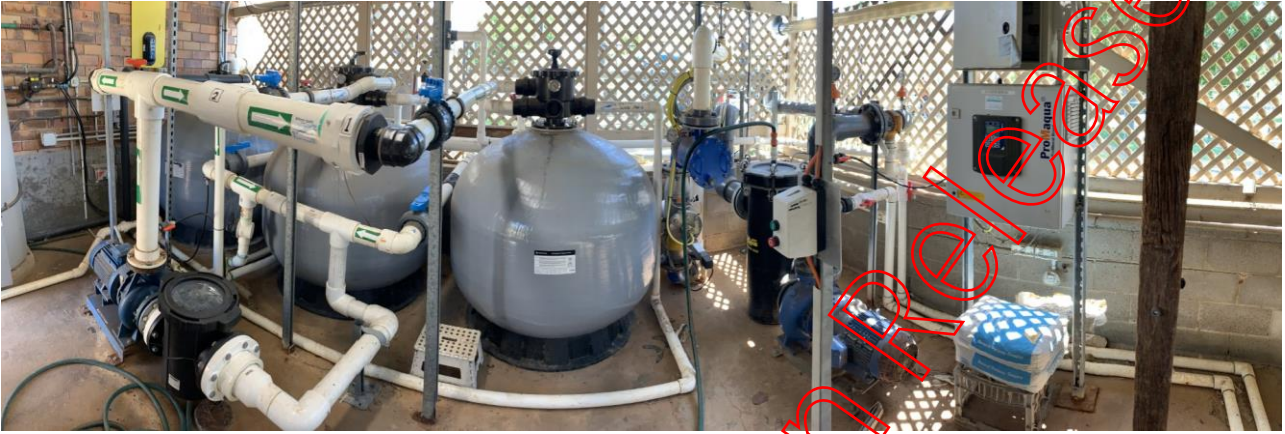
Figure 75: Poor access through equipment room

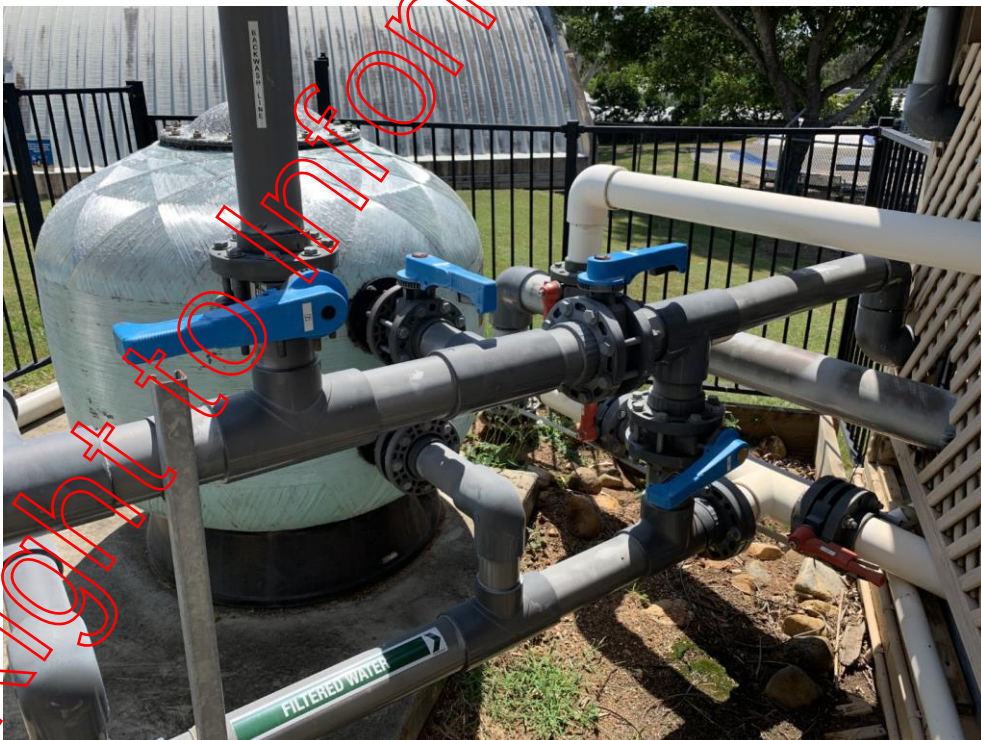
Figure 78: Poorly installed and supported pipe

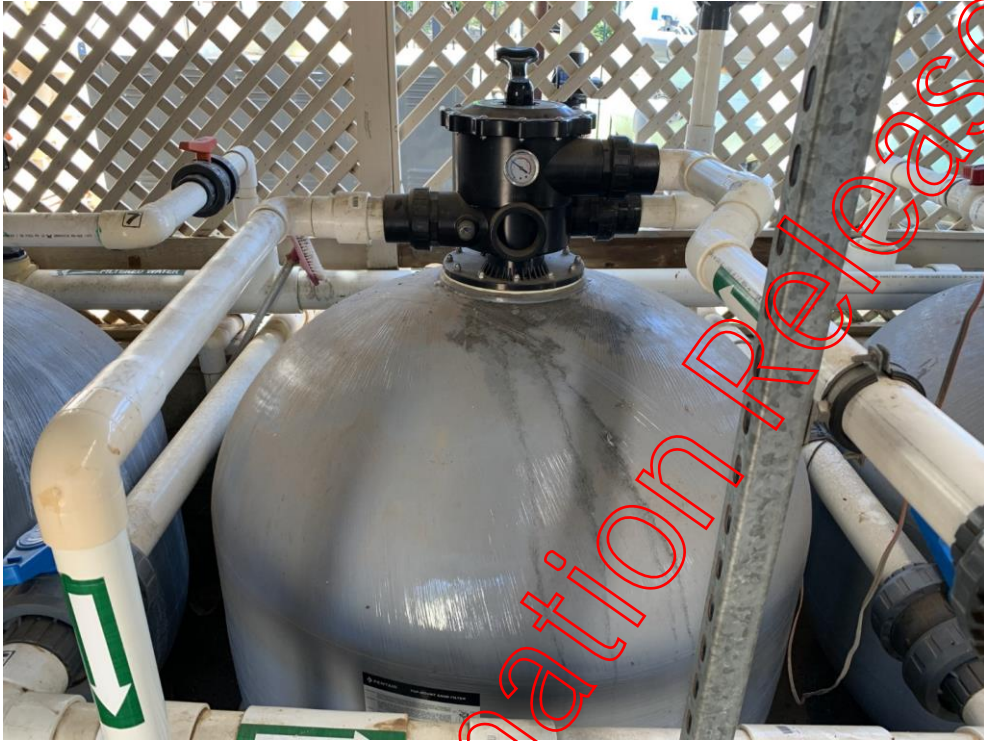
Figure 79: Poorly installed pipework, inaccessible multiport valve

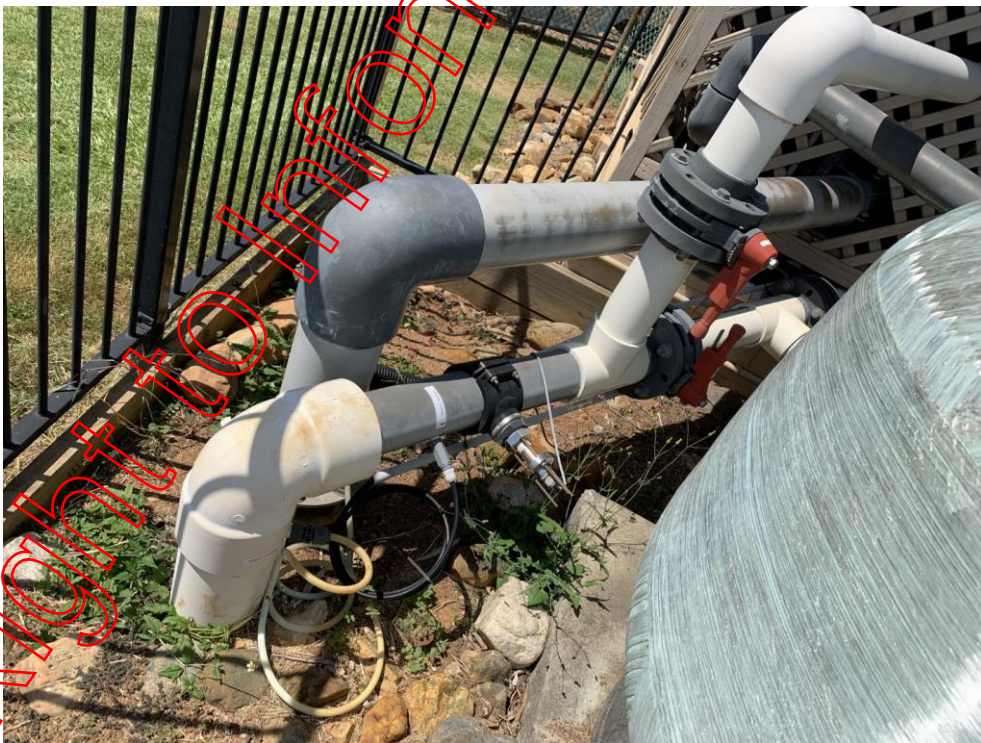
Figure 105: Chlorine injection point

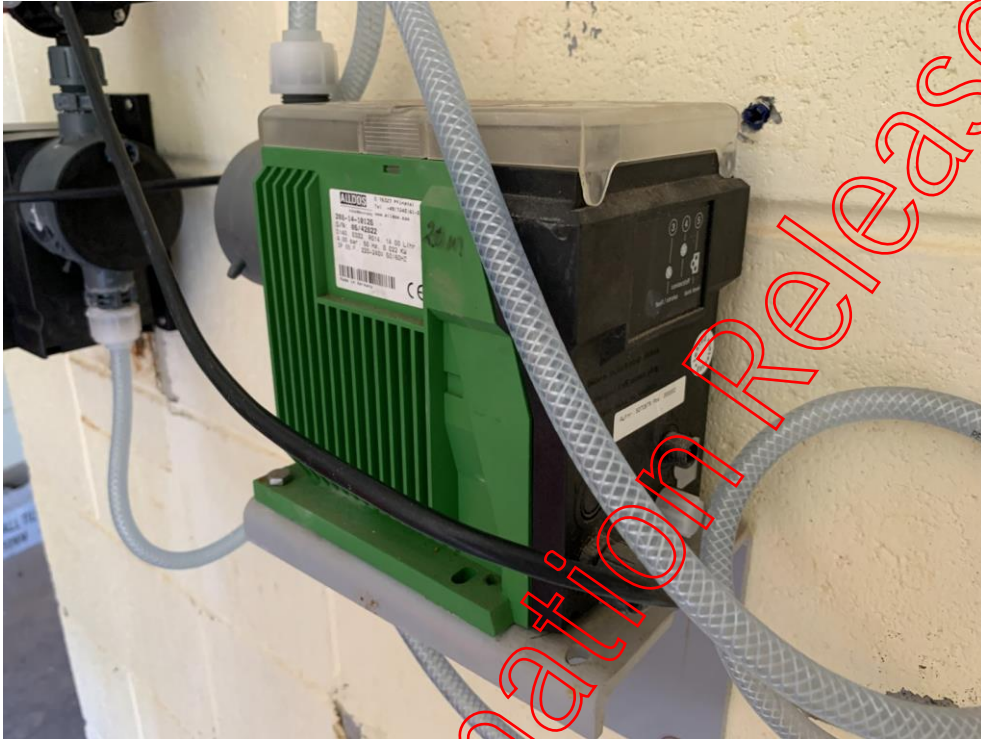
- The primary limitation in the pool appears to be the pool skimmers, which are nominally rated to 5 L/s each. Increasing the system flow to support higher bather loads would require major replacement of the hydraulic plumbing components.
- The filtration strainer has a solid lid. Operators must remove the lid to inspect the strainer internals.
- Access to the filters is poor. The filters are degrading from UV exposure. A leak is present in the manifold.
- The filtration pump is rusty and is not provided with inlet or outlet valves. The pump is not provided with no-flow protection, which may result in a pump burnout.
- The chlorine dosing pump is not labelled, has an inaccessible injector and is not fitted with a multifunction valve (overpressure relief / anti-siphon).

Figure 106: Chlorine dosing pump with no multifunction valve

- Provide reliable flow monitoring equipment and confirm the system flow.
- As part of the equipment room replacement and LTS pool replacement, provide a new correctly designed filtration system, rated to suit the required flow for the pool. Due to the numerous issues with access, pipework configuration and the like, minor refurbishment works are difficult to provide.
- Rectify the chlorine dosing pump situation.

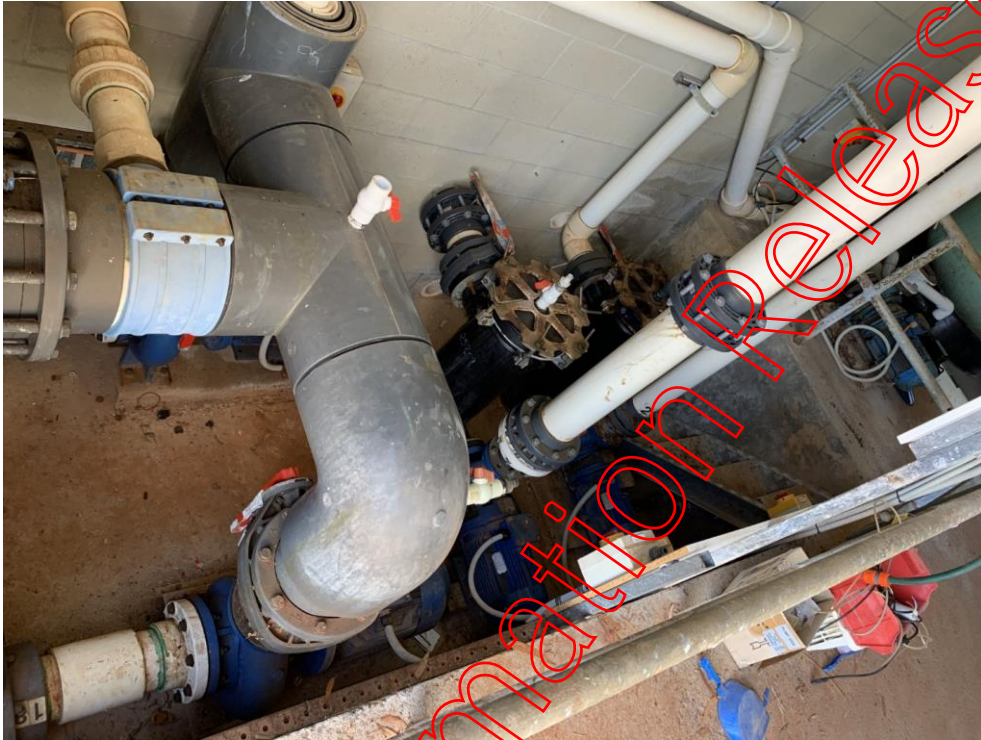
Figure 109: Submerged pump well, poor access

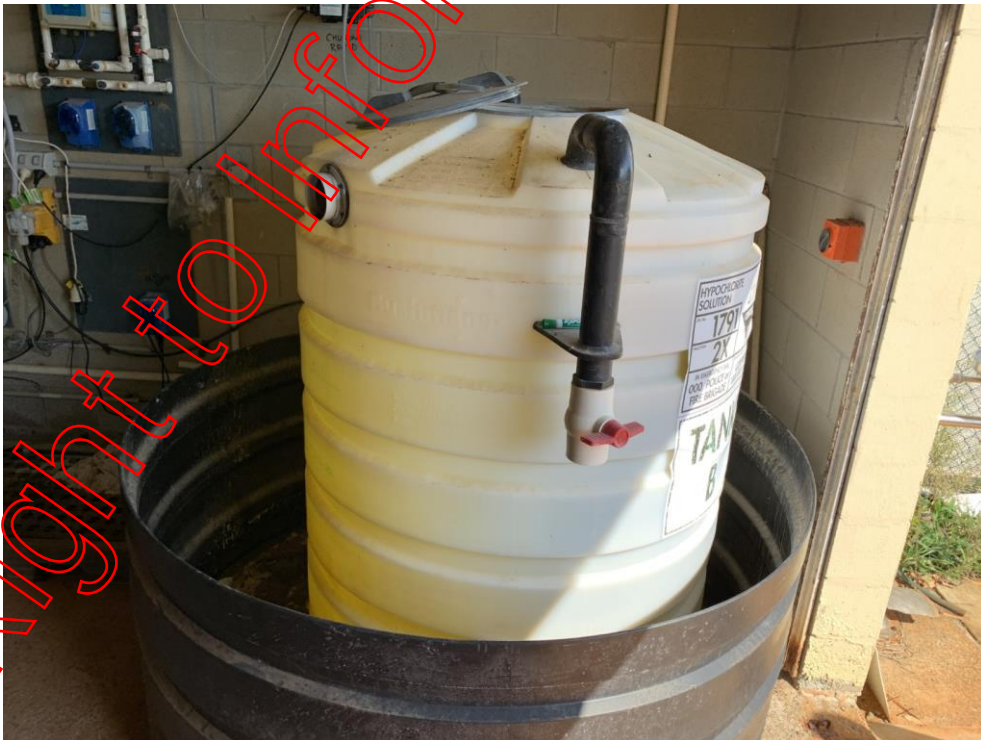
- Chemical injection points are not labelled.
- The chlorine storage tank produces several compliance and condition issues:
  - The tank vent discharges to the room instead of the plant room exterior.

Figure 110: Chlorine tank with no fill point, overflow or level markings

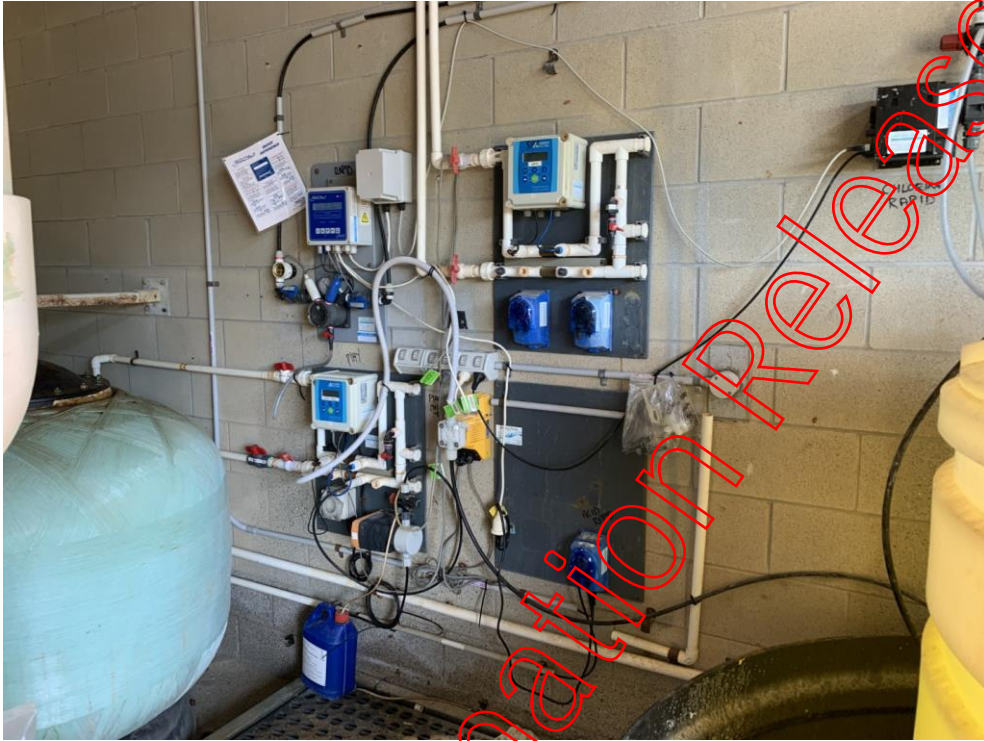
- A drip tray is provided below the chemical measurement and dosing area. Both chlorine and acid injectors are present, meaning that if a leak occurs in both and acid and chlorine line the incompatible substances can mix and cause a dangerous environment.

Figure 111: Chemical control and dosing area with disused equipment

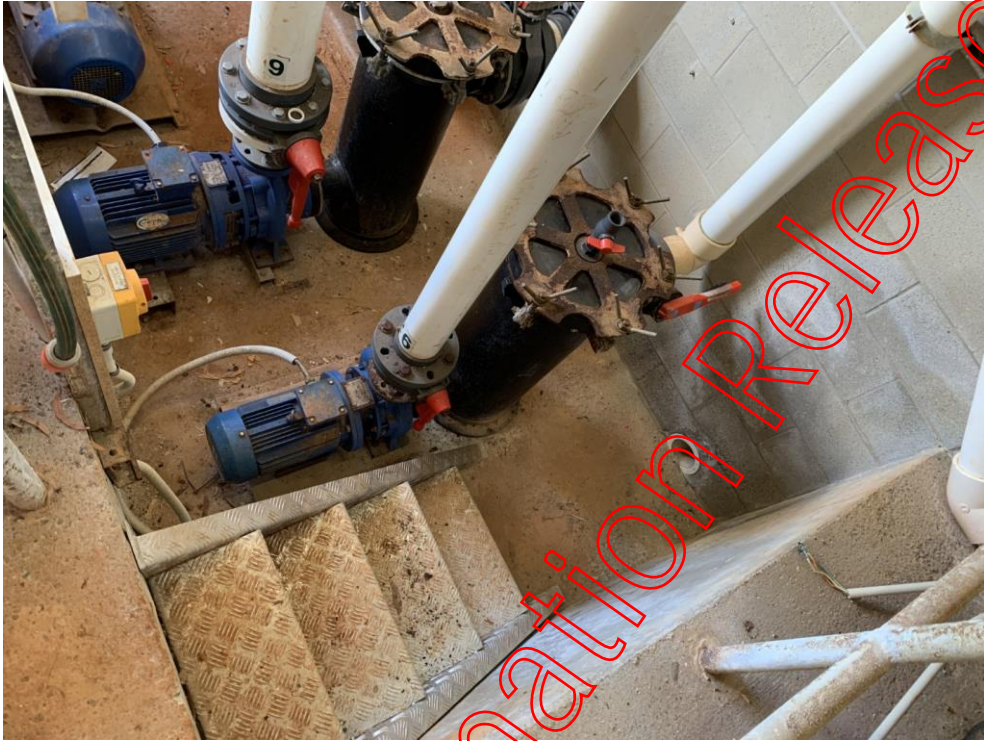
Figure 113: Stairway into pump well with no access at bottom

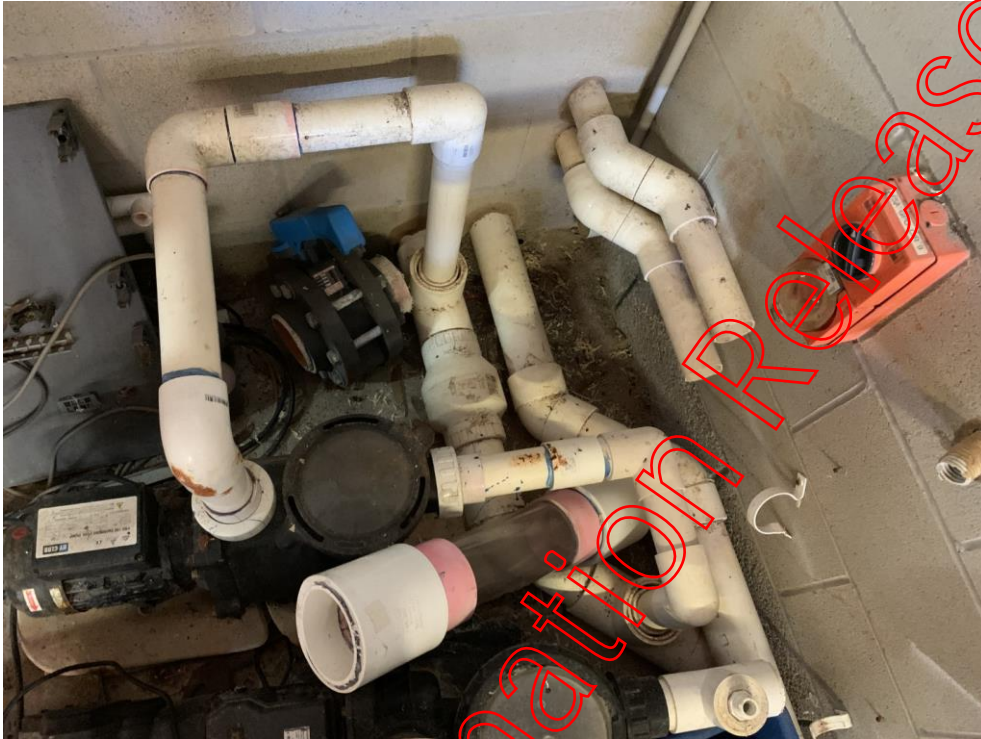
Figure 115: Obsolete equipment, poorly labelled pipework, disconnected heater pipework

- Label all pipes with their flow direction and contents.
- Engage an electrical contractor to provide a full internal condition and compliance audit on the boards and electrical installation.

- Remove all obsolete equipment.
- Fill around the concrete step.
- Replace the flow meters and provide in the correct locations to measure full flow of the systems.

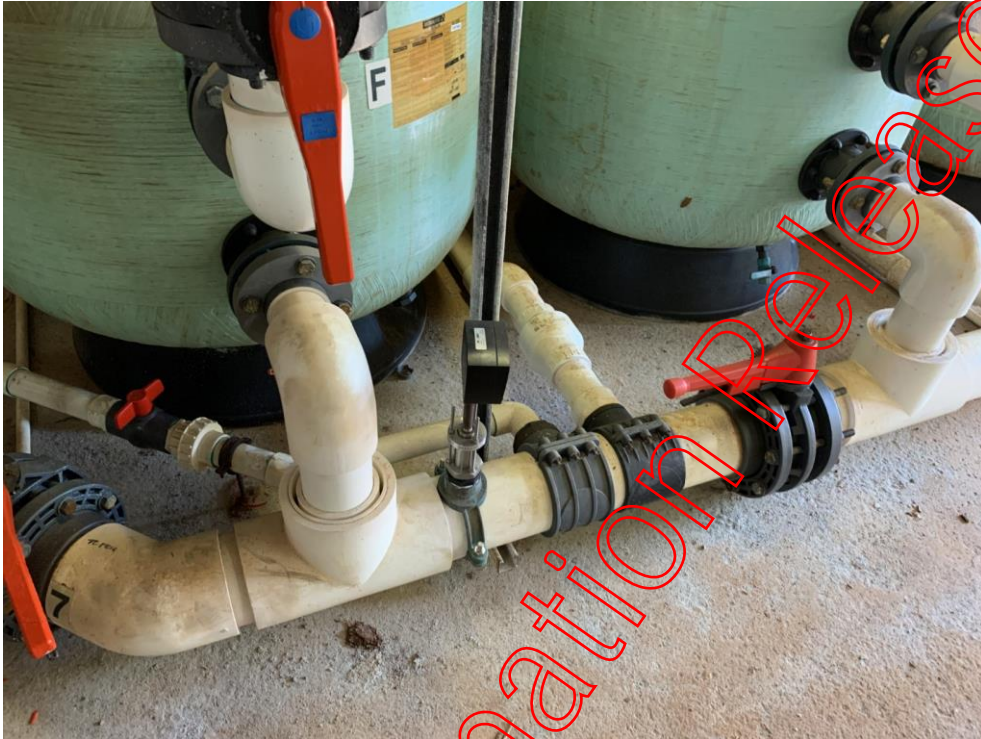
*Figure 117: Flow meter installed in wrong location*

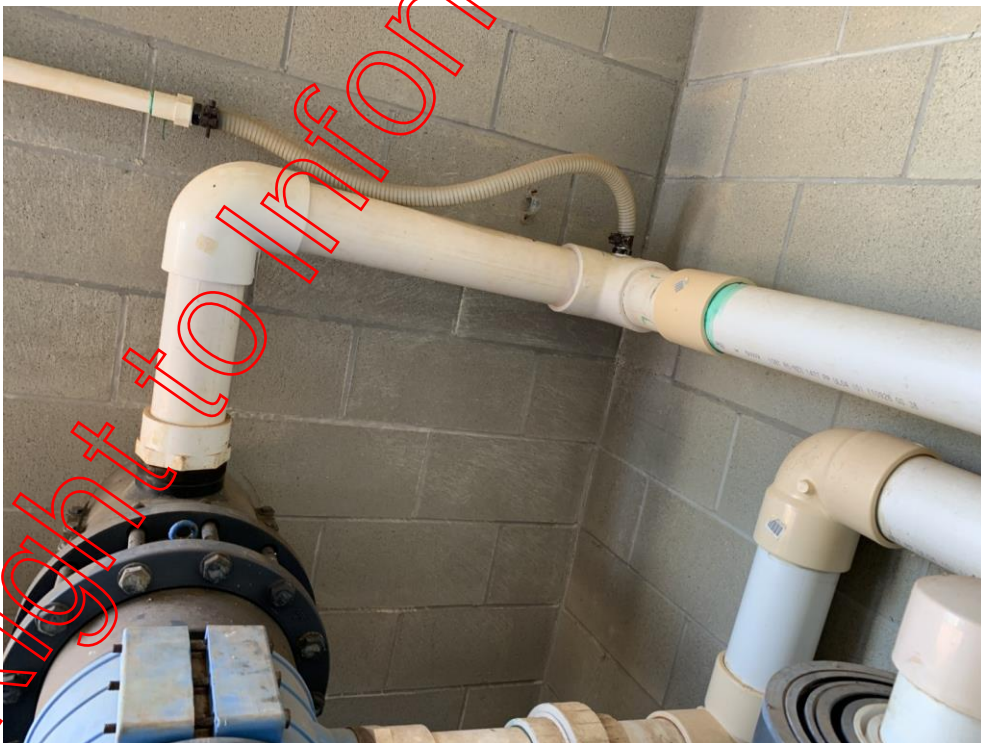
Figure 130: Filtration suction and return connections from river pump

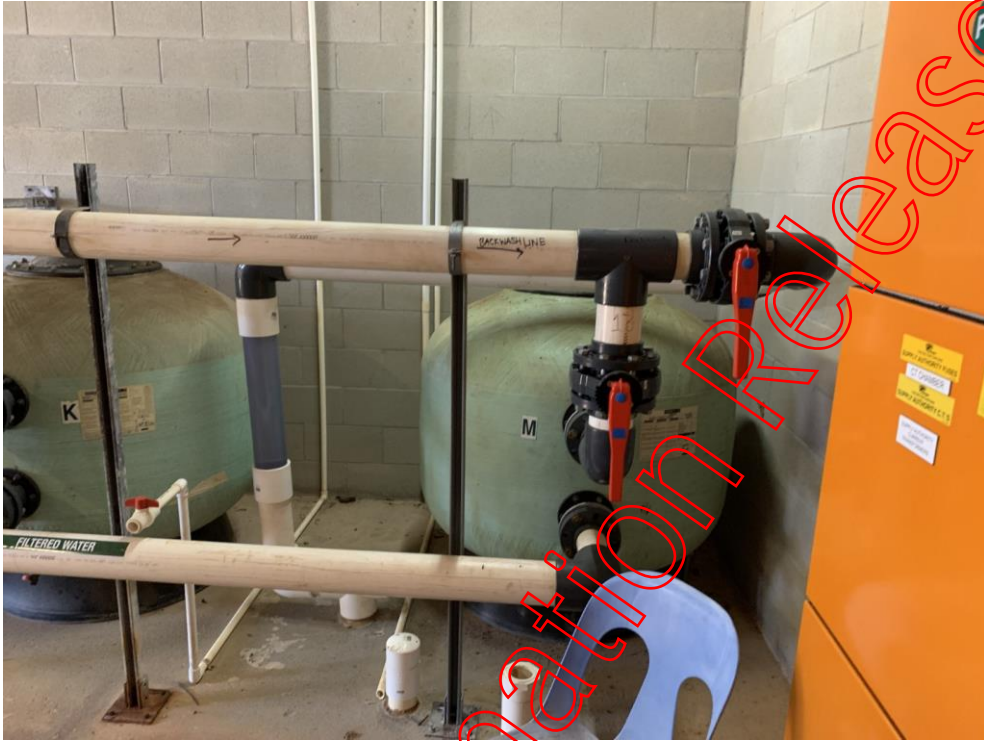
Figure 131: Spa filter incorporated into main manifold

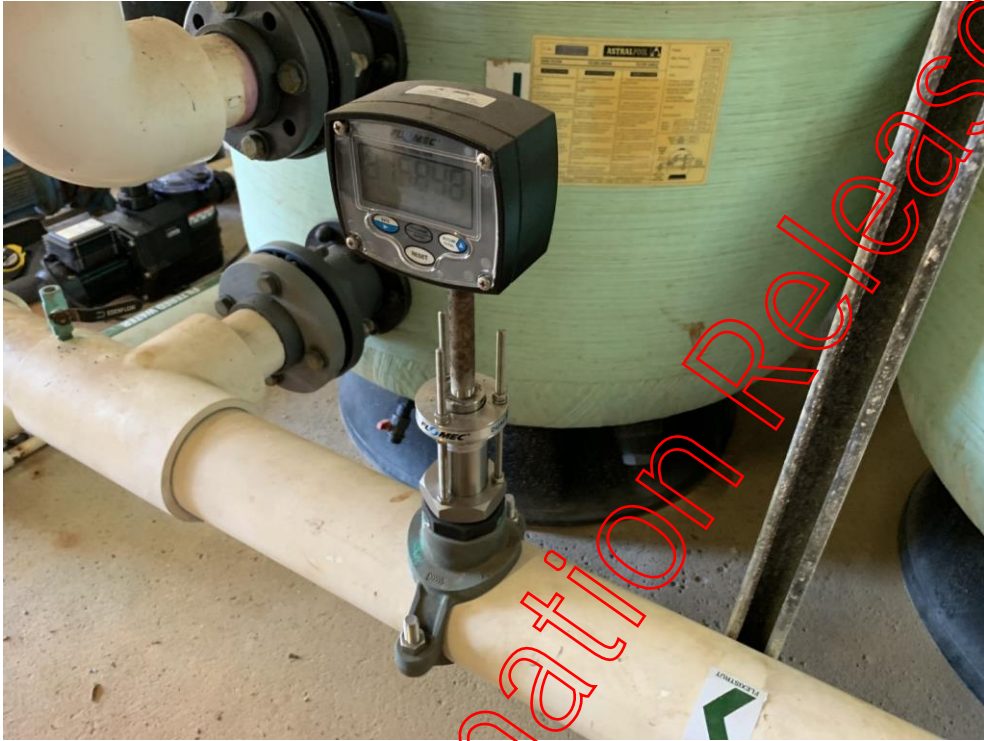
Figure 133: Flow meter installed upstream of filter

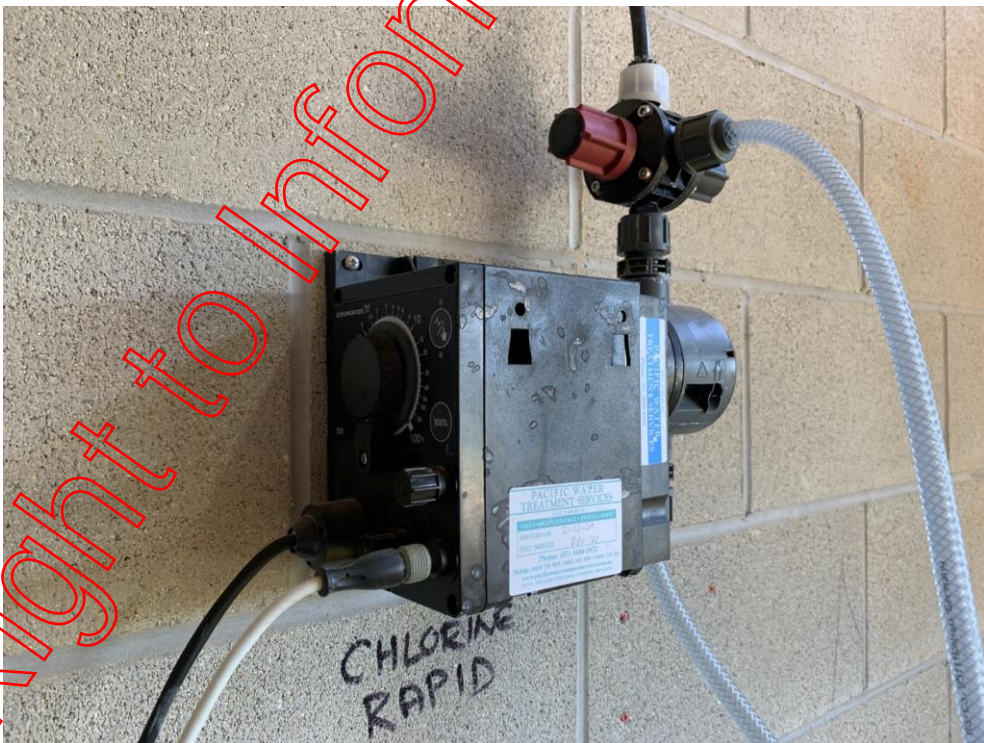
Figure 134: Chlorine pump installed at high level
