# Aquatic Facility Audit

AQ1-0224-DR1, Revision A

## Cleveland Aquatic Centre

**REDLAND CITY COUNCIL**

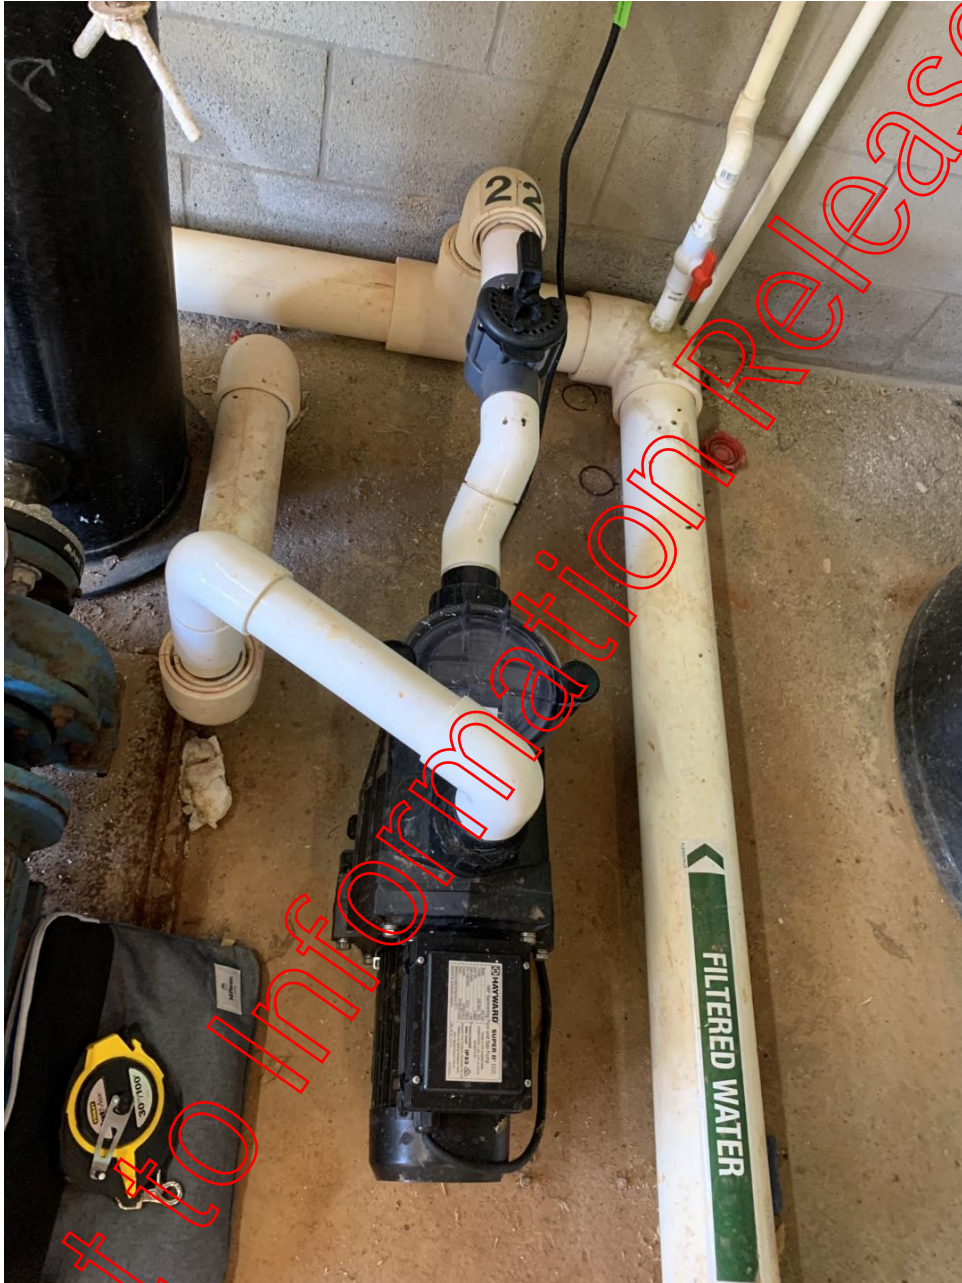
Figure 135: Disused boost pump, possibly for waterfall
