Aquatic Centre Condition Audit

Condition and compliance audit for an existing aquatic centre

Cleveland Aquatic Centre, July 19, 2023

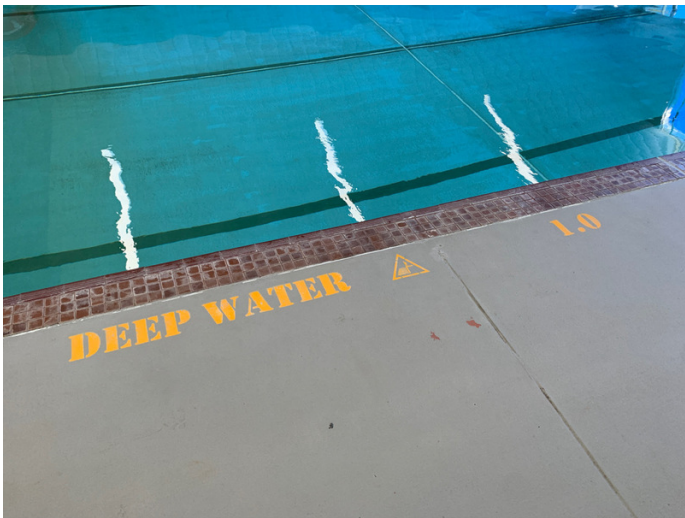
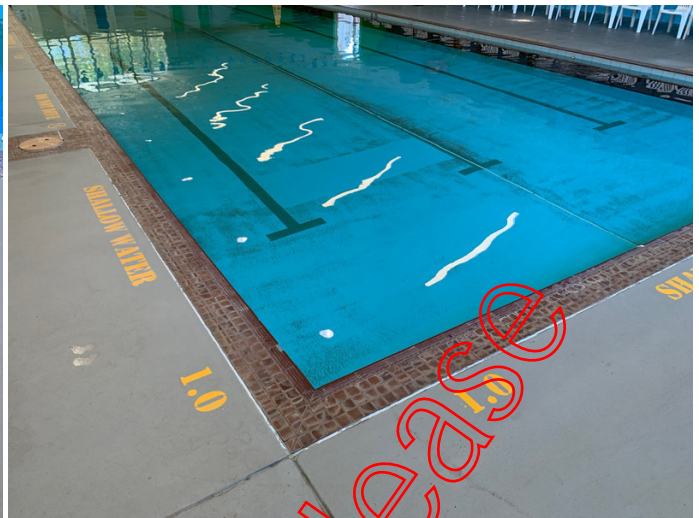
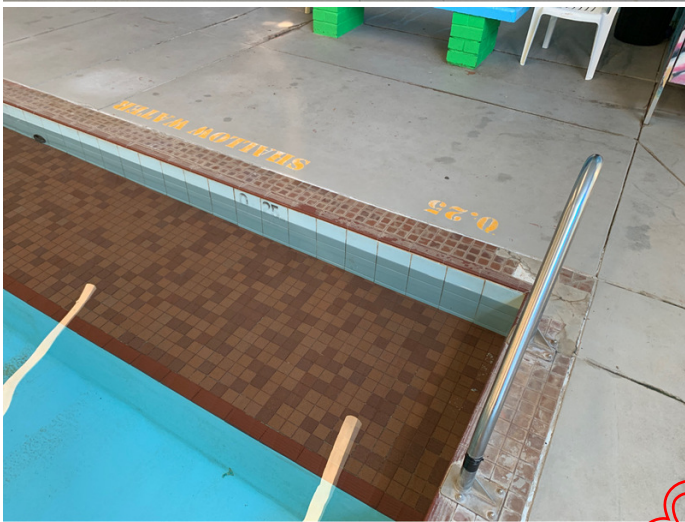
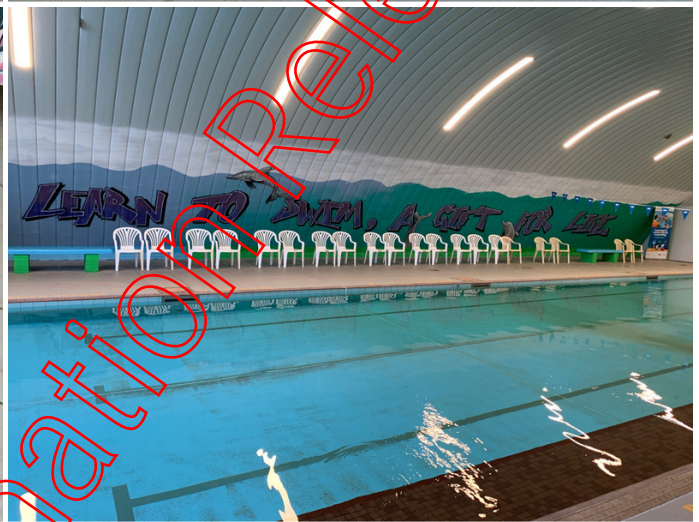
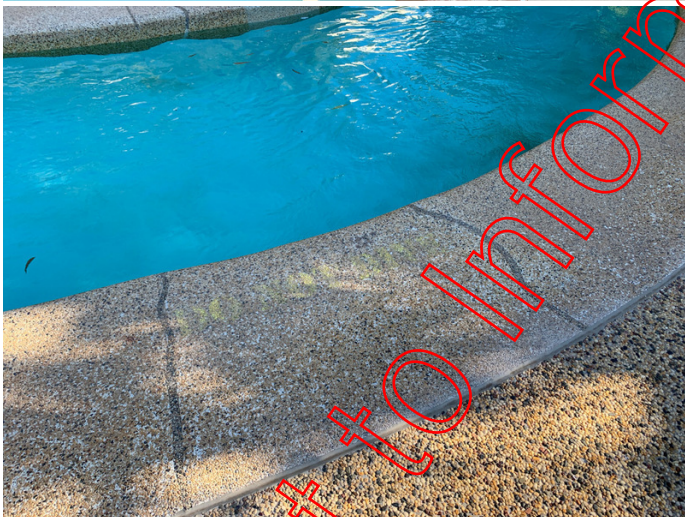
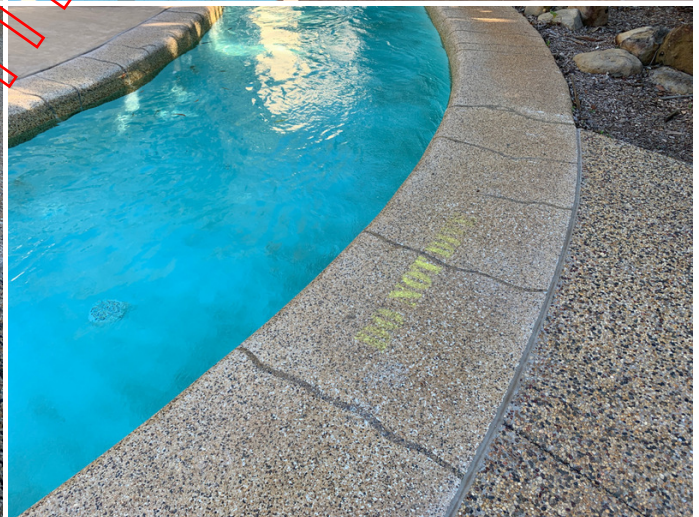
Observation Description	Tiling
Observation Details	The tiling provided in the pool is aging and not slip resistant. This is an issue for activities requiring grip on the pool floor
Recommendations	Replace the pool tiling
Critical Item?	No

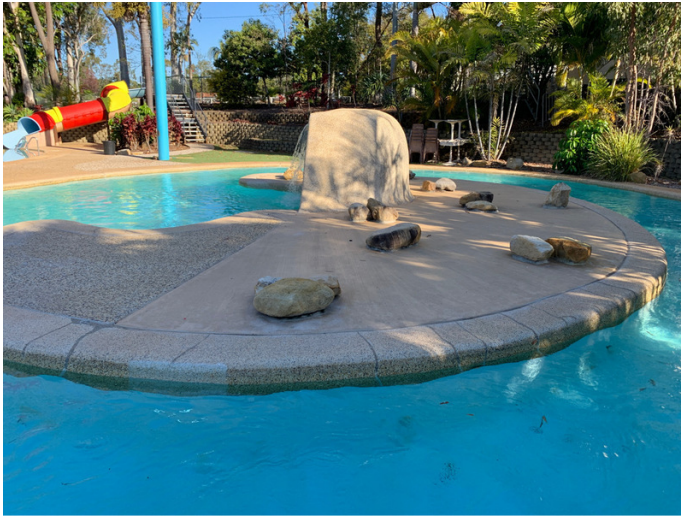
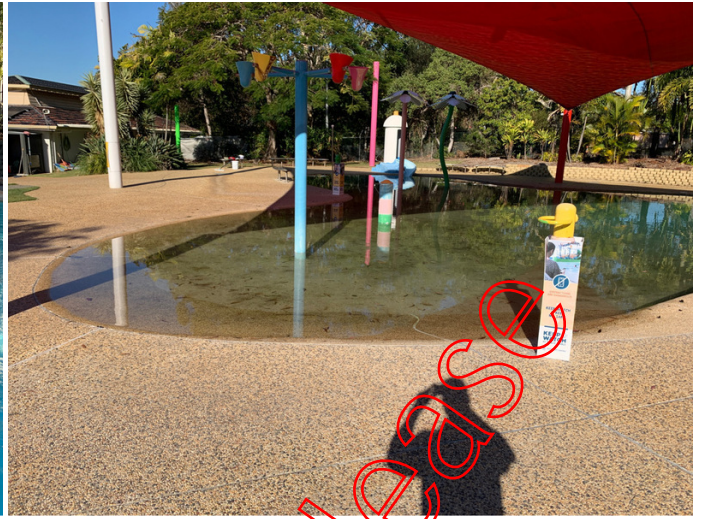
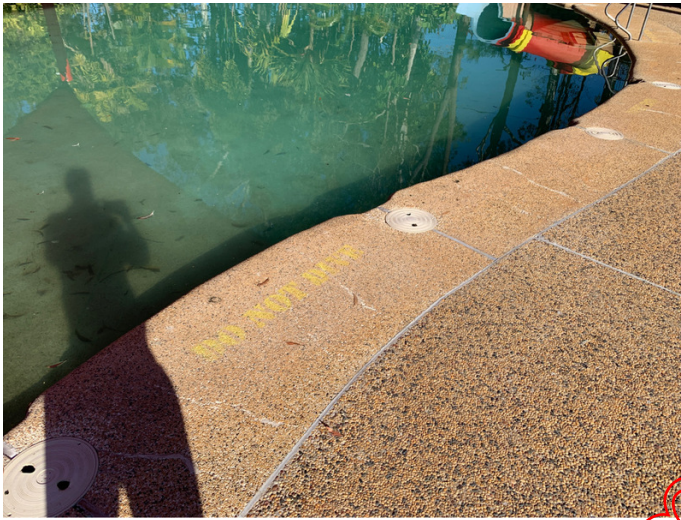
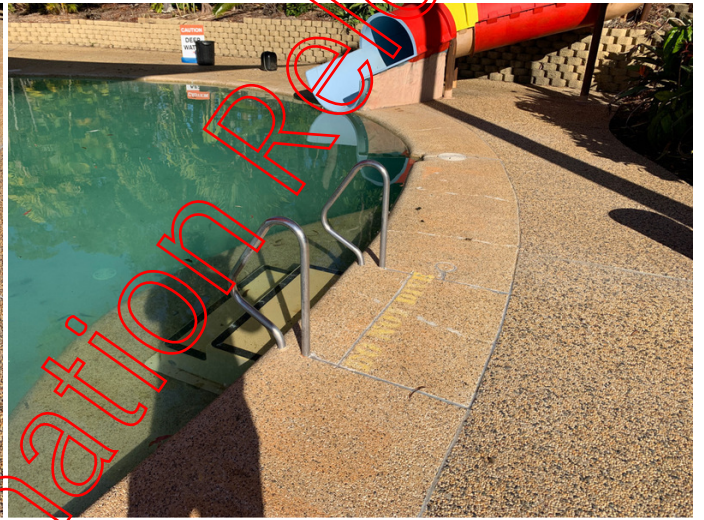
Observation Description	Depth and Warning Signage
Observation Details	Applicable to all the pools onsite, current signage does not comply with the Royal Lifesaving guidelines. Depth markers are inconsistent or not legible whilst advisory signage is not provided.
Recommendations	Engage Royal Lifesaving to undertake a signage audit at the facility including pools and plant rooms
Critical Item?	Yes

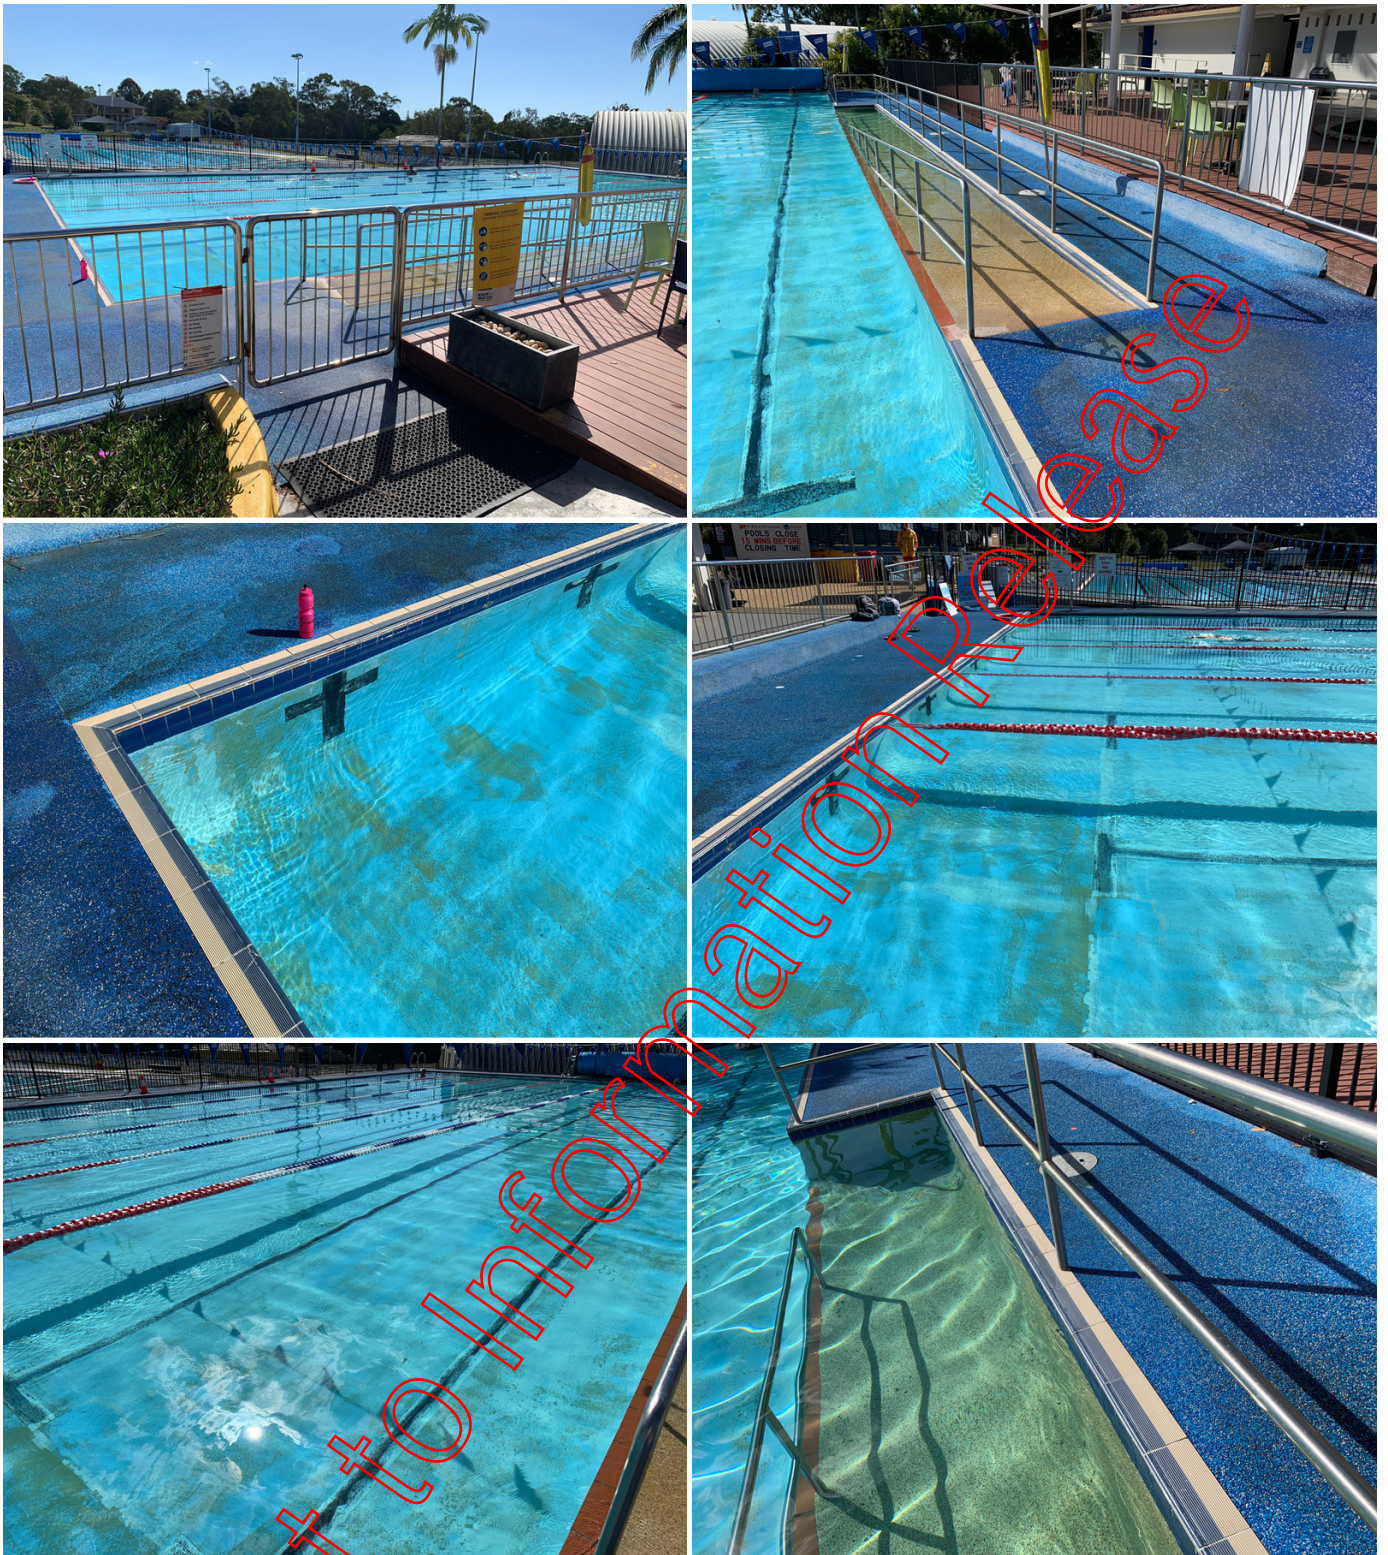
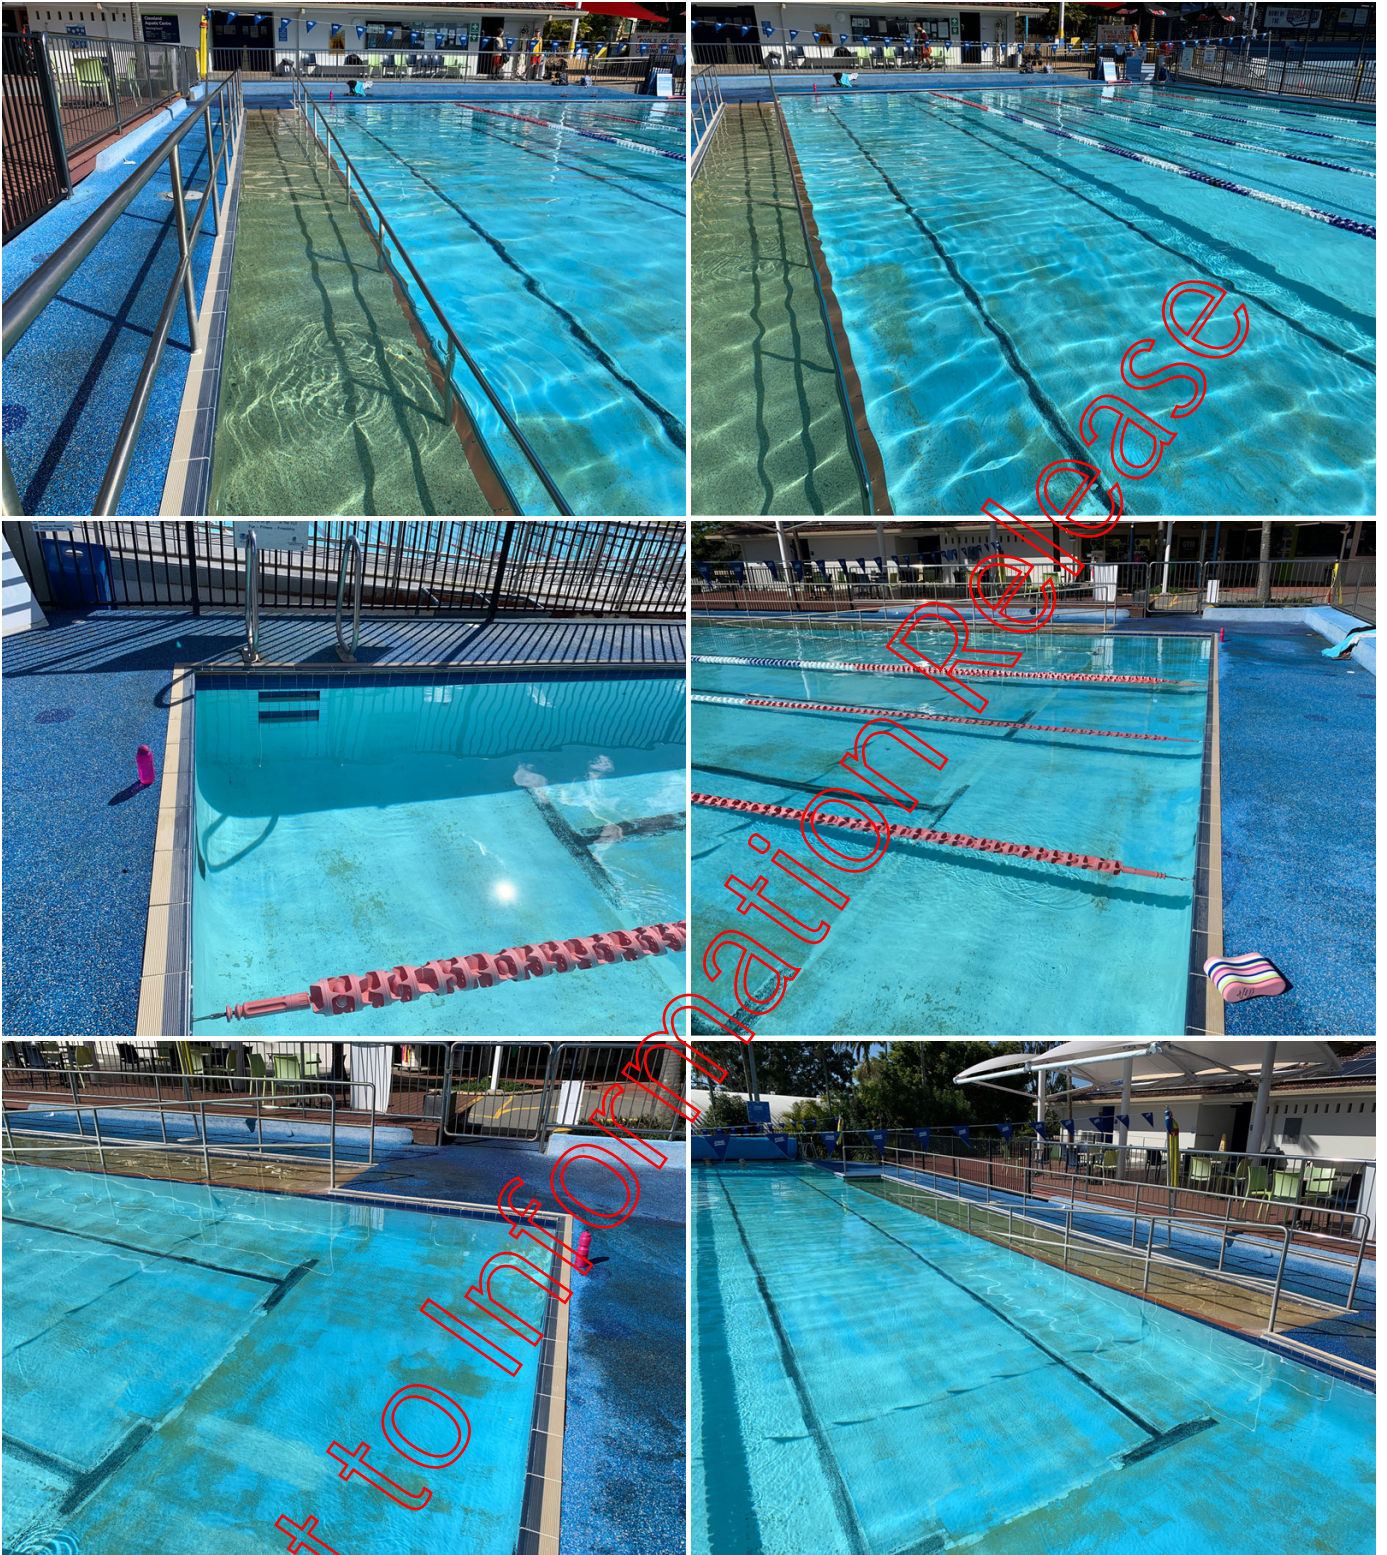
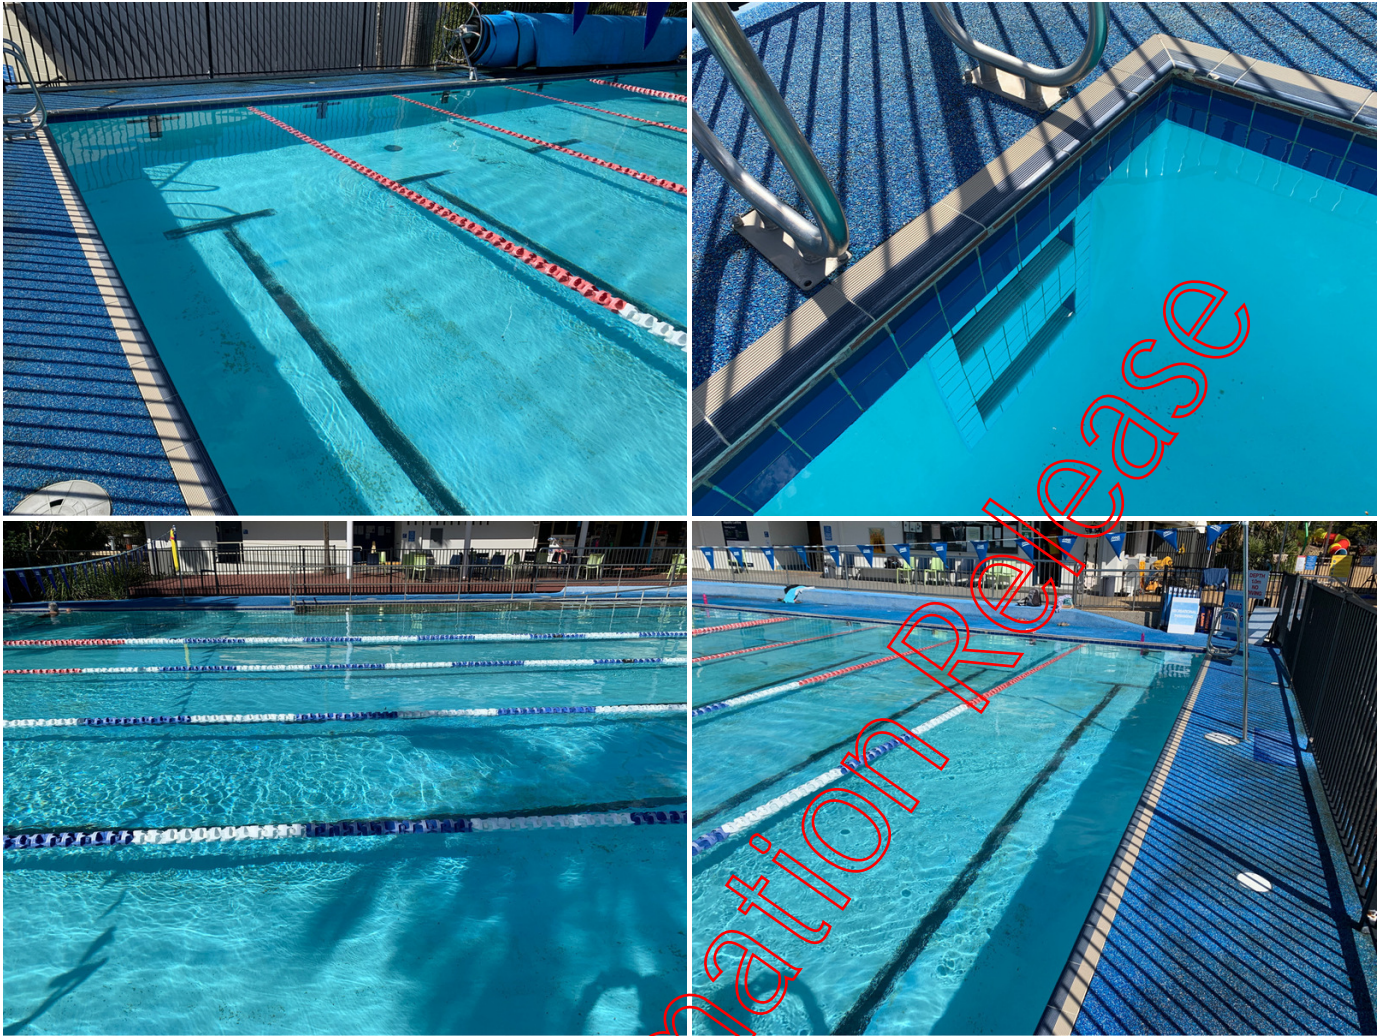
Features Description	N/A
Element Condition	4 - Poor
Remaining Life (Years)	5
Replacement Cost (\$)	1250000

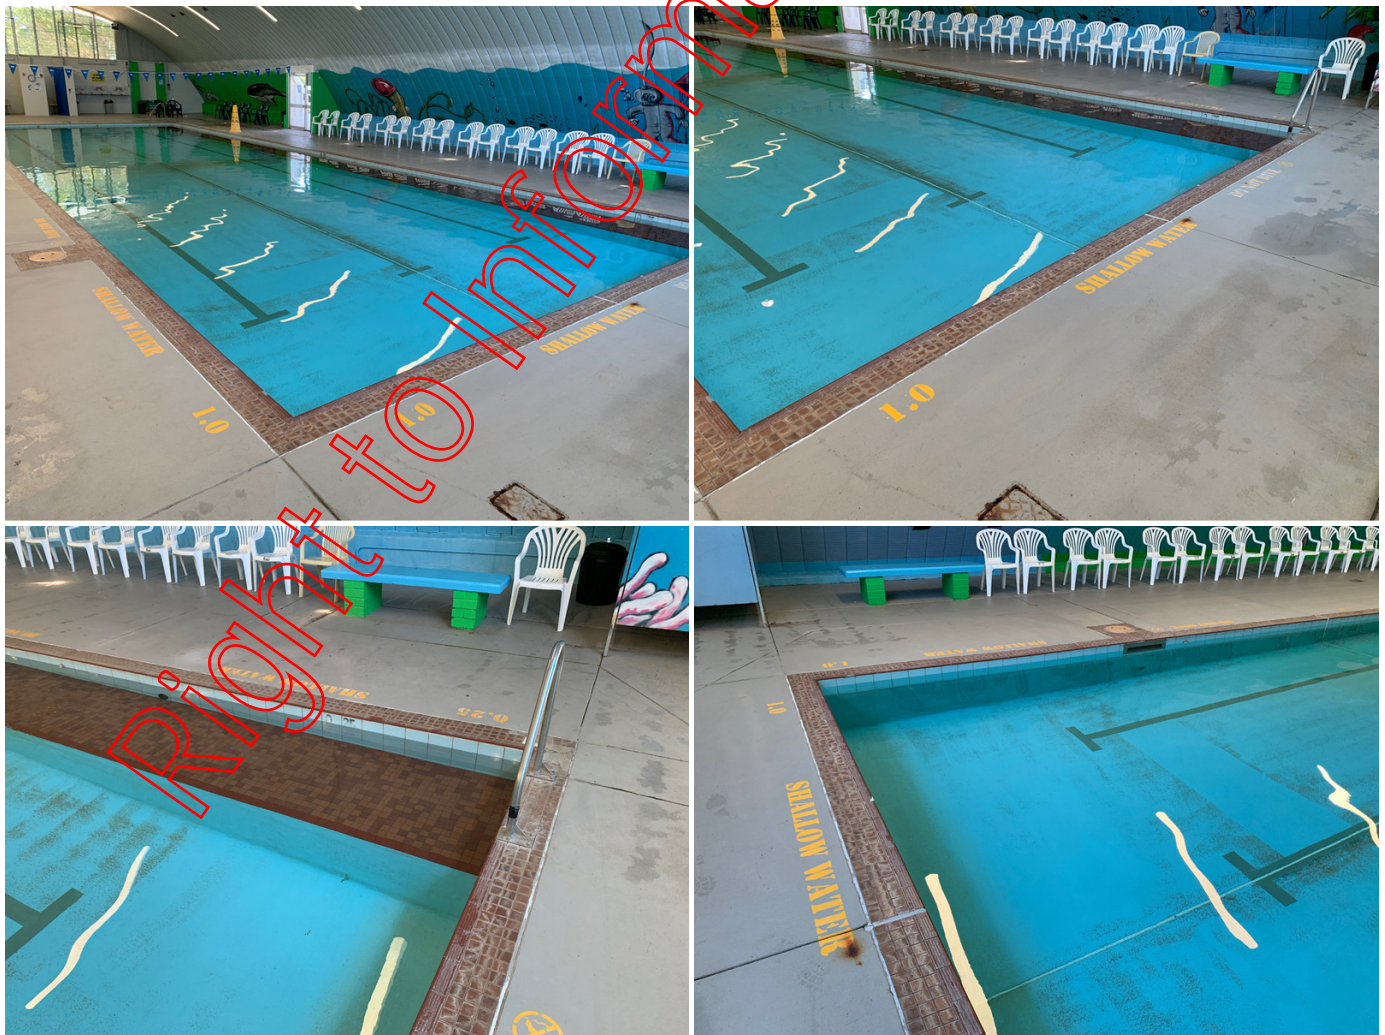
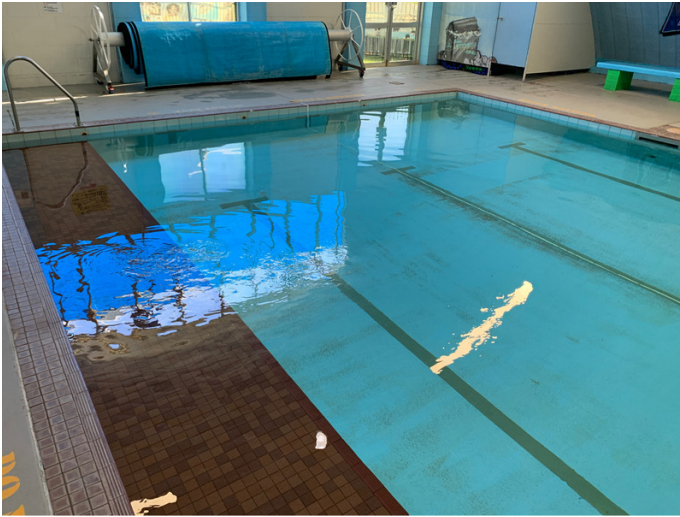
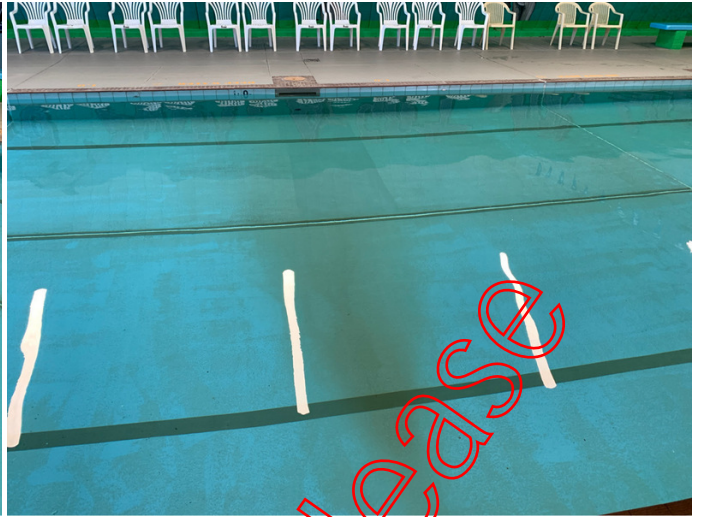
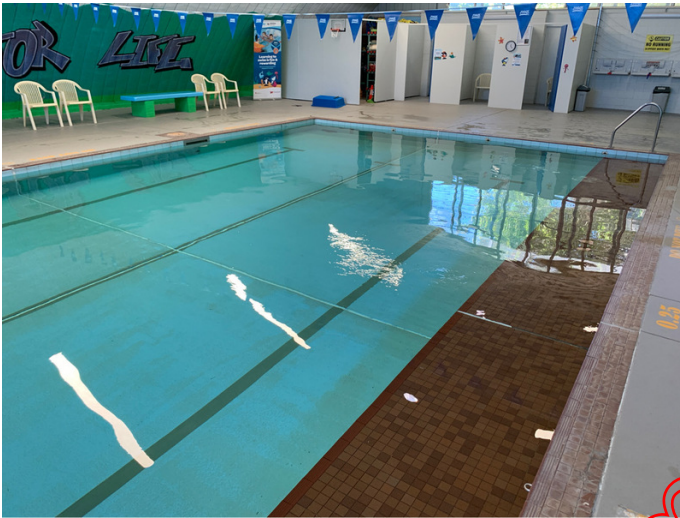
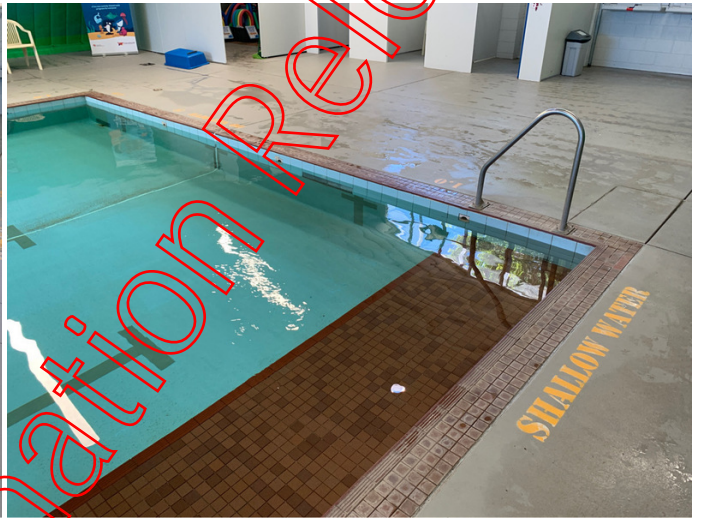
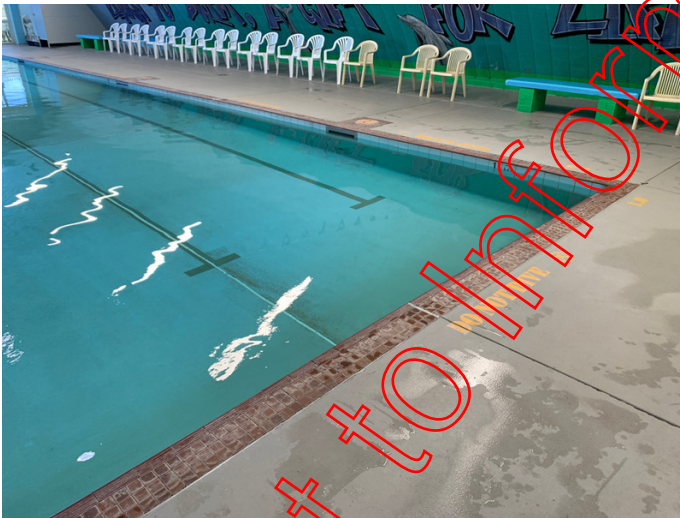
Features Description	N/A
Element Condition	4 - Poor
Remaining Life (Years)	5
Replacement Cost (\$)	750000

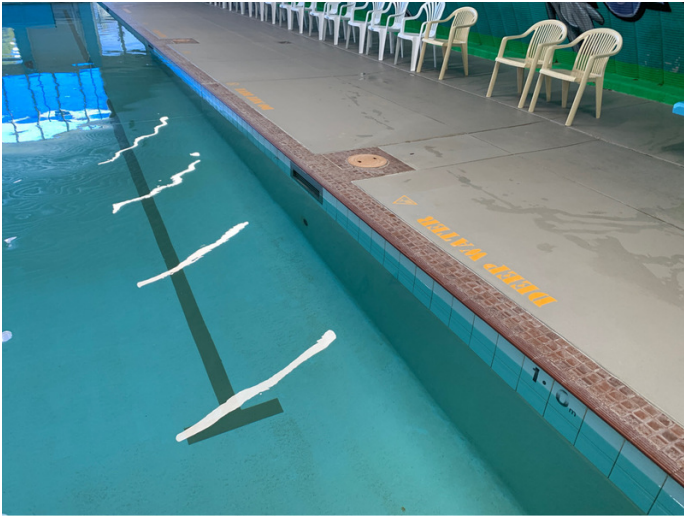
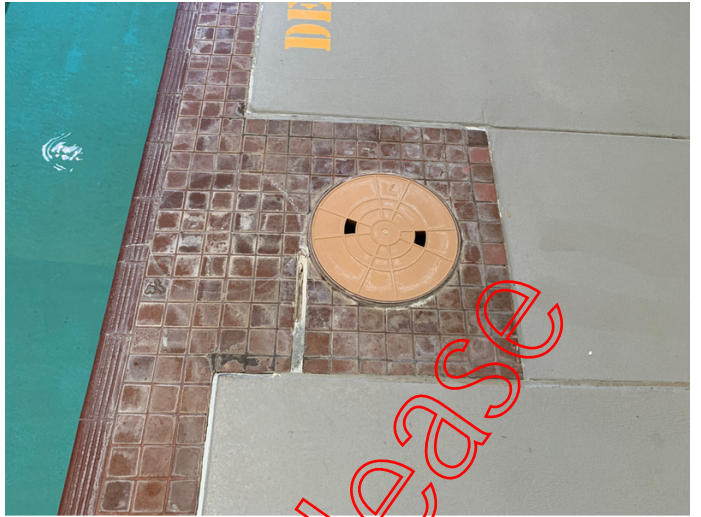
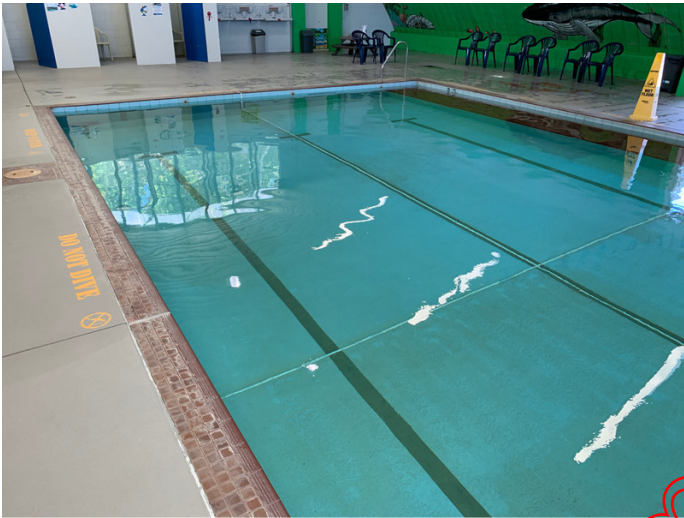
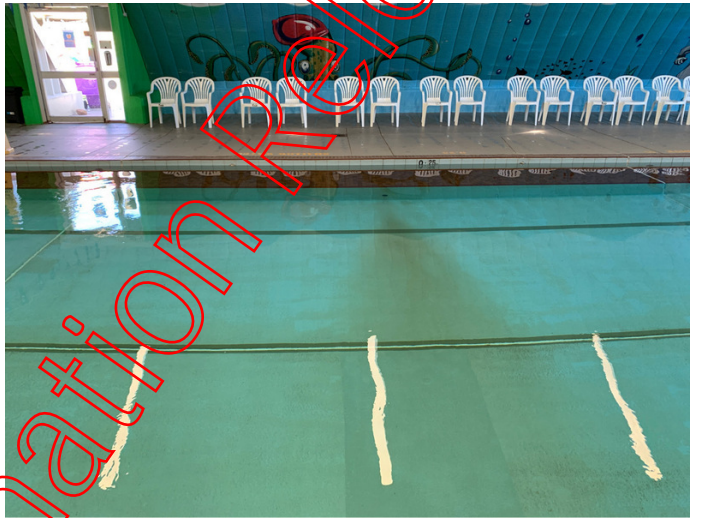
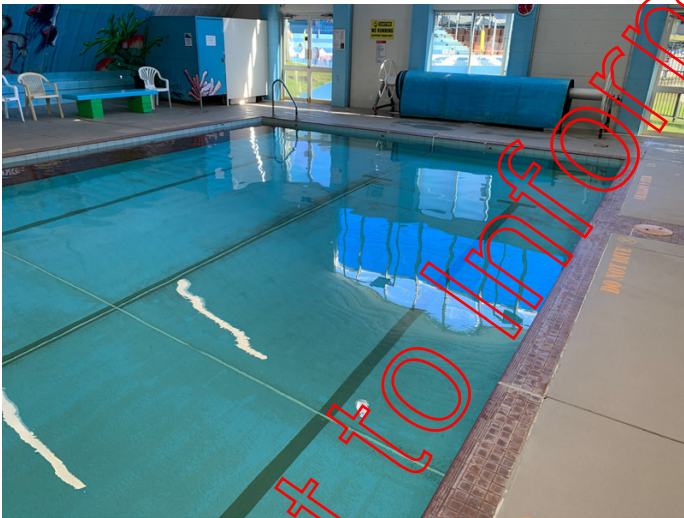
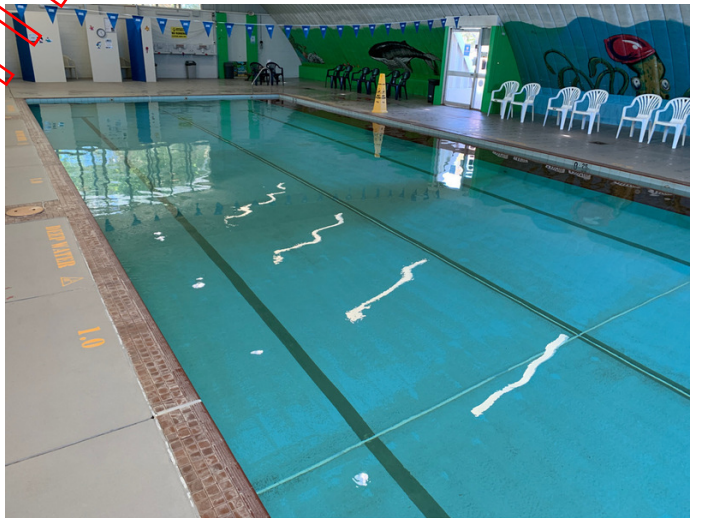
Observation Description	Finishes Condition
Observation Details	The finishes are in poor condition overall. The painted finish has failed with fibreglass visible through. Grout on the bench is generally missing whilst coping tiles are stained.
Recommendations	Replace the pool finishes
Critical Item?	No

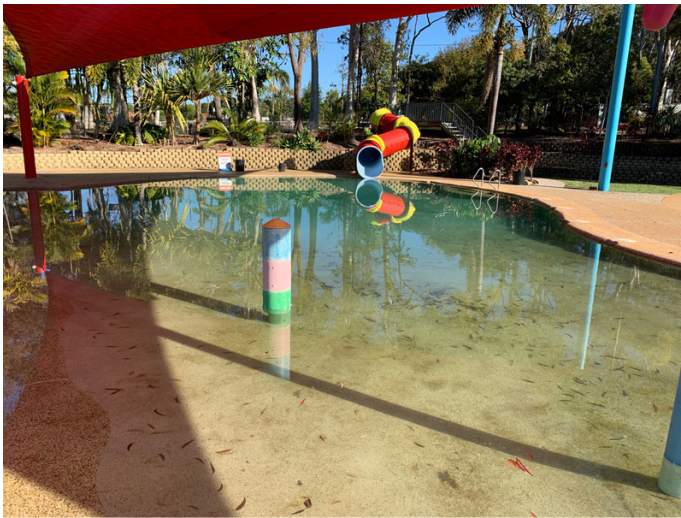
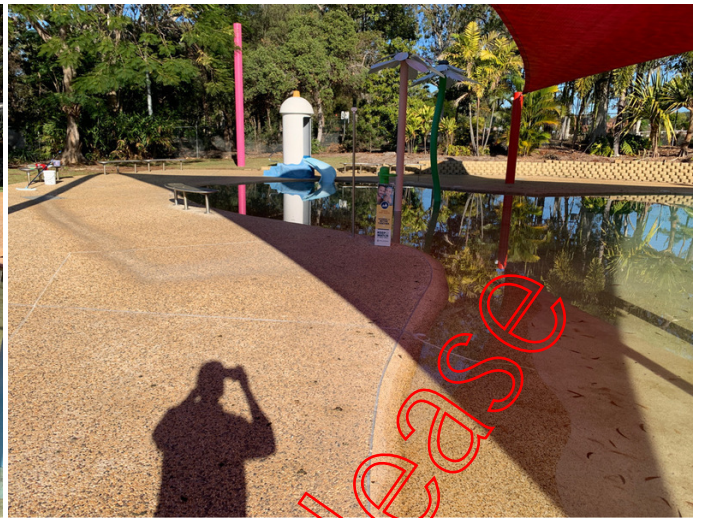
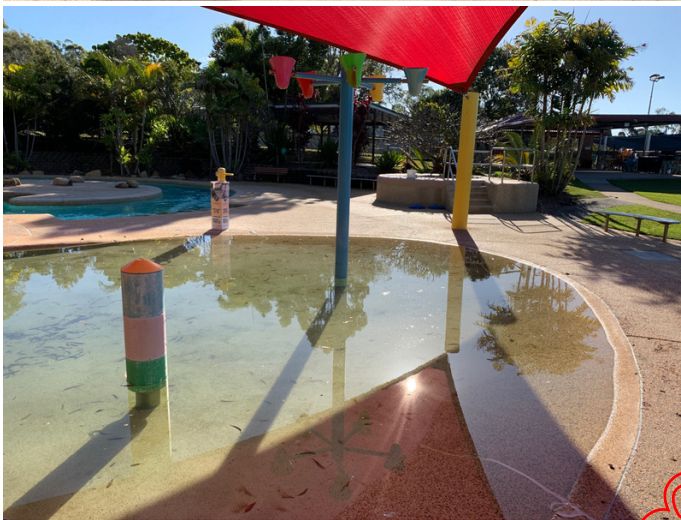
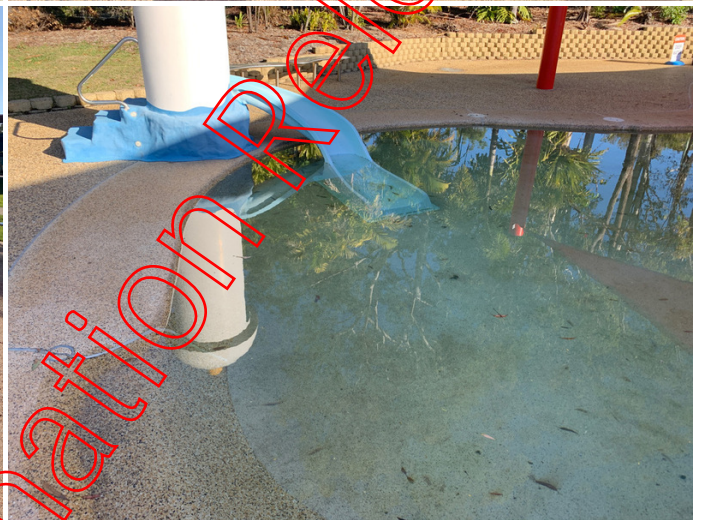
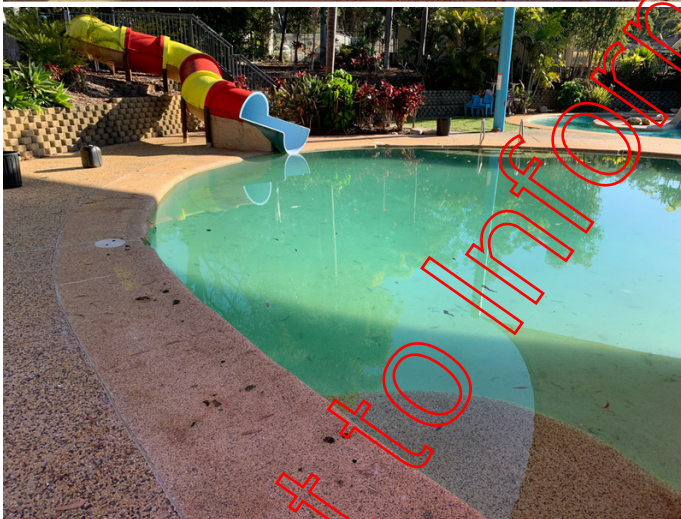
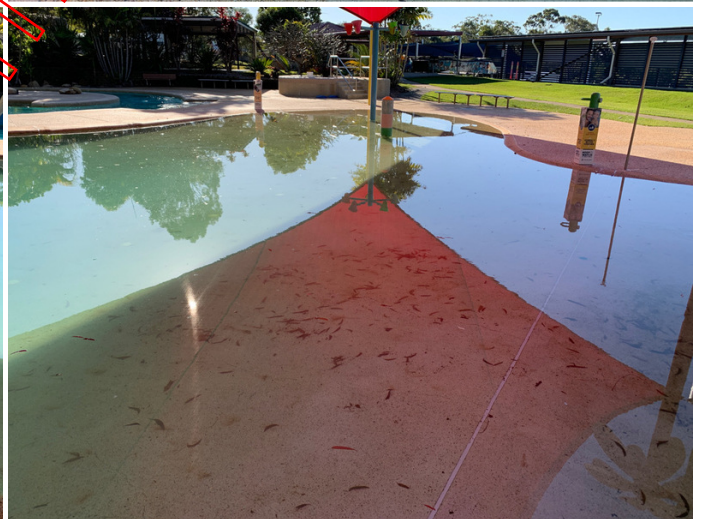
Features Description	Spray features are installed in the shallow regions of the pool whilst a fibreglass slide is installed in the deep area
Element Condition	3 - Average
Remaining Life (Years)	10
Replacement Cost (\$)	1000000
Element Photos

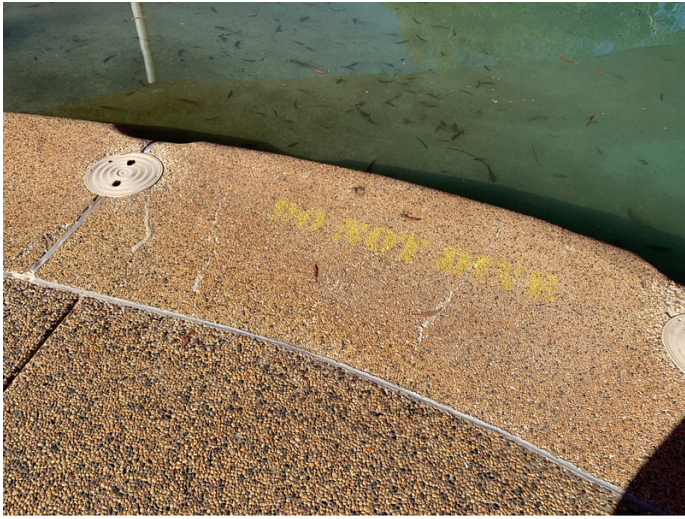
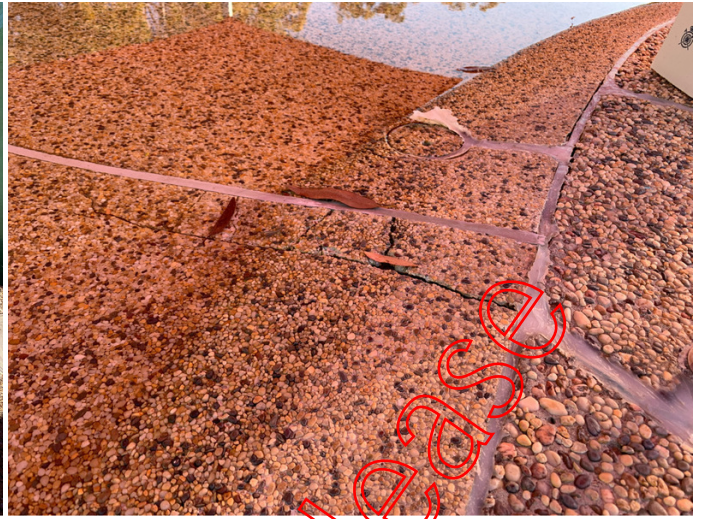
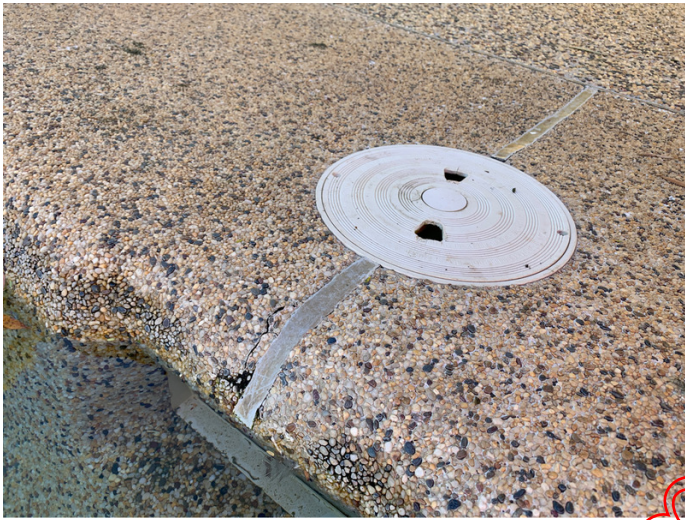
COPING FINISHES CONDITION

Observation Description	Coping Finishes Condition
Observation Details	The coping finishes condition is poor, with notable cracking observed in the finishes. In some areas sections of the finish are missing or delaminated.
Recommendations	Remove all finishes and inspect the sub grade for condition. Provide new finishes. In the interim, remove any loose areas and make good.
Critical Item?	Yes

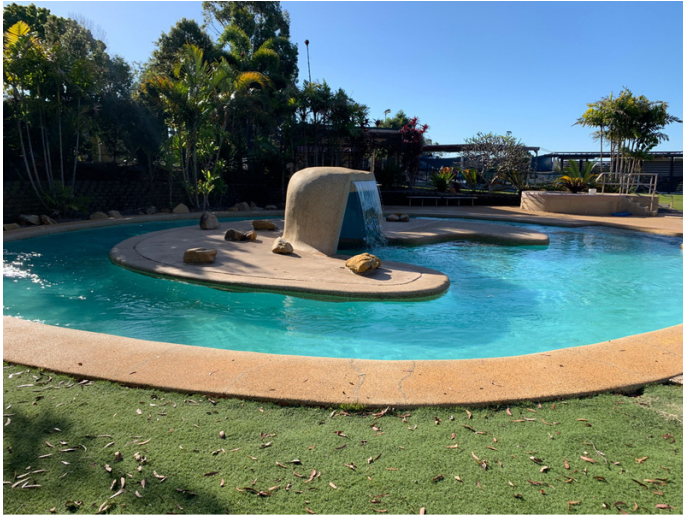
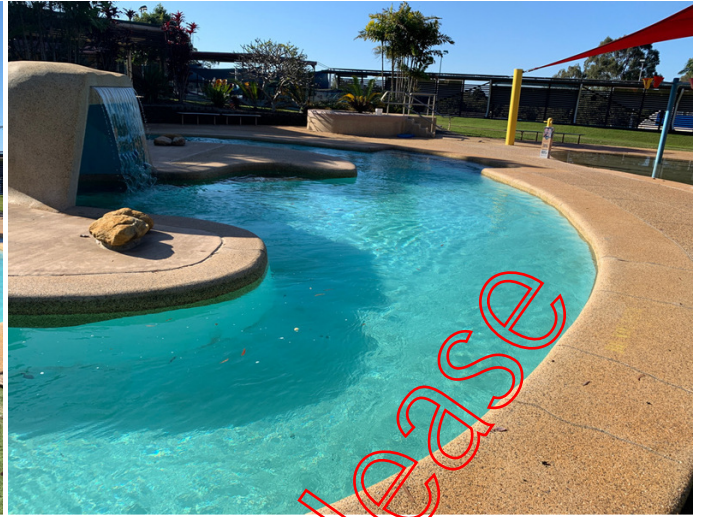
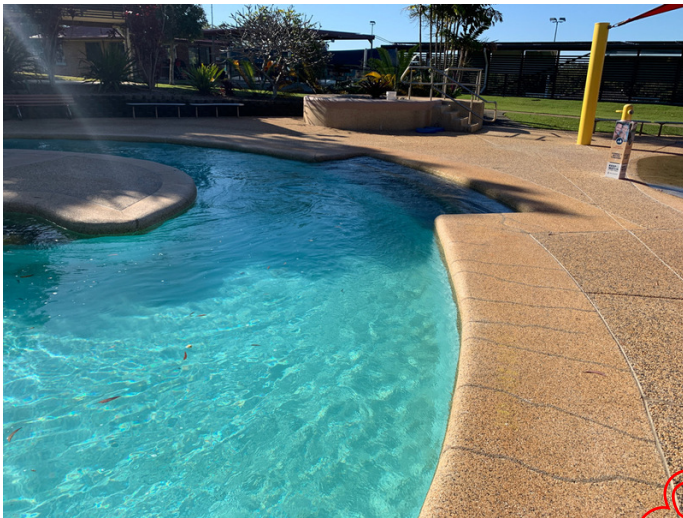
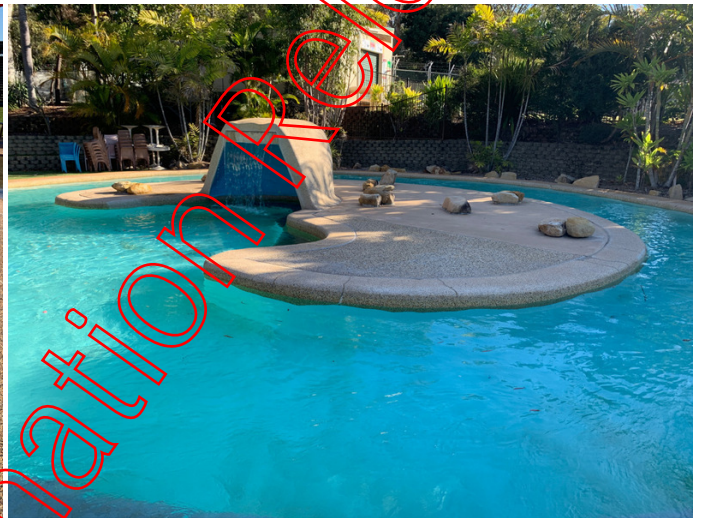
Features Description	Motive jets located in the walls provide the river current.
Element Condition	4 - Poor
Remaining Life (Years)	5
Replacement Cost (\$)	500000
Element Photos
