# Aquatic Facility Audit

AQ1-0224-DR1, Revision A

## Cleveland Aquatic Centre

**REDLAND CITY COUNCIL**

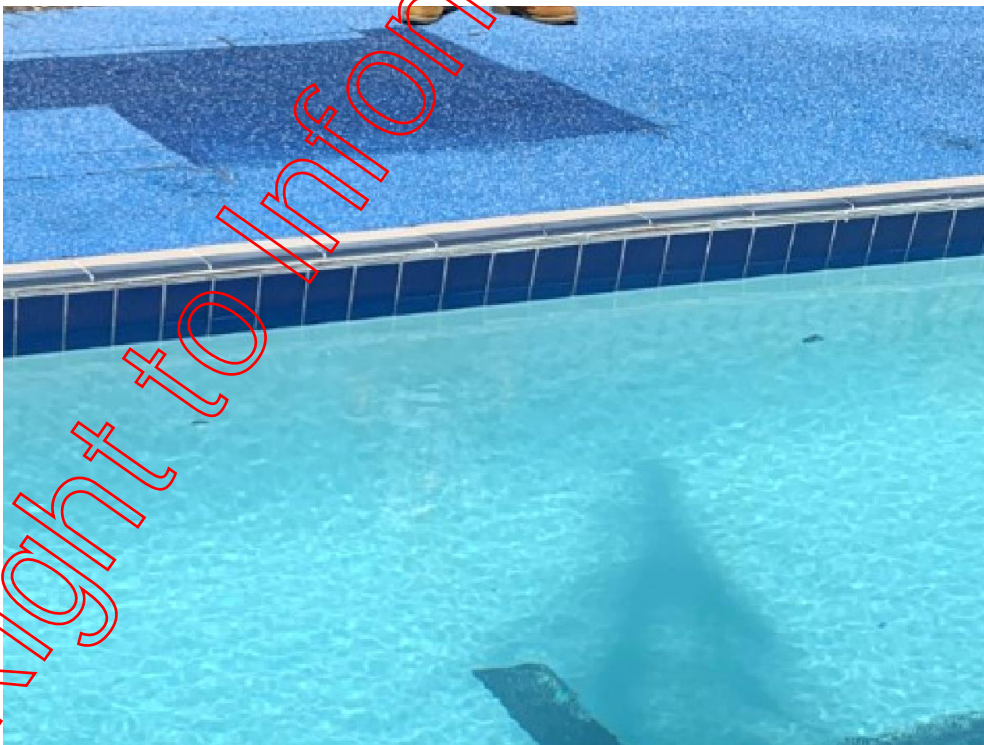
Figure 14: Uncovered filtered water returns

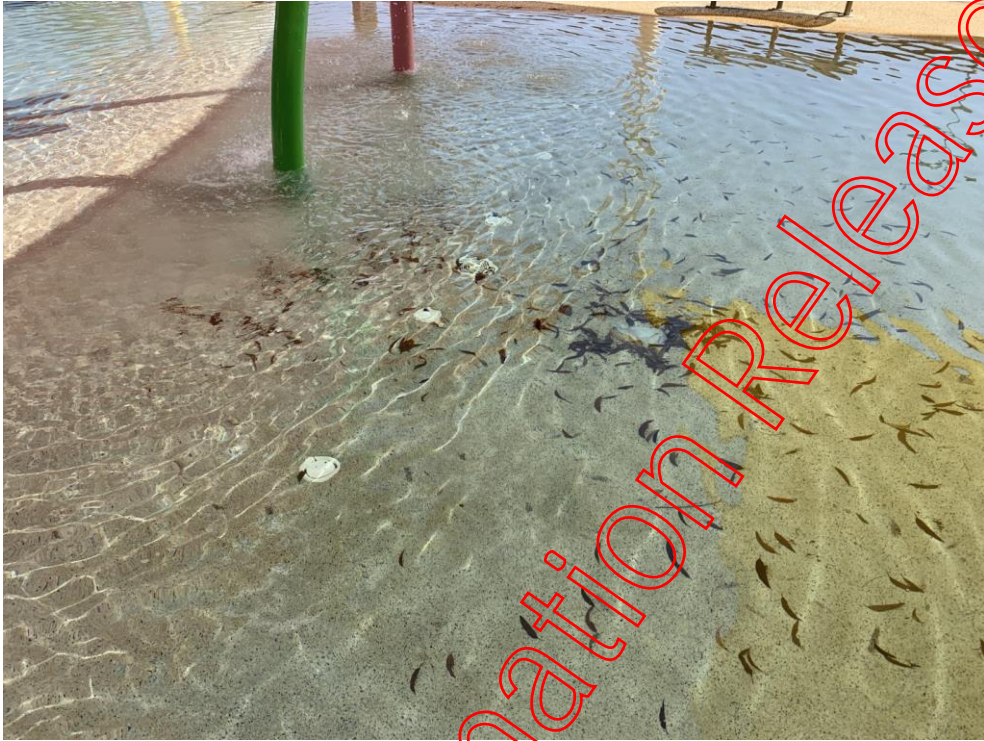
- Circulation through the pool appears low in areas. A large amount of leaf material was observed in the pool and in the shallow region some of these leaves sat on the filtered water returns without moving.

Figure 35: Leaves in shallow region sitting on returns

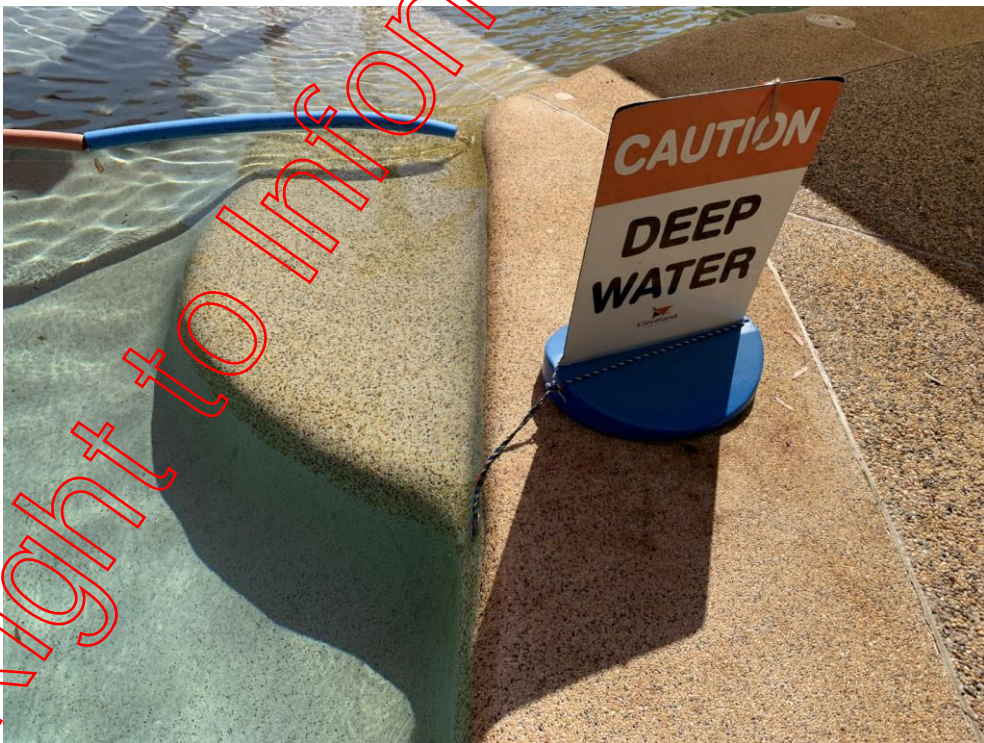
- A set of fiberglass stairs have been added to the waterslide splash down area above a bench. These only reach the bench.
- Signage around the pool is generally lacking or incorrect. For example, a warning sign adjacent the waterslide landing area notes 'deep water' however the pool is only 900mm deep here. This may cause confusion.

Figure 36: Deep water sign adjacent shallow water

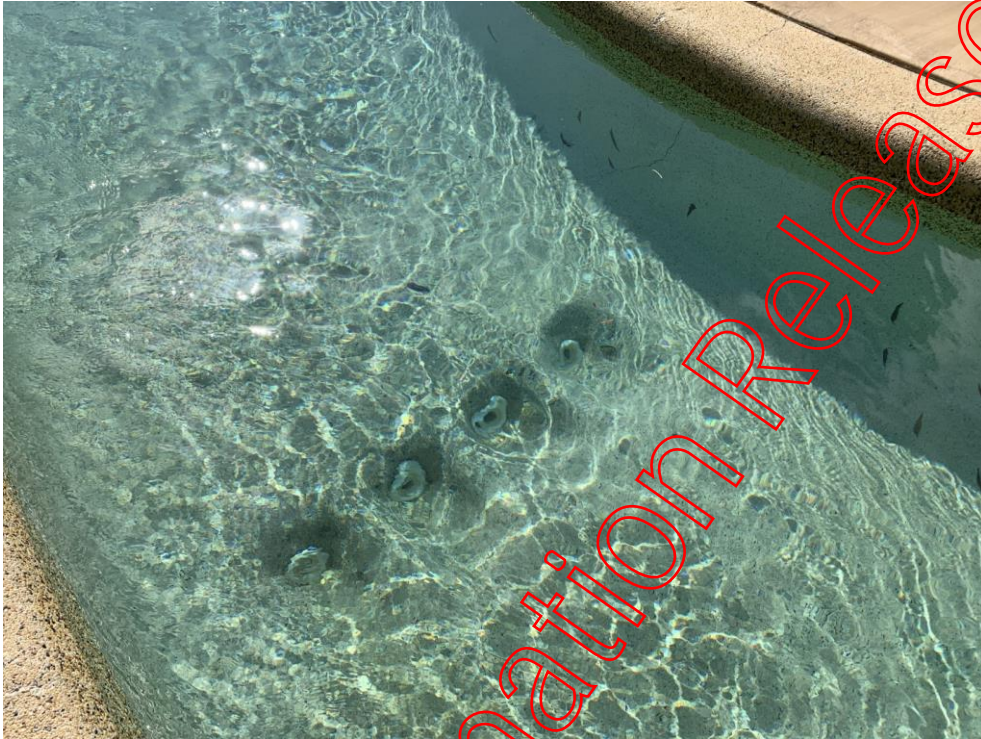
Figure 57: Jets in pool floor

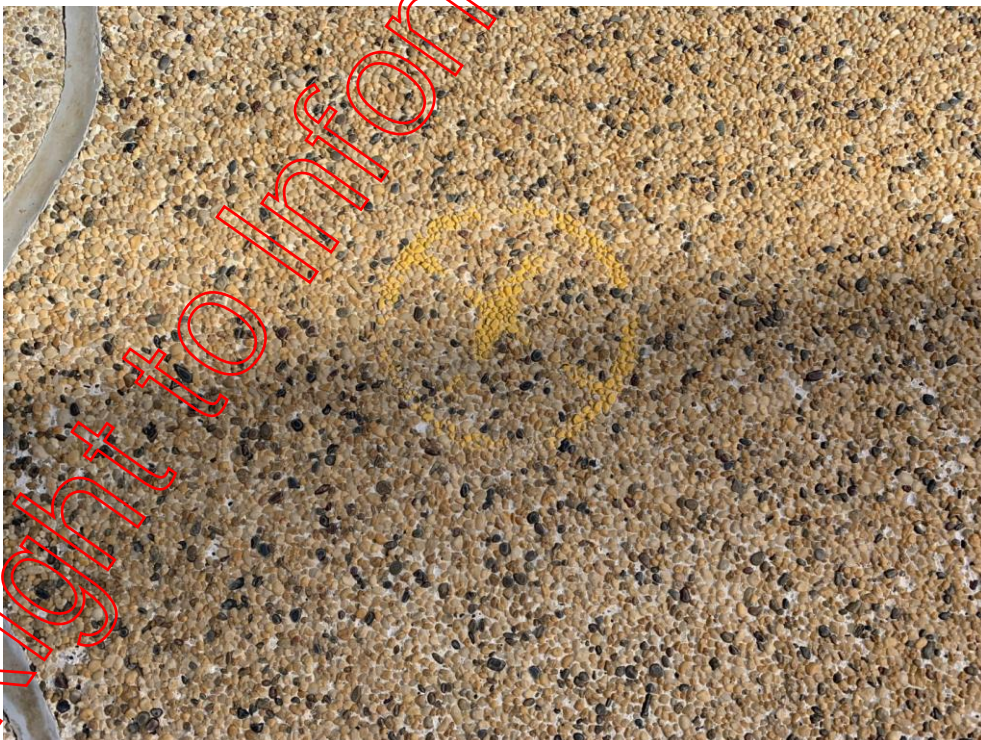
Figure 58: Faded signage

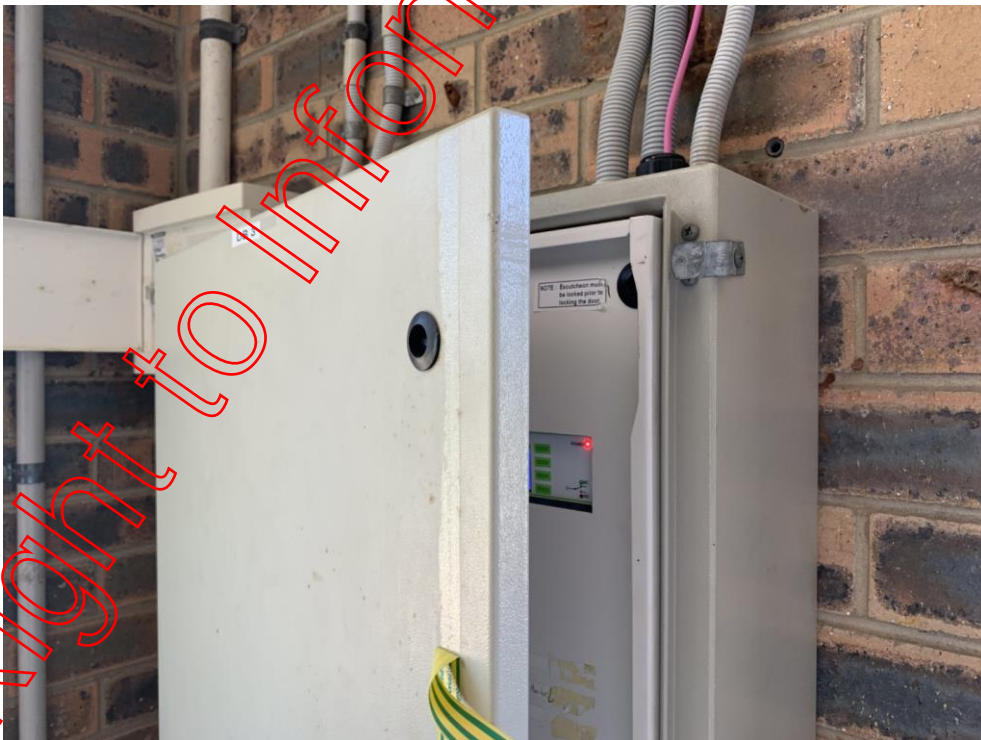
Figure 64: Conduit clip to hold door closed

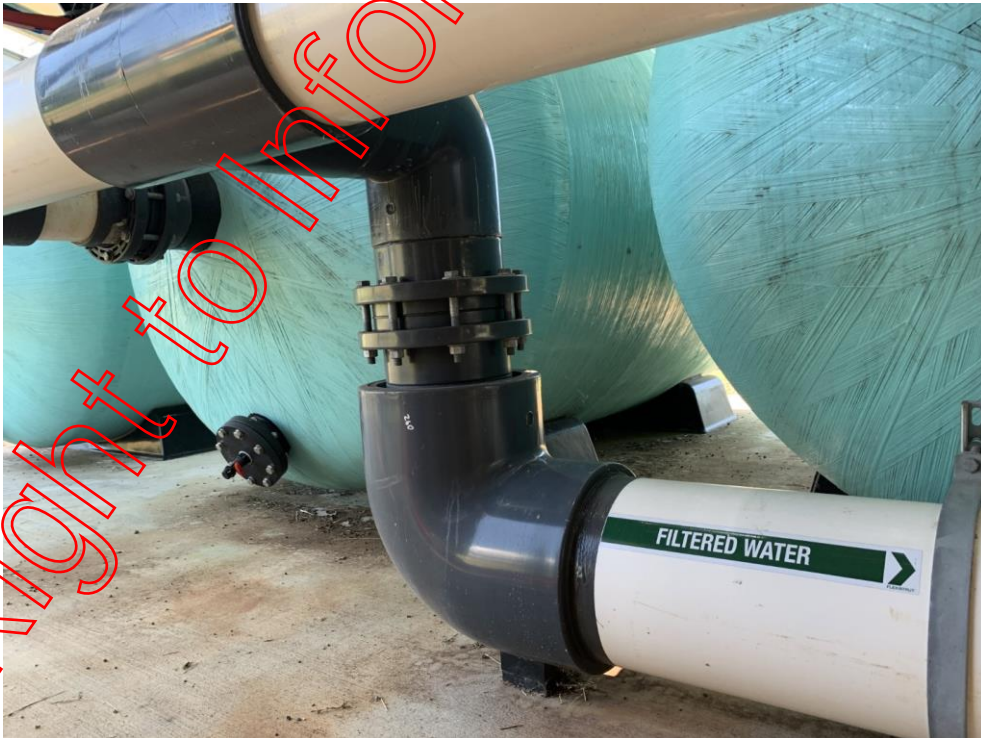
Figure 68: Late increase in pipe size

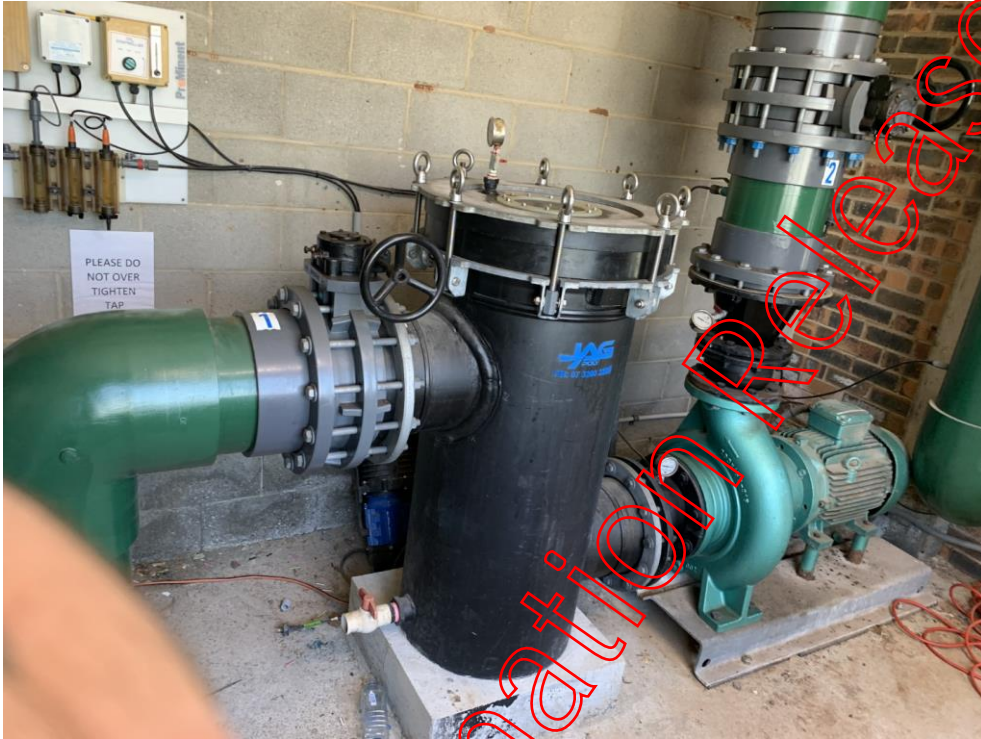
Figure 69: Large hair and lint pot

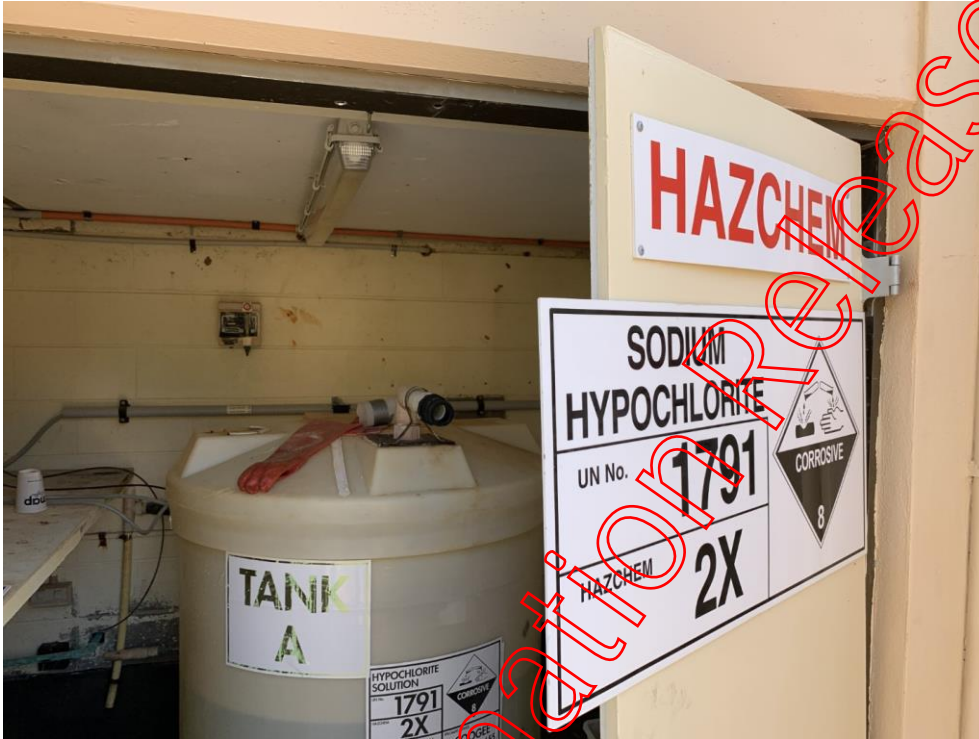
Figure 89: Poorly installed signage on broken door

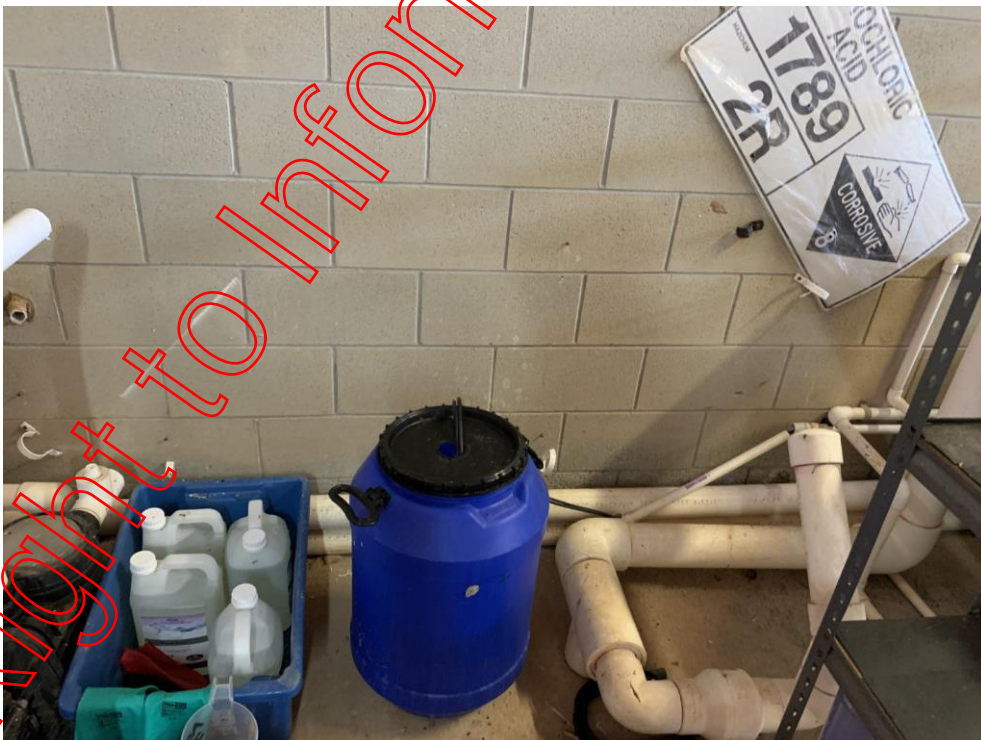
Figure 116: Poorly managed acid storage

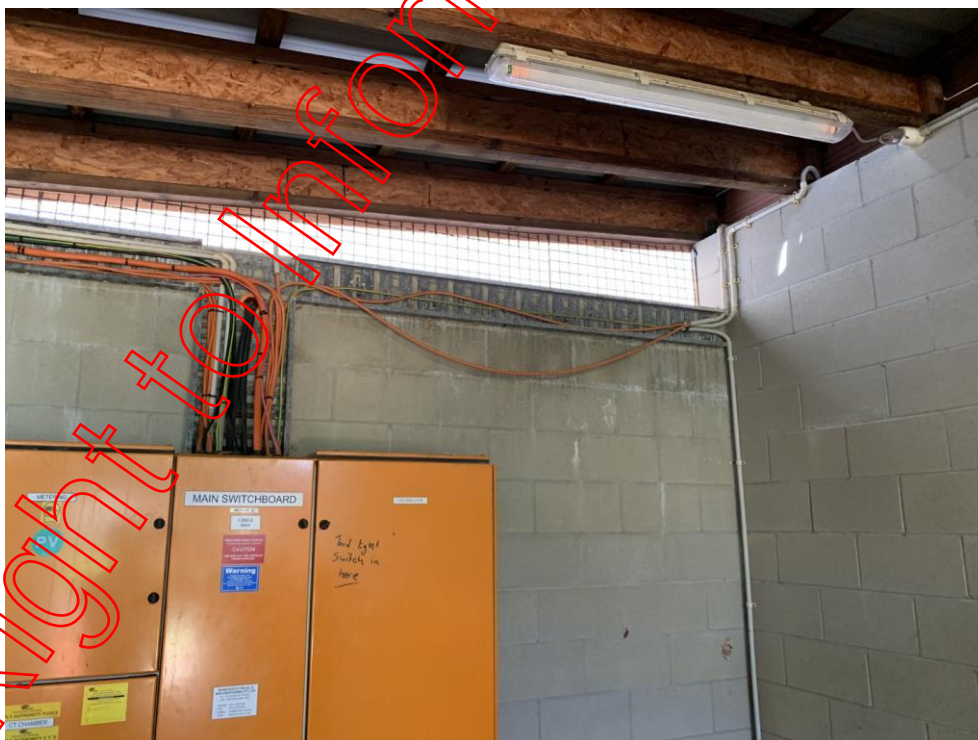
Figure 122: Electrical Cabling

- The electrical installation is poor in general, with inadequate signage, disused equipment and aged components. Cable trays are rusting and the switchboard contains obsolete equipment.

- Label all pipes with their flow direction and contents.
- Engage an electrical contractor to provide a full internal condition and compliance audit on the boards and electrical installation.

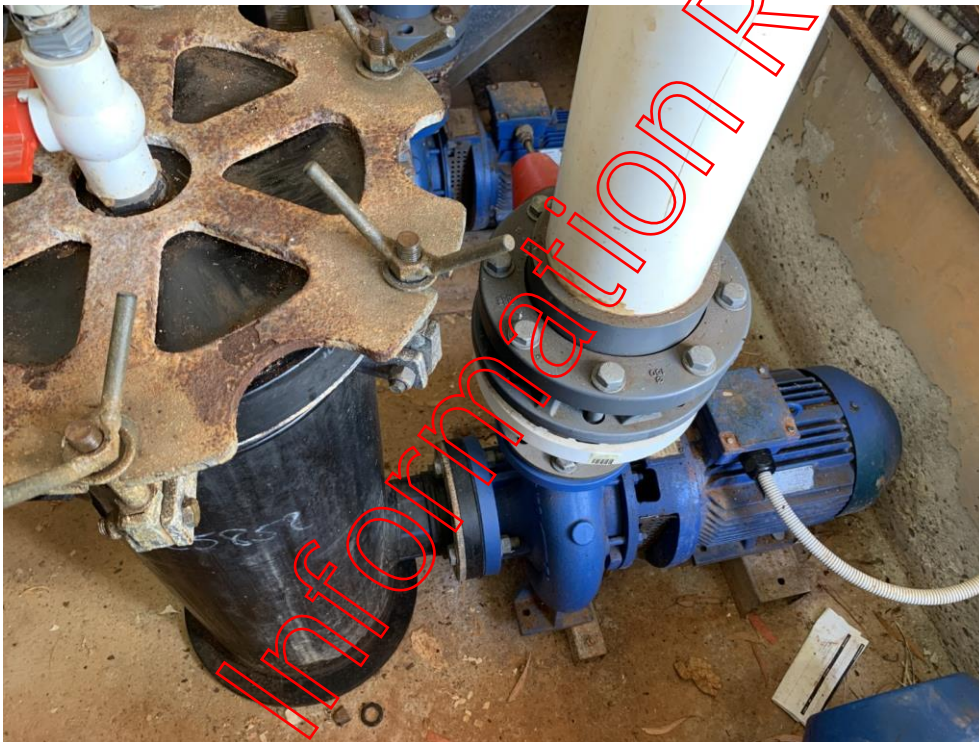
- The filtration pump is rusty and is not provided with inlet or outlet valves. The pump is not provided with no-flow protection, which may result in a pump burnout. Access to the pump and strainer is very poor.

Figure 124: Filtration pump

- Provide reliable flow monitoring equipment and confirm the system flow.
- Consider relocation of the pump to a more appropriate location as discussed above.
- Relocate acid dosing pumps, lines and storage to the opposite end of the equipment room and neaten up overall.

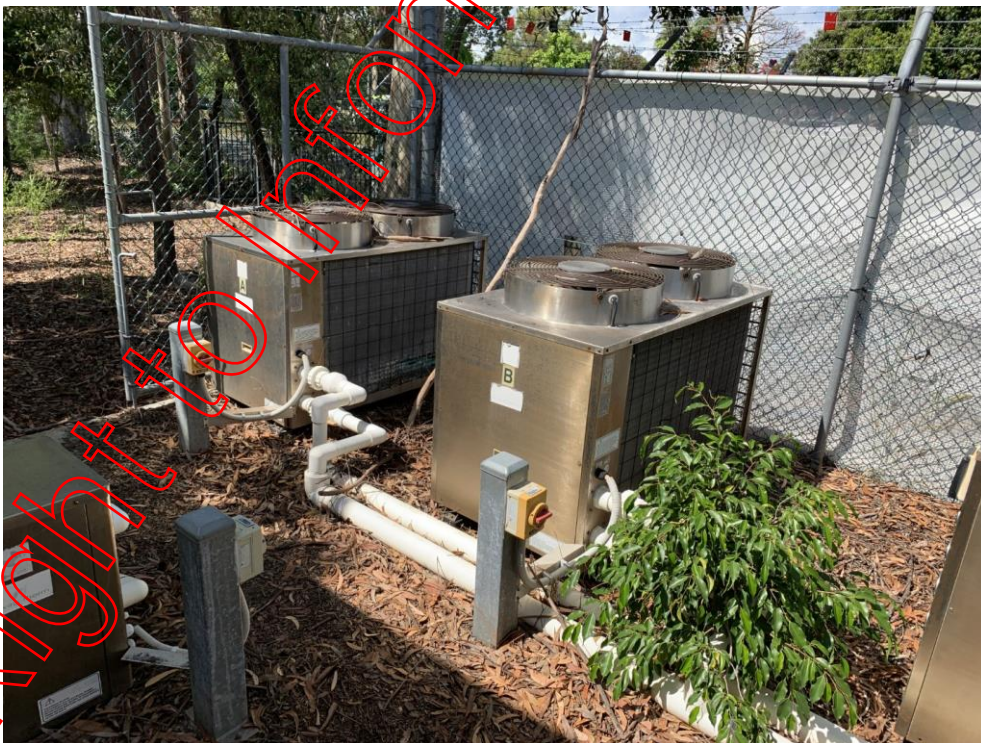
- Heating for the pool is currently shut down, with the heaters in poor condition. It's not known as to why.
- At the time of the inspection the chemical controller was not operational. It's understood that since then a replacement has been ordered.

Figure 126: Play pool heaters

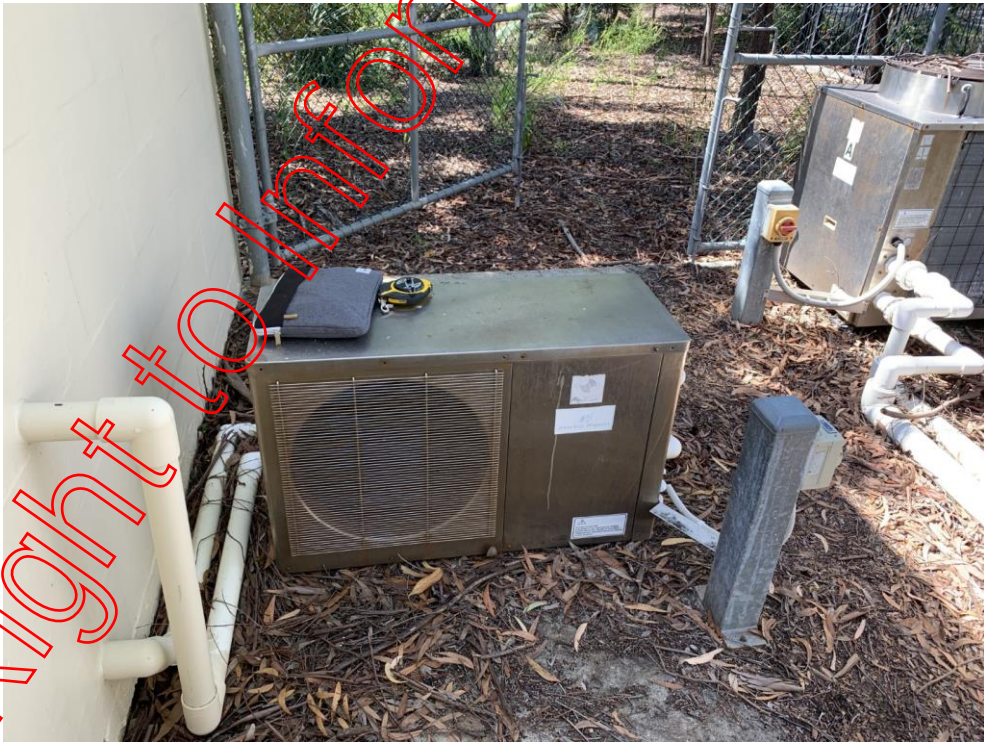
Figure 132: Disused heating
